Operation of PAL-XFEL LLRF

J. Hu[†], J. Hong, K.H. Kim, S. Jung, D. Na, Y. J. Park, S.-H. Kim, S. Park, C.-K. Min, H.-S. Kang, H.-S. Lee, PAL, POSTECH, Pohang, South Korea

Abstract

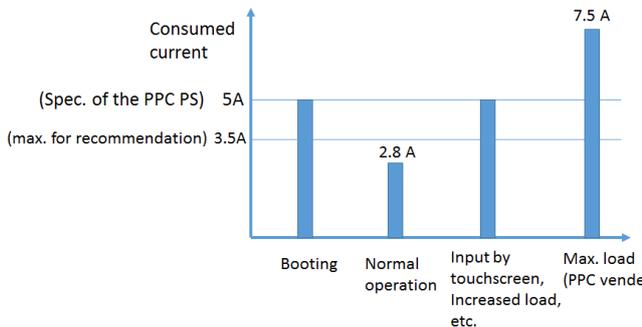
Figure 6: A simple current analysis of a PPC of a PAL-XFEL LLRF set.

With some investigation it was identified that the problems came from the degradation of power supplies of the PPCs. To see why the PSs were degraded, a simple current analysis was done as shown in Figure 6. It was judged from the analysis that the occasional use of the power supplies higher than the recommended value (3.5A, 70% of the indicated specification) caused the reduction of the lifetime of the power supplies.

All the PPCs' PSs were upgraded Feb. 2019. After the upgrade, the problematic sets were recovered but some sets which had not shown the problems newly showed the symptoms (Table 4). Therefore, we will be conducting further investigation.

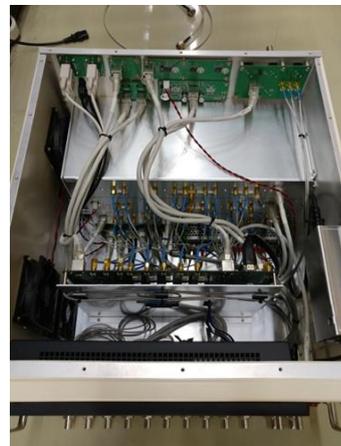
Figure 7: Internal view of a PAL-XFEL LLRF set.

PAL-XFEL LLRF had symptoms such as no output power, PSK (Phase Shift Keying) action working incorrectly, and incorrect temperature display. They had common features like normal operation of LLRF until the moment of failure and random occurrence. In total, there were less than 5 times for 4 years. Replacements of LLRF sets were made whenever the incidents occurred.

Symptoms that seemed to be irrelevant were due to incomplete connection of connectors. Figure 7 shows the internal picture of a PAL-XFEL LLRF unit. As one can see from the figure, many RJ45 connectors and 2 HDMI connectors are used.

Figure 8 shows a block diagram of the connection of cables between a digital board and a RF module illustratively. This configuration enables the internal connection simple, very efficient and high-speed operation but not perfect. Through reconnection of the cables, all the sets were recovered. We will search for better solutions such as new venders or new types of connections.

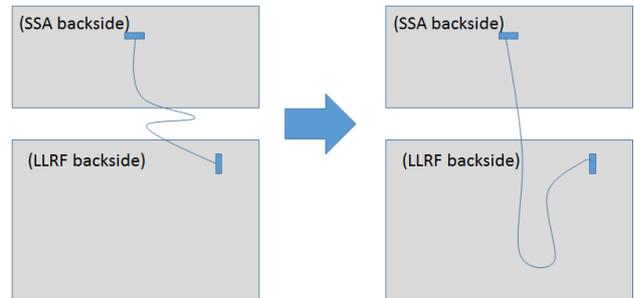
Figure 9 : Rerouting cable between LLRF and SSA pair

Another hint was found at L4-2 SSA, which occurred “over repetition” interlock several times suddenly right after winter maintenance. The job in the period was reinstallation of LLRF and reconnection of cables at the site. Therefore, the cable rerouting as shown in Figure 9 has been applied and no problem has occurred so far.

It is inferred from these hints that the strong electrical noise from the HV modulator affected RS-232 communication. For L4-2 SSA case, the abnormal interlock was disappeared in the change as shown in Figure 9 but for some

other stations, the reverse showed positive effects. As long-lasting solutions, noise countermeasures will be in place or more noise-resistant communications will be applied in the next version.

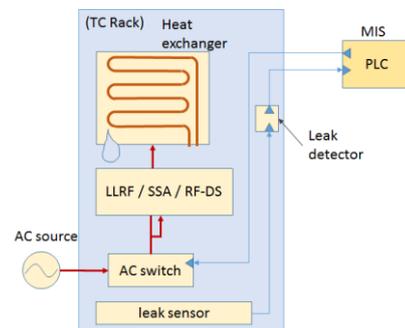
Figure 10: Block diagram of PAL-XFEL TC rack

TC rack (Temperature-Controlled Rack) for PAL-XFEL is shown in Figure 10. The TC rack regulates temperature inside the rack with cooling water and has a leakage detector to cut electricity when leak events occur. The leak detection system worked properly and helped to detect leakage remotely early.

As shown in Table 5 leak events increased considerably this year. Whenever cooling water leak, the leak exchangers are replaced with spare exchangers. The working time required for each replacement is about 1~2 hours and the number of spare exchangers is only two, which are not enough to manage the events.

Therefore, we proceed in three ways; preparing more spare exchangers, redesigning heat exchangers and developing a rack easier to replace heat exchanger.
