# Interpreted Investigation Report: Loss of Vikram Lander During Lunar Landing Phase

**Abstract:** This article examines India's first science lander mission on 22 July 2019, attempting a historic landing on the Lunar South Pole Region. Communication was lost at 2.1 km above the lunar surface during the rough braking phase. The cause of the Chandrayaan 2 lander "Vikram" failure remains undisclosed. Possible factors such as vibrations, thruster issues, and power depletion are considered. Recommendations include backup power sources and direct communication systems for interplanetary missions. Despite the setback, ISRO proposed "Chandrayaan 3" to explore the lunar polar region. Chandrayaan 2's legacy influences future missions, shaping India's aspirations for pioneering space endeavors. Gratitude is expressed to ISRO for insights gained during live coverage.

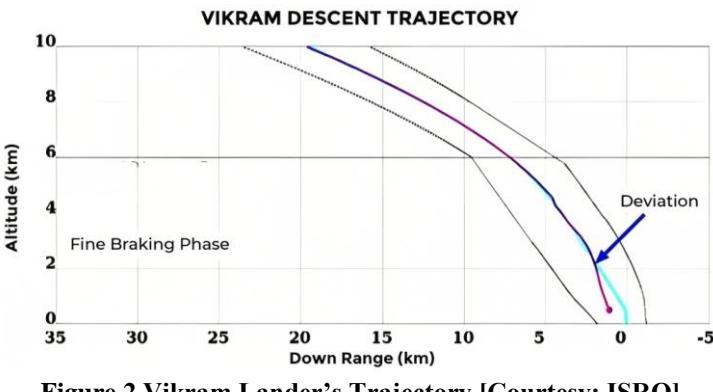
Figure 2 Vikram Lander's Trajectory [Courtesy: ISRO]

- At the juncture where a trajectory graph indicates a deviation, it's conceivable that the cessation of thruster activity or incorrect firing of descent thrusts might have led to the spacecraft's loss of control over its orientation. This, in turn, could have resulted in the crash of the lander onto the lunar surface.

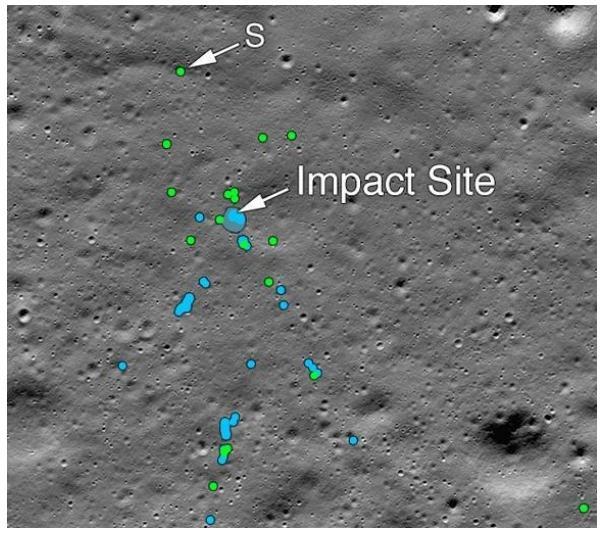
The detailed sequence of the Vikram lander's landing process is depicted in Figure 1. Subsequent to the landing attempt, efforts were undertaken to locate the impact site of the lander. It was Shanmuga Subramanian who first reported notable changes in lunar surface activity, ultimately aiding in the identification of the lander and its impact site by NASA. The crash site of the lander was determined to be at coordinates 70.8810°S, 22.7840°E, with an elevation of 834 meters (Source: NASA), as illustrated in Figure 3 [1].

During the phase known as Camera Coasting, ISRO took measures to stabilize the altitude of the Vikram Lander at around 7-8 kilometers. This involved fixing both horizontal and vertical orientations in a single direction. However, although the Vikram lander was able to manage its horizontal velocity, it experienced a loss of control over its vertical velocity, leading to a downward acceleration. As the lander transitioned into the rough braking phase, the engine thrust unexpectedly reached maximum levels. This excessive thrust aggravated the inability to control the lander's vertical velocity, resulting in the generation of erroneous trajectory data. Consequently, this erroneous data led to a trajectory deviation, as illustrated in Figure 2. Furthermore, the lander's designed with an orientation adjustment of 10 degrees per second, but it could not be maintained. This led to a loss of control over the lander's orientation, culminating in a crash landing at an unspecified location (Refer Figure 3). In addition to these challenges, the lander encountered a timing issue where the timer experienced a brief interruption, reducing the effective landing duration. This timing anomaly further contributed to the unsuccessful landing attempt. Subsequent to these malfunctions and the subsequent necessary corrections, Chandrayaan 3 successfully addressed these issues, achieving a successful landing on the lunar surface in the South Polar Region on August 23, 2023 [7-10] [Dr.Somnath (ISRO) explained about the root cause at IISc, Bangalore].

Figure 3 Impact Site of Vikram Lander [Credit: LRO, NASA] (Color Code: Green – Debris; Blue – Soil Disturbance S – Debris found by Subramanian) 5. Recommendations

Based on the comprehensive analysis conducted following the incident involving the Vikram Lander, we extend our key recommendations to the broader space industry. Specifically, we advise space organizations to consider the integration of Nuclear Thermoelectric Generators (NTG) or Radioisotope Thermoelectric Generators (RTG) as secondary power sources, serving as reliable backups for spacecraft engaged in missions to destinations such as the South Lunar Region or even locations beyond the Mars orbit. This strategic implementation is motivated by the challenges associated with solar irradiance and sunlight availability, which have been identified as primary factors contributing to power loss and battery depletion [8].

Furthermore, we advocate for the adoption of a direct communication framework for both lander and rover missions targeting interplanetary destinations. By employing this approach, the potential impact of communication system impairments can be mitigated. In the event that one communication system encounters difficulties, the alternative channel would ensure continuous and robust connectivity. This dual communication system setup not only to maintain mission reliability but also guarantees the ability to promptly ascertain mission status even in the face of unforeseen communication disruptions. These recommendations, derived from a comprehensive analysis of the Vikram Lander's incident, offer valuable insights into enhancing mission success rates and fortifying communication integrity for ventures aimed at celestial bodies across the cosmos.
