Assembly and Installation of the Daya Bay Antineutrino Detectors

ABSTRACT: The Daya Bay reactor antineutrino experiment is designed to make a precision measurement of the neutrino mixing angle θ_{13} , and recently made the definitive discovery of its non-zero value. It utilizes a set of eight, functionally identical antineutrino detectors to measure the reactor flux and spectrum at baselines of $\sim 300 - 2000\text{m}$ from the Daya Bay and Ling Ao Nuclear Power Plants. The Daya Bay antineutrino detectors were built in an above-ground facility and deployed side-by-side at three underground experimental sites near and far from the nuclear reactors. This configuration allows the experiment to make a precision measurement of reactor antineutrino disappearance over km-long baselines and reduces relative systematic uncertainties between detectors and nuclear reactors. This paper describes the assembly and installation of the Daya Bay antineutrino detectors.

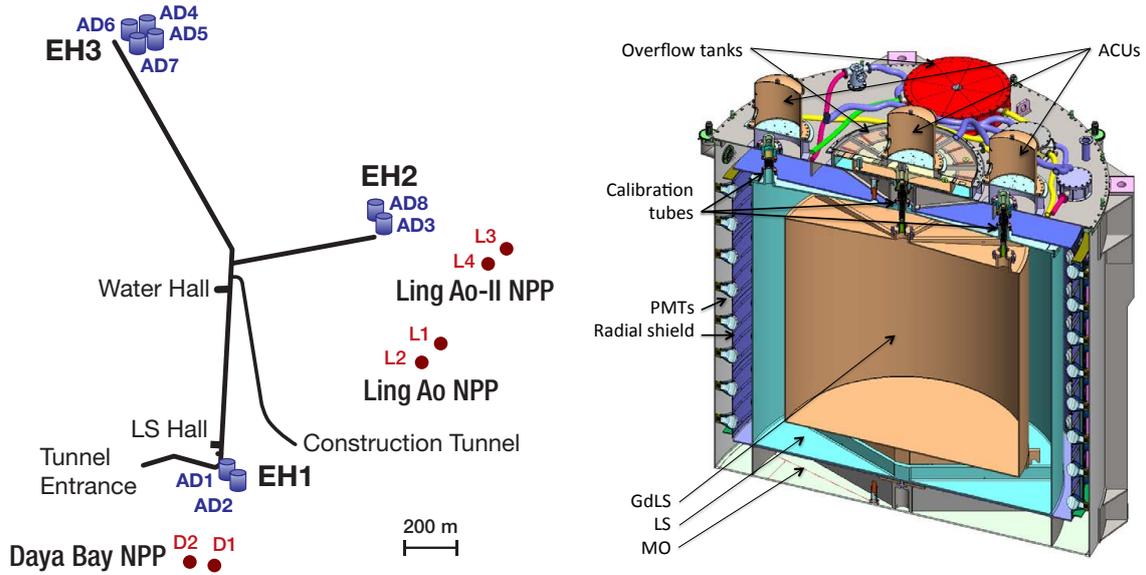
Figure 1. (left) Layout of the Daya Bay experiment. The dots represent reactors cores, labeled as D1, D2, L1, L2, L3 and L4. There is one pair of cores at each of the Nuclear Power Plants (NPP). Eight antineutrino detectors (ADs) are installed in three experimental halls. (right) The Daya Bay antineutrino detector contains 3 zones: a gadolinium loaded liquid scintillator inner target (20 tons) inside the inner acrylic vessel (brown), a liquid scintillator gamma catcher (21 tons) contained by the outer acrylic vessel (aqua), and a mineral oil buffer (37 tons) inside the stainless steel outer vessel (grey).

As shown in Fig. 1 the Daya Bay experiment consists of three underground experimental halls located 360-2000 m from three pairs of reactor cores. The experimental halls are excavated under the side of an adjacent mountain to reduce cosmic ray backgrounds and are connected by large aperture tunnels. Each of the two near experimental halls contains two antineutrino detectors (ADs) in an instrumented water pool. The far experimental hall contains four ADs in a larger water pool. The ADs are constructed in an above ground assembly building before being transported underground to the liquid scintillator (LS) filling hall. The filled ADs are then moved on a custom transport to the appropriate experimental hall and lifted by an overhead crane into the water pool.

Each AD consists of a Stainless Steel Vessel (SSV) containing 3 detector zones filled with different liquids as shown in Fig. 1. Two nested acrylic cylinders separate the 3 zones. The innermost target zone contains 20 tons of gadolinium-doped liquid scintillator (GdLS) inside an Inner Acrylic Vessel (IAV). This zone is surrounded by 21 tons of liquid scintillator (LS) gamma catcher contained by an Outer Acrylic Vessel (OAV). The scintillation light from IBD interactions is observed by 192 photomultipliers (PMTs) arranged in a cylindrical shell. An outer zone of liquid contains 37 tons of mineral oil (MO) that shield the inner zones from radioactivity originating in the PMT glass or other background sources. Overflow tanks above the SSV lid allow for the expansion of the liquids with changes of temperature or external pressure. Reflectors above and below the LS volume improve the light collection efficiency, increase the uniformity of the light collection, and reduce variations in the energy response of the detector along its vertical axis. Three automated cal-

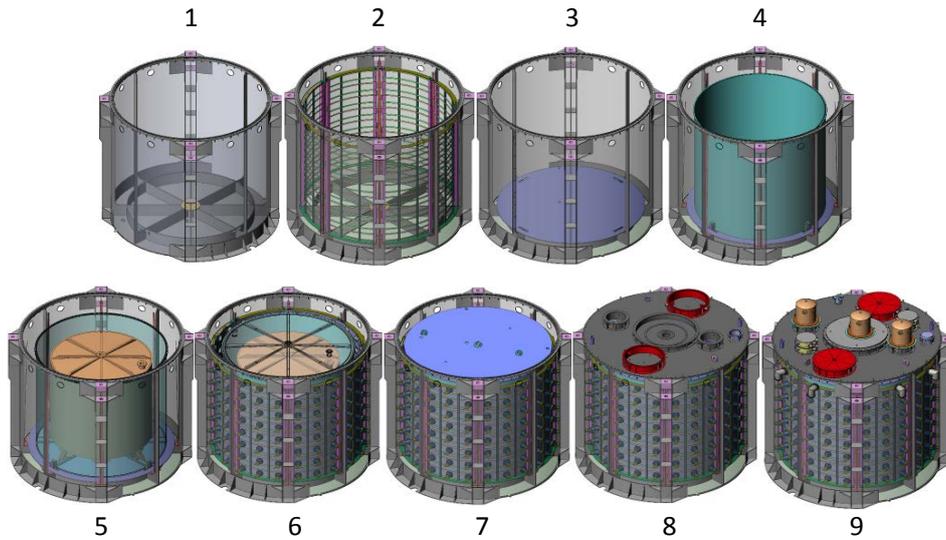
Figure 2. AD assembly sequence. (1) After cleaning, the SSV is placed in the assembly pit. (2) Bare PMT ladders are test mounted and surveyed. (3) The bottom reflector is inserted. (4) The OAV is placed on the reflector. (5) The IAV is brought in and mounted inside the OAV. (6) the OAV lid is mounted and the PMT ladders are installed. (7) The upper reflector and lower parts of the OAV calibration tubes are installed. (8) The SSV lid is installed. (9) The overflow tanks, upper calibration tubes, covers and ACUs are installed.

Assembly of an AD followed a well defined sequence of steps, previously shown in Fig. 2 and

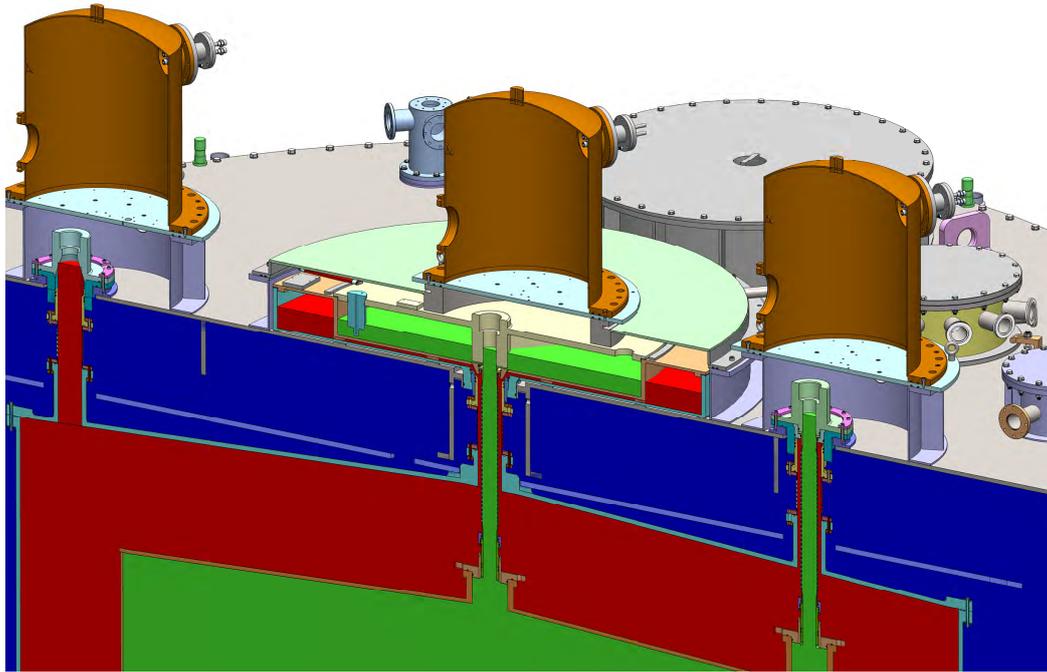
Figure 3. Liquid volumes inside the Daya Bay vessels, calibration tubes, and overflow tanks: GdLS - green, LS-red, MO-blue. The outside of one of the MO overflow tanks is seen behind the central ACU. The IAV and OAV are connected by convoluted teflon tubes to the SSV lid or to the central overflow tanks. All surfaces contacting the GdLS or LS (red or green) are constructed from acrylic or teflon components.

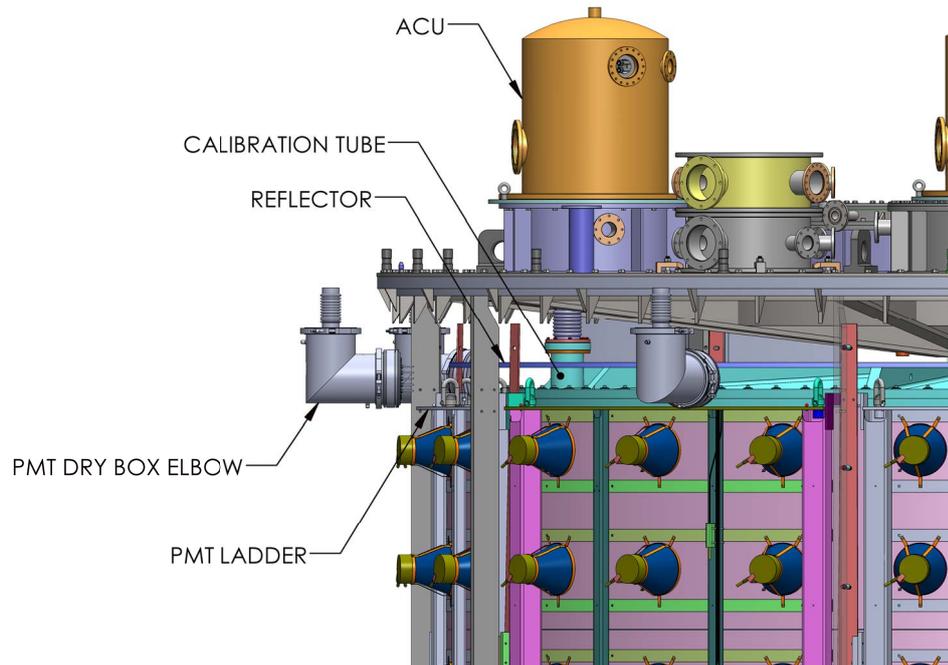
Figure 4. AD section with the SSV wall removed to show details of the PMT mounting method, the dry box connections, upper reflector support and one of the OAV calibration tubes. Above the SSV lid are ACUs, electrical interface boxes and overflow tanks. The complicated geometry of the SSV ribs and tube connections are hidden from the PMT field of view by the reflector.

Daya Bay ADs have reflectors below and above the GdLS target volume to reduce the number of PMTs required and to simplify construction (see Fig. 4). Monte Carlo simulations [6] predict an acceptable light collection uniformity. The reflector also has the advantage of hiding complex lid or SSV base geometry from the PMT's field of view.

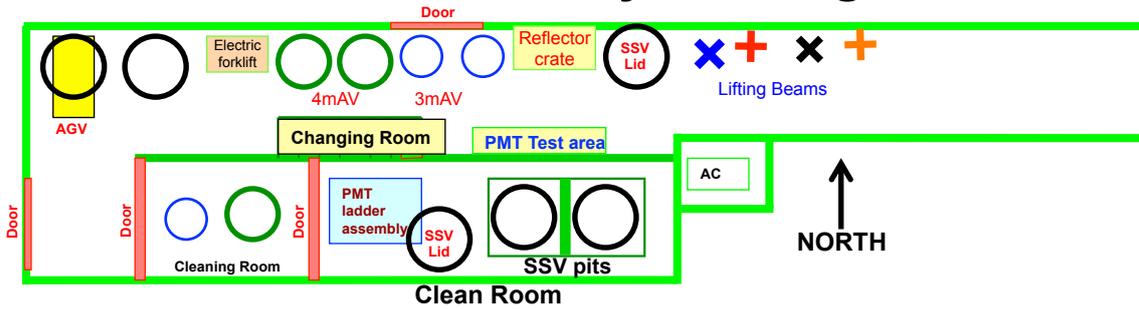
Figure 5. Surface Assembly Building during the height of activity. Two partially assembled stainless steel vessels (SSVs -black circles) are in the clean room. A recently cleaned 4 meter outer acrylic vessel (OAV - green circle) waits in the cleaning area. A 3 meter inner acrylic vessel (IAV - blue circle) is also being prepared for cleaning. Other components are stored in the neighboring bay.

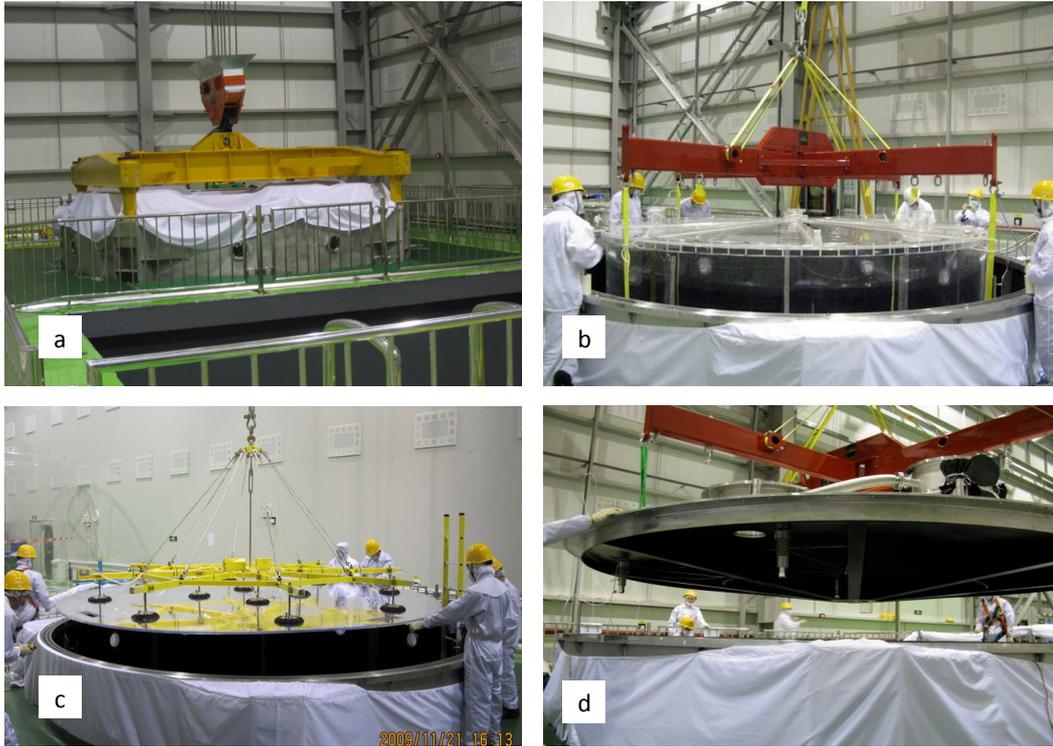
Figure 6. Custom lifting fixtures for AD assembly. (a) SSV lifting fixture (yellow) connected to a SSV. (b) multipurpose fixture (red) used to lower an OAV into the SSV. (c) vacuum pad fixture (yellow) used to install the reflector. (d) the multipurpose fixture lowering the SSV lid into place.

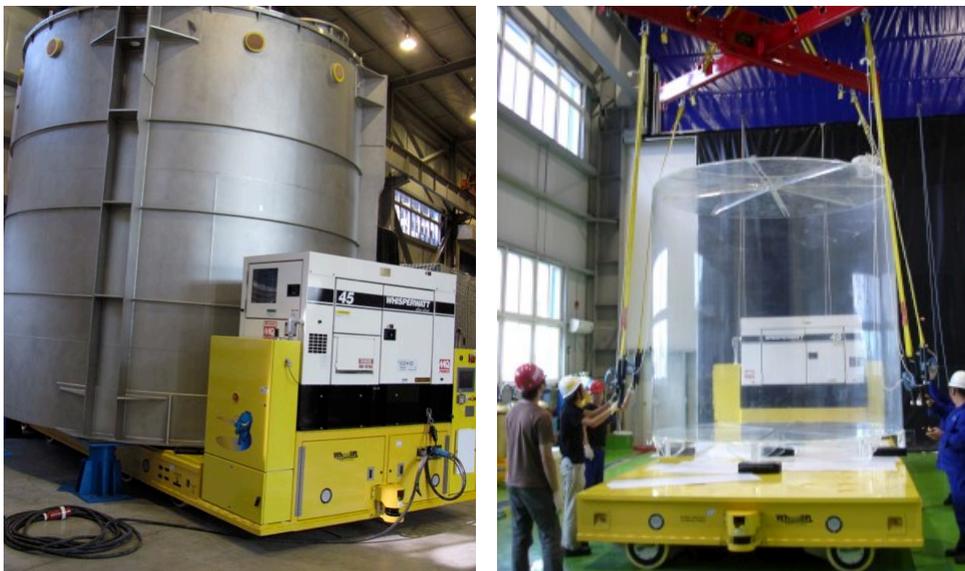
Figure 7. (left) The SSV is being lifted by the AGV from storage stands prior to transport to the cleaning room. (right) An IAV has been lifted onto the AGV after cleaning.

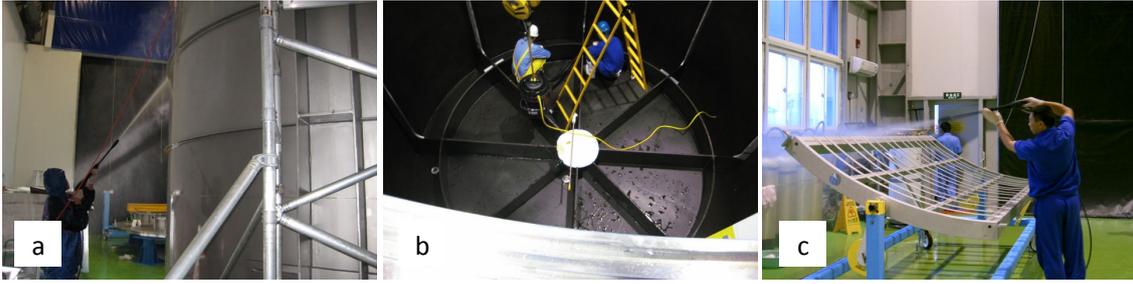
Figure 8. (a) Pressure cleaning of the outside of the SSV. (b) Cleaning the interior of the SSV. (c) Pressure cleaning of a PMT ladder..

A summary of the SSV cleaning procedure follows. The SSV was delivered into the cleaning area and set on temporary stands. The SSV lid was removed and stored for a separate cleaning. The top flange and grooves were cleaned with a microfiber cloth and a 1% Alconox solution. The flange area was then pressure rinsed with high resistivity water. Cleaning the outside of the SSV followed the same procedure as seen in Fig. 8a. Extra spot scrubbing was done with Al_2O_3 powder and microfiber cloth. The rinse water was collected and measured with a conductivity meter. When the rinse water conductivity matched that of the water from the pressure washer, $\approx 6\mu S$, rinsing was considered complete. The cleaning of the interior of the SSV, shown in Fig. 8b, followed

The PMT ladders displayed some corrosion after shipment to Daya Bay from the United States. An additional acid cleaning step at a local factory was added to the cleaning regimen with an extra vigorous pressure wash as seen in Fig. 8c.

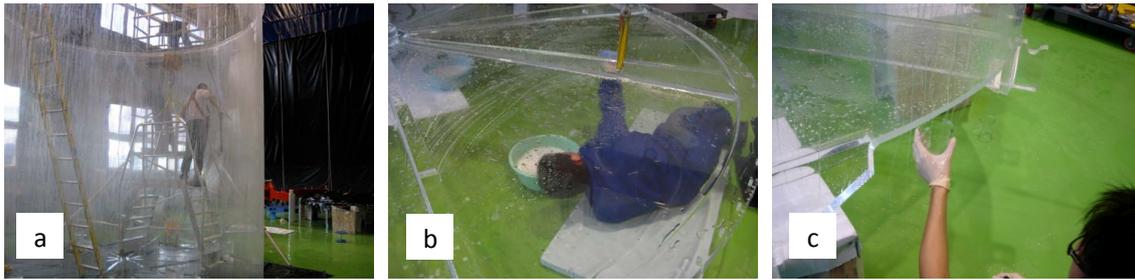
Figure 9. (a) Pressure cleaning of the inner OAV. (b) Scrubbing the bottom of an OAV with an Alconox solution. (c) Collecting the rinse water from an IAV.

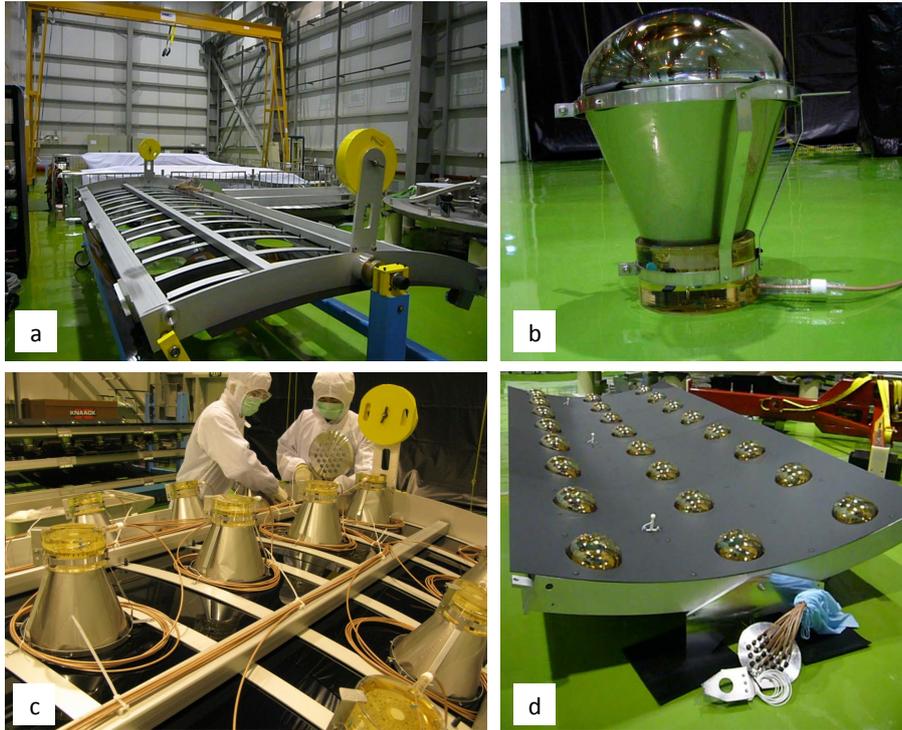
Figure 10. (a) Empty ladder mounted on assembly frame. (b) PMT with magnetic shield ready to mount. (c) Routing signal cables after PMTs were mounted. (d) Completed PMT ladder with calibration LEDs installed.

the mount where it touched the PMT glass or base. A completed PMT assembly is shown in Fig. 10b. Each 7-m-long RG303 cable carrying both signal and HV was tagged with the PMT serial number and location on the ladder. The PMT assemblies were then bolted to pre-drilled holes in the ladder frame.

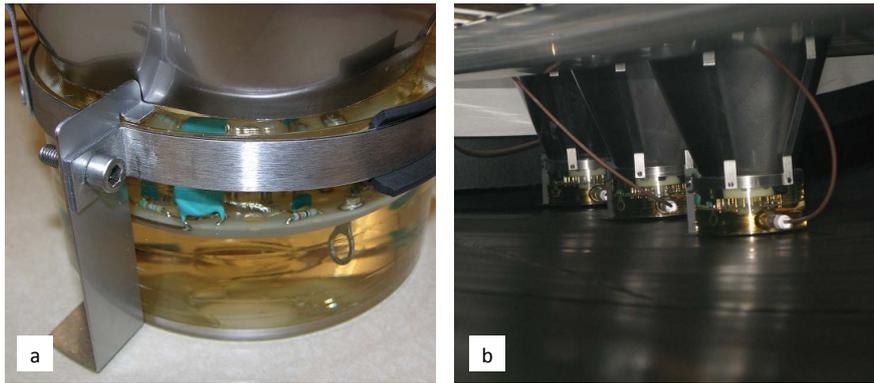
Figure 11. (a) Details of the PMT mount showing the retaining clamp which can be adjusted to move the PMT radially in or out as needed. (b) View of an installed PMT ladder showing typical clearances.

One minor modification of the original design was required. Both the PMT frames and SSV cylinder deviated from true cylinders by up to 35 mm. In some cases the back end of the PMTs touched the SSV inner wall. A retaining clamp was added to the design which could be adjusted to move the PMTs radially inward. PMTs were moved inward up to 20 mm from their design position when necessary. A closeup of the clamp and PMT base is seen in Fig. 11a. Fig. 11b shows the clearances of a typical installation.

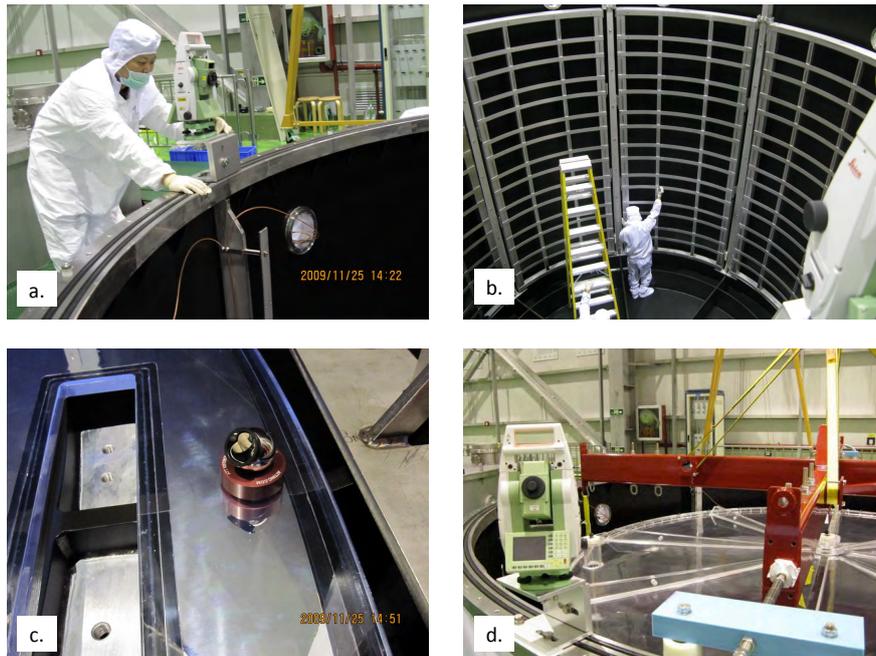
Figure 12. (a) Setting up Total Survey Station on SSV flange. (b) Measuring radius of PMT ladders. (c) Survey of height of lower reflector. (d) Adjusting the position of the OAV to align the central port with the SSV.

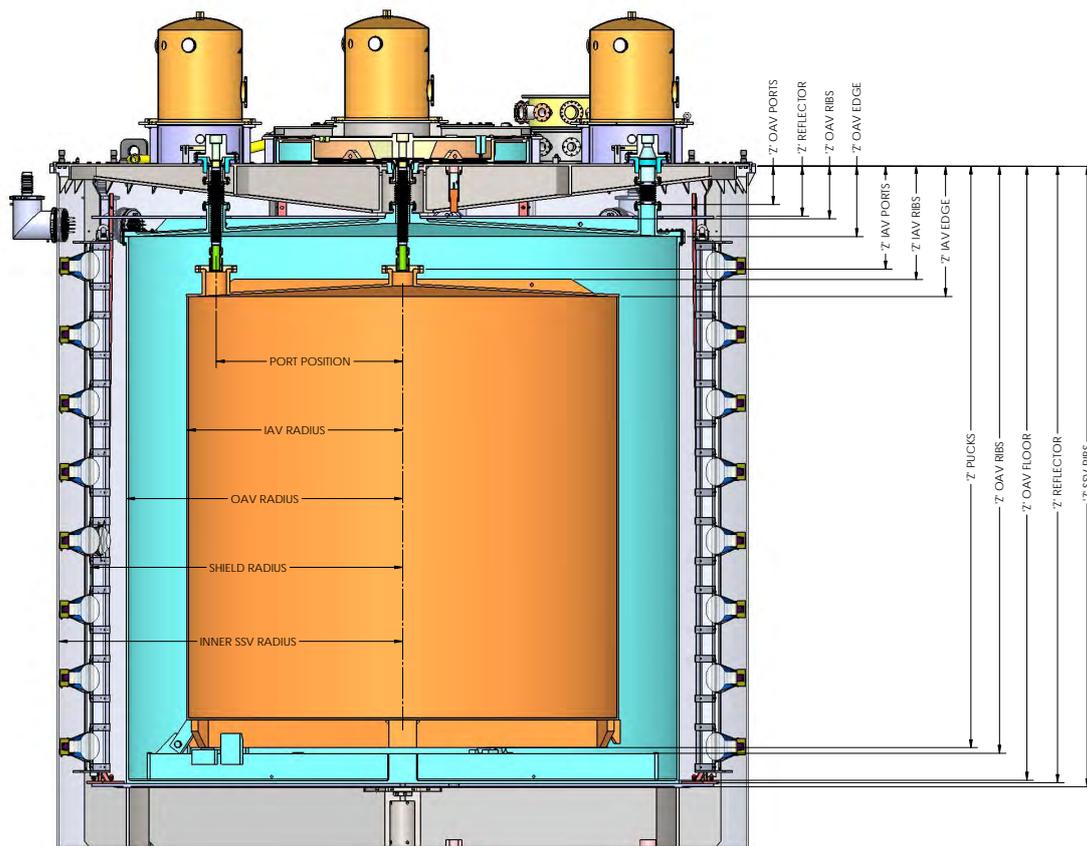
Figure 13. Some of the survey data points available for each AD. Measurements at multiple locations sampled variations in the shape of the reflector, SSV, IAV and OAV.

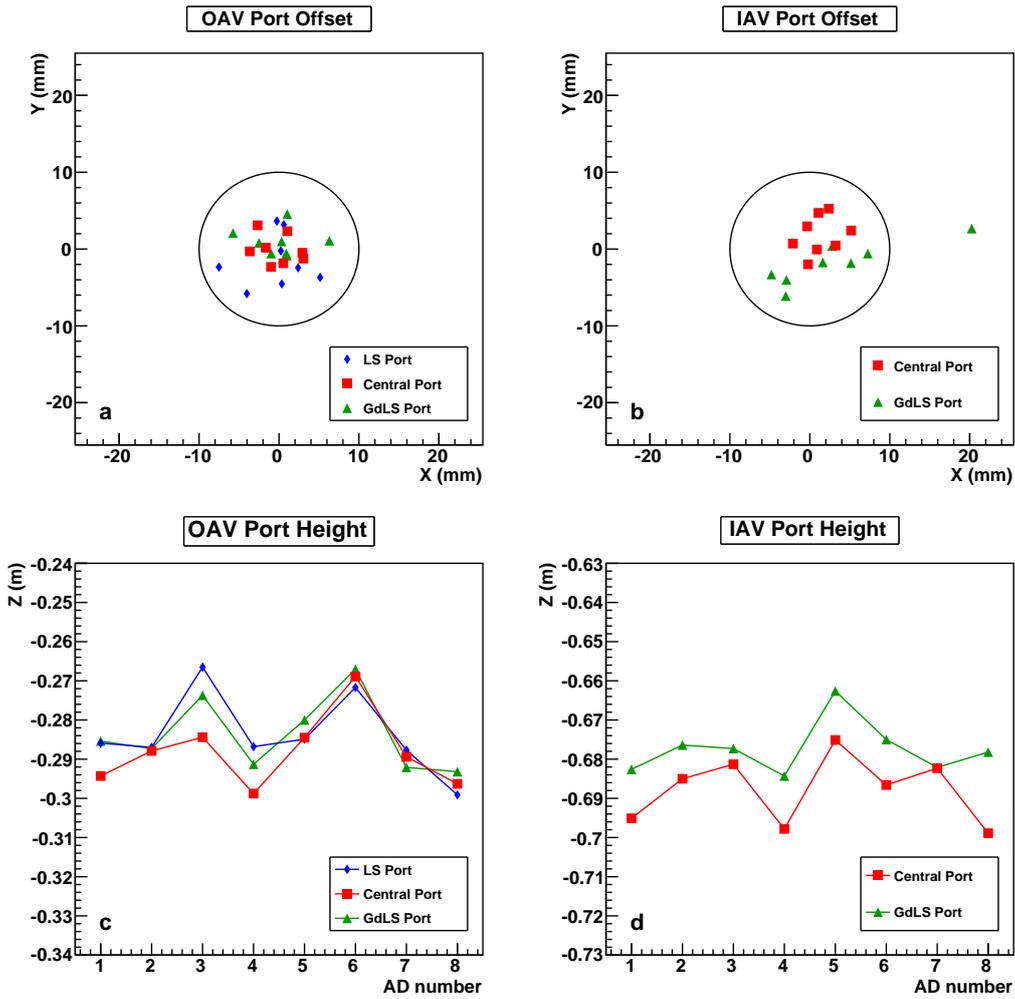
Figure 14. Measured XY locations of the OAV and IAV calibration ports relative to the SSV port are shown in a and b. A 1 cm radius circle is shown for scale. The z positions relative to the SSV lid are shown in c and d have a larger spread.

During AD assembly particular care was taken to align the IAV and OAV calibration ports with the openings in the SSV lid to minimize interference with the calibration sources which are lowered through these ports. The measured XY offsets are shown in Fig. 14a and b. All but one of the ports are well within 1 cm of the nominal location. A construction error in the first AD caused the 2 cm offset in the IAV off-axis port. The z locations of the AD ports are shown in Fig. 14c and d. In many cases the central port is lower than the off-axis ports indicating that the central lid has sagged in the center without the presence of the final liquids.

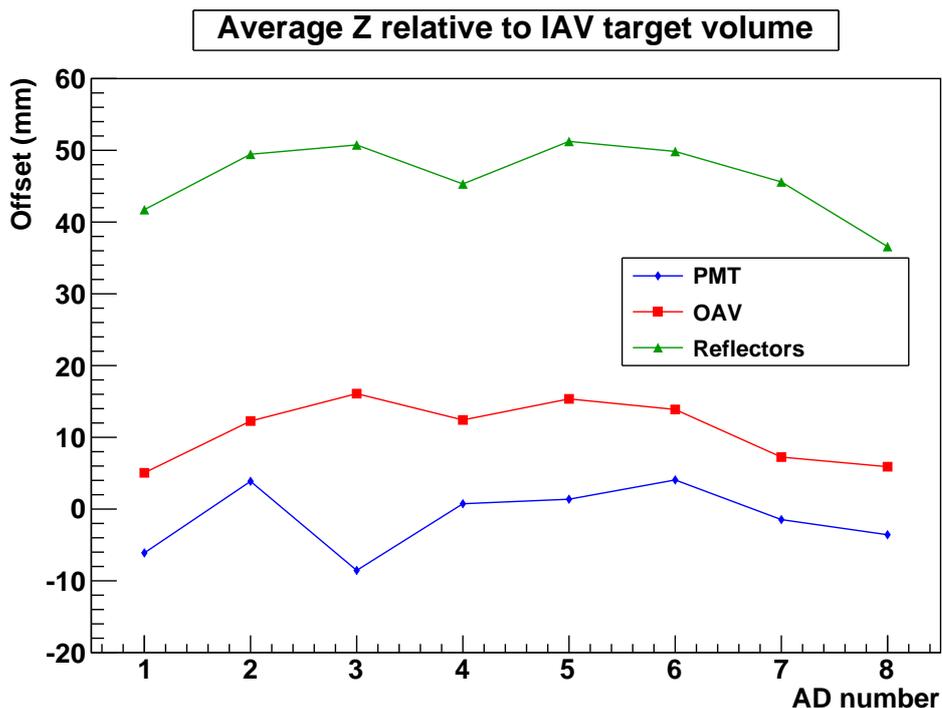
Figure 15. Average z position of detector elements relative to the center of the GdLS target mass.

The survey data can also be used to characterize parameters which may alter the light collection efficiency between differing ADs. Fig. 15 compares how well various detector elements are centered vertically on the center of the visible GdLS target mass volume contained in the IAV. The

average GdLS z is calculated from a combination of survey and construction data with a correction for the volume in the cone shaped IAV lid. Although the PMTs are centered on the GdLS volume within a cm, the center of the OAV is systematically displaced from the IAV center by ≈ 1 cm. By design, the difference between the OAV top and bottom rib heights and the conical lid cause the reflectors to be placed asymmetrically causing the observed 4.5 cm offset between the center of the reflectors and the center of the IAV. The RMS spread observed about these central values is 0.5 cm.

Other dimensions that could impact the light collection efficiency are the average radii of the PMTs and the space between the upper and lower reflectors. The position of the PMT photocathodes are measured from the highest point of the glass bulb to the surface of the radial shield. Although the spread in the measured PMT ladder radii can be over 3 cm within a single AD, the average AD radii are consistent with a standard deviation of 0.2 cm. Seven of the eight ADs have similarly consistent distances between the two reflectors ($\sigma = 0.2$ cm), however in the last AD this

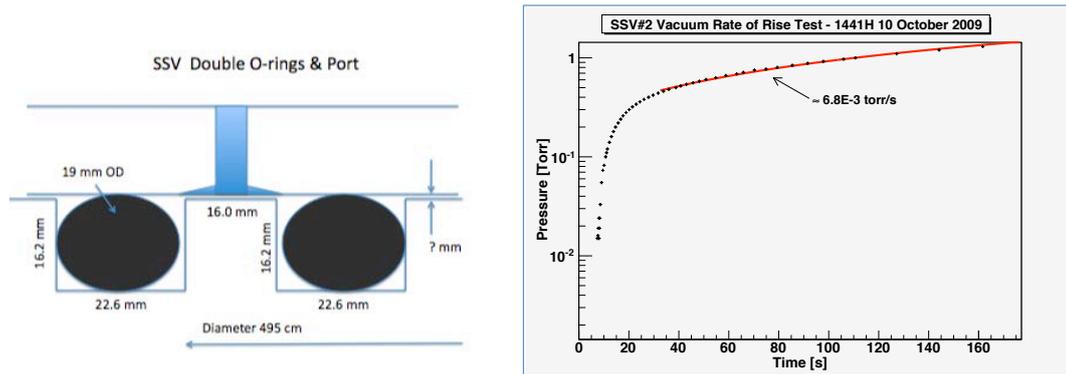
Figure 16. (left) Drawing of the double O-ring design for the SSV lid. (right) Typical vacuum rate of rise measurement.

Several methods of differing sensitivity were used for leak checking. Where possible, a vacuum pump-down followed by a vacuum rate of rise measurement was used since this had the best sensitivity and tested the entire surface area or volume. All bellows used on the lid of the AD or used to connect the AD to the outside of the water pool were pre-tested by this method. Vacuum tests were also made on the double O-rings used in most of the overflow tank covers, ACUs, and port covers. For example the pump-out port between the O-rings on the SSV lid, shown in Fig. 16, was used to evacuate the air between the O-rings until the pressure fell to ≈ 1 Torr. The vacuum pump was then valved off and the vacuum rate of rise was measured and plotted in Fig. 16. Using the known volume under vacuum, the leak rate could be calculated. Leak rate goals of $\approx 1.5 \cdot 10^{-3}$ cc/sec were achievable despite significant out-gassing of the O-rings.

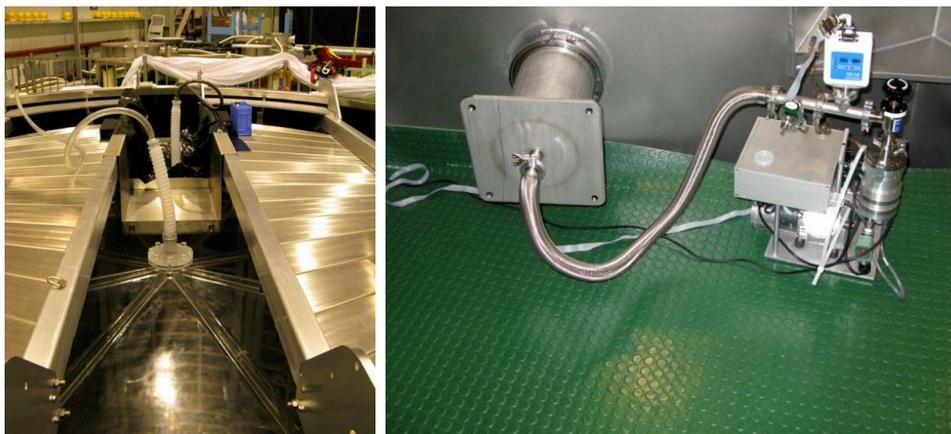
Figure 17. (left) The IAV was filled with more than 75% argon at 12cm of water equivalent pressure for a leak test. (right) Leak test of the PMT cable flange with the Top hat.

Leak checks were performed at specific stages of the assembly process. After the IAV vessel was positioned in the OAV, the port covers capping the calibration tubes were tested by filling the IAV with argon at 15 cm of water pressure and sniffing the O-ring joints as shown in Fig. 17 After the OAV lid was installed the double O-rings were pressure tested at 5 psi. The lower parts of the OAV calibration tube and the connections to the OAV flanges were also tested with argon. No

surrounds the IAV plus IAV calibration tube volume and is surrounded in turn by the SSV volume. The OAV volume is then filled with $\geq 75\%$ freon134a at ≈ 12 cm of water pressure for several days. The other two volumes are maintained near atmospheric pressure during the test. Any leak would allow freon to flow from the higher pressure OAV volume into one of the other volumes. The freon content of the other volumes was measured before, during, and after the test [28] and checked with the freon sniffers. Assuming that a leak would be diluted by the entire IAV or SSV-OAV volume (worst case) daily increases of >105 and >53 ppm would be observed in the IAV or SSV-OAV volume for leaks larger than the goal of $\approx 1.7 \cdot 10^{-2}$ cc/sec. This test identified one AD in which the 3m calibration tube assembly was found to be too short to seal reliably. A new longer part was fabricated, installed and retested successfully.

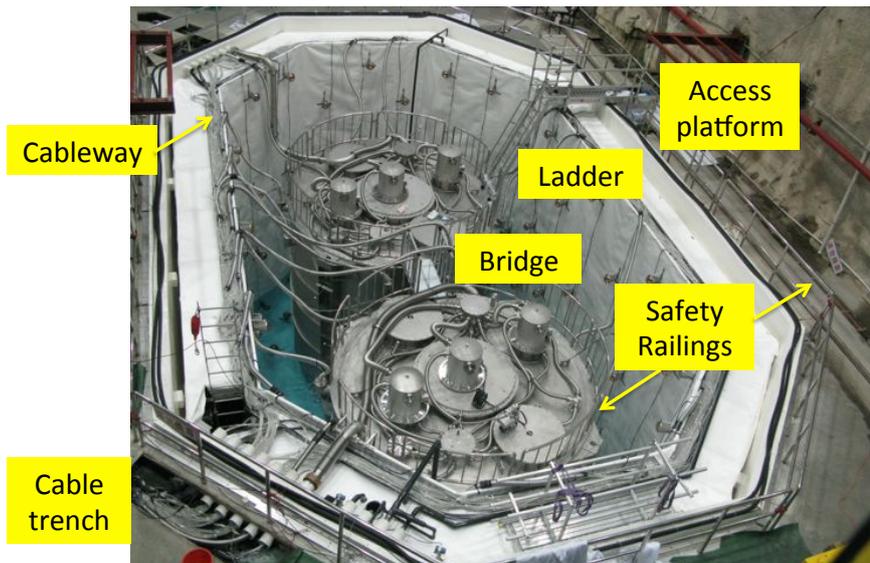
Figure 18. A near hall nearing completion. The access platform and ladder provided access to the top of the detector where final gas and electrical connections were made. Railings around the AD and pool protect workers from the 7-10m drop to the pool floor. The cableway running around the pool and the cable trenches outside the pool are also shown.

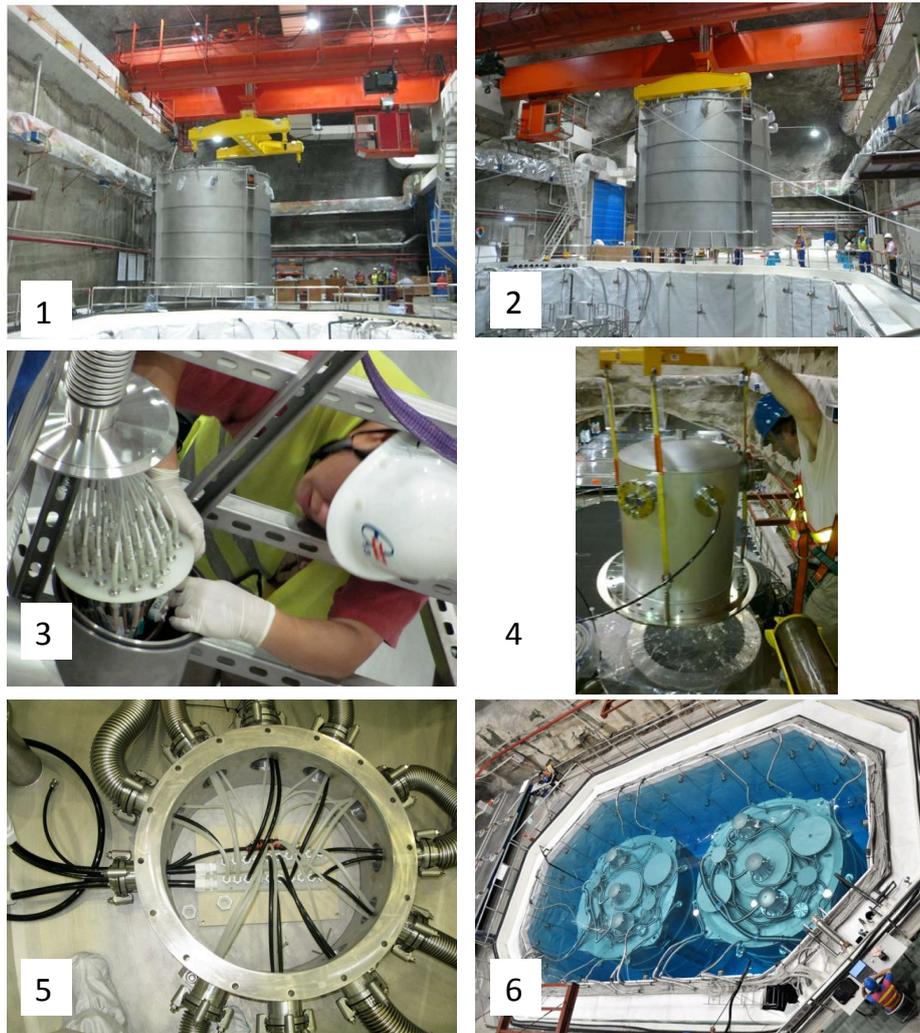
Figure 19. Installation sequence. 1) AD is prepared for lift into pool. 2) Lift into pool. 3) PMT cables connected 4) ACUs installed. 5) Gas lines installed. 6) Water pool filled.

The typical installation sequence is shown as a series of photographs in Fig. 19.

1. An AD is delivered from the LS hall on the automated guided vehicle (AGV) and placed on temporary stands next to the water pool. The move dislodges gas bubbles under the OAV and SSV lids lowering the liquid levels in the overflow tanks. The level change is measured by the AD levels monitors. The fluid levels are then manually topped up to the desired levels. Drybox elbows were mounted over the PMT feedthrough ports. Muon pool calibration LEDs were mounted on the side of the AD. Finally the heavy lifting fixture and positioning cameras were mounted in preparation for the lift into the pool.

5. Gas connections to the ACUs are finalized and leak checked. The PMT, electrical and gas line bellows are independent gas volumes distinct from the gas in the overflow tanks and
