# ATLAS Pixel Detector: Operational Experience and Run-1 to Run-2 Transition

**Alessandro La Rosa\*, on behalf of the ATLAS Collaboration**

*The 23rd International Workshop on Vertex Detectors,  
15-19 September 2014  
Macha Lake, The Czech Republic*

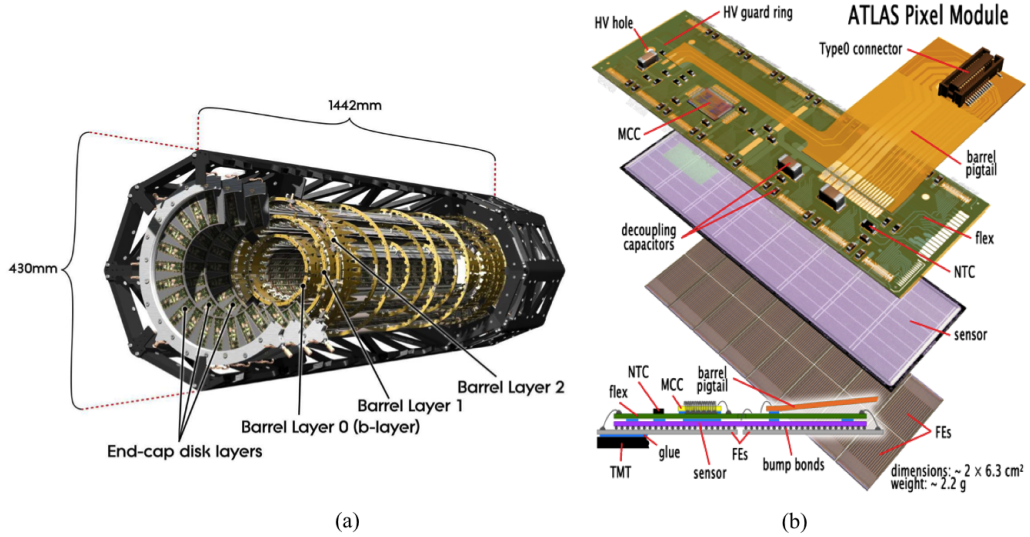
**Figure 1:** (a) Schematic drawing of the ATLAS Pixel Detector. The detector comprises three concentric barrel layers and two end-caps with three discs each. The single detector modules are mounted on carbon fibre support structures with incorporated cooling circuits. (b) Assembly view and cross-section of an ATLAS Pixel Detector module. Sixteen front-end chips are bump bonded to the silicon pixel sensor. Interconnections are done on a flexible kapton PCB, which is connected by wire bonds to the electronics chips [2].

The Pixel Detector [2] is the core of the ATLAS Inner Detector (ID), and as shown in Figure 1, it consists of three concentric barrel layers with mean radii of 50.5 mm, 88.5 mm and 122.5 mm centred around the beam axis and two end-caps with three discs each, forming a three-hit system up to pseudo-rapidities of  $\pm 2.5$ . The full detector contains 1744 pixel modules, which are mounted on carbon fibre local supports (staves). An evaporative  $\text{C}_3\text{F}_8$  cooling system is incorporated into the staves to absorb the heat produced by the modules and to allow for an operation at temperatures below  $0^\circ\text{C}$  to limit the effects of radiation damage. The individual pixel modules are made of a  $250 \mu\text{m}$  thick  $\text{n}^+$ -on- $\text{n}$  silicon sensor, 16 front-end chips (FE-I3 [3]) and a module controller chip (MCC [4]). The sensor is divided into 47232 pixels with a typical pixel size of  $(50 \times 400) \mu\text{m}^2$  and approximately 10% of pixels (long pixels) have a size of  $(50 \times 600) \mu\text{m}^2$  to bridge the gaps between the front-end chips. In addition, in each column eight pairs of pixel implants, located near the center lines, are ganged to a common read-out, resulting in 320 independent read-out rows or 46080 pixel read-out channels. The front-end chip provides pulse height measurement by means of time over threshold (ToT) with zero suppression on chip while the module event is built by the MCC.

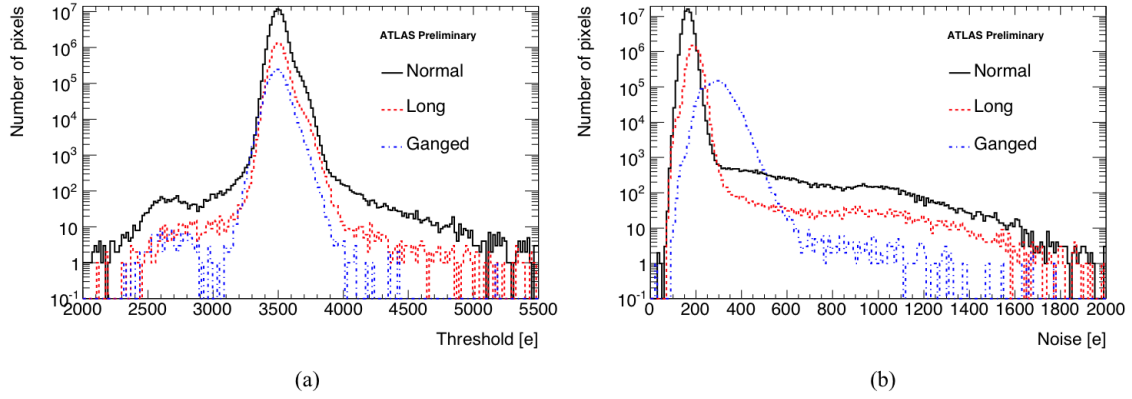
**Figure 2:** Measured threshold values for all pixels in the detector. Prior to the scan the threshold setting have been tuned to  $3500\text{ e}^-$ . (b) Noise values obtained from the same threshold scan [5].

The pixel thresholds were tuned to  $3500\text{ e}^-$  with a typical dispersion of  $40\text{ e}^-$ . The measured noise was  $180\text{ e}$  for normal sized pixels, with a higher value for long pixels and about  $300\text{ e}$  for ganged pixels as expected due to the higher capacitance these pixels present to the readout electronics. Threshold and noise values obtained from a threshold scan are shown in Figure 2 [5]. Pixels exceeding noise occupancy of  $10^{-6}$  hits per bunch crossing in dedicated noise data taking runs were masked for data taking already in the module configuration. Typical occupancies for physics data have been in the order of  $10^{-4}$ . Only 0.1% of the pixels needed to be masked out to achieve such performance. The front-end chip has the capability to provide information about the deposited charge by the measured Time Over Threshold (ToT), which has a nearly linear dependence on the charge released in the sensor. The tuning target was a ToT of 30 bunch crossings for an injected charge of  $20\text{ ke}^-$  that corresponds to a minimum ionization particle deposited charge.

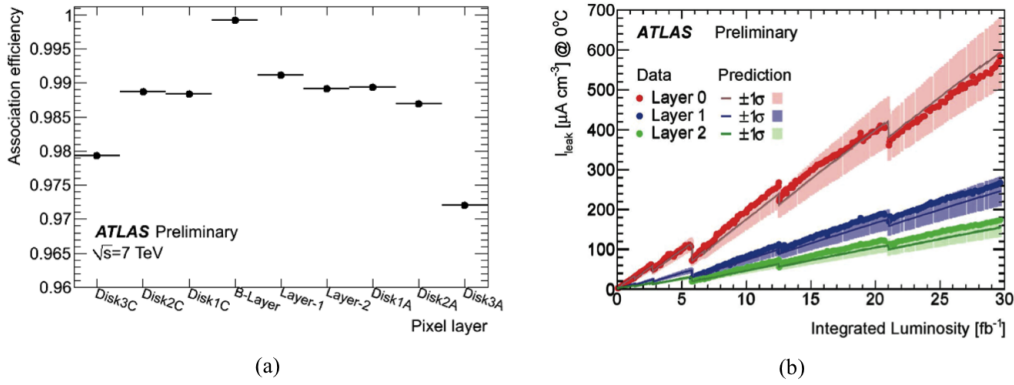
**Figure 3:** (a) Hit association efficiency for the different parts of the ATLAS Pixel Detector. The high efficiency of the B-layer is an artefact of the track set used for the measurement, whereas the low efficiency of the outermost discs is due to few bad modules known from production [5]. (b) The averaged reverse-bias current for all Pixel modules in the different barrel layers as a function of the integrated luminosity [5].

Looking at the detector performance the efficiency of tracks having associated hits in the different Pixel Detector layers was about 99%. As shown in Figure 3(a), a slightly lower efficiency in the outermost disks (Disk 3C of  $\sim 0.98$  and Disk 3A of  $\sim 0.97$ ) was measured and it was due to few bad modules that were already identified at the production stage.

The radiation damage effects were within expectation and they become visible when a significant increase in leakage currents has been observed in Pixel Detector. The leakage current was mainly measured by high voltage power supplies on a level of 6 or 7 modules per channel and with a precision of  $80\text{ nA}$ . As shown in Figure 3(b), the evolution of leakage current with the respect to the integrated luminosity was in agreement with the prediction. The steps in the leakage current evolution correspond to annealing during detector warm-up periods.

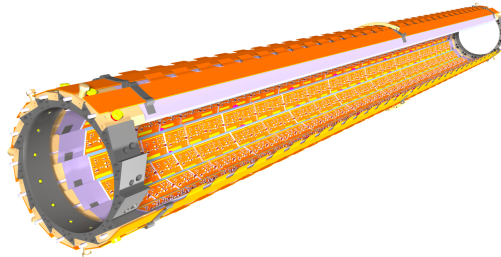
**Figure 4:** Schematic drawing of the ATLAS IBL Detector. The single detector modules are mounted on carbon fibre support structures with incorporated CO<sub>2</sub> cooling circuits.

The IBL Detector is the additional fourth pixel layer that has been built around the new Beryllium beam pipe (4 mm of radius) and then inserted inside the Pixel Detector in the core of ATLAS detector. It consists of 14 carbon fibre staves 64 cm long, 2 cm wide, and tilted in  $\phi$  of  $14^\circ$  surrounding the beam-pipe at a mean radius of 33 mm and a pseudo-rapidity coverage of  $\pm 3$ . Each stave, with CO<sub>2</sub> cooling integrated, is equipped with 32 front-end chips (FE-I4 [6]) that are bump bonded with the Silicon sensors.

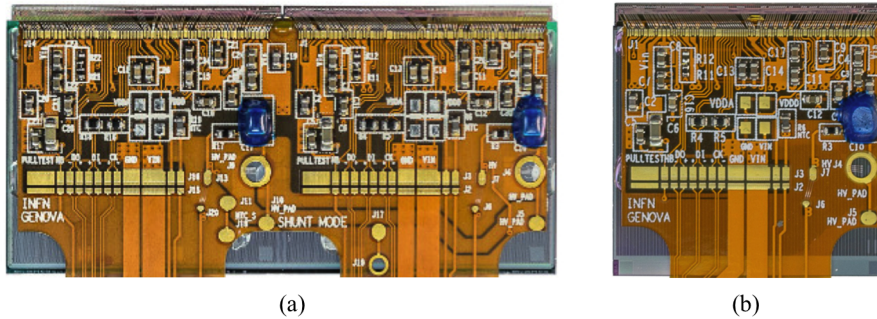
**Figure 5:** Photo of a dressed IBL two-chip (a) and a single-chip (b) module.

A total of 710 modules have been produced in between January and October 2013. The thinning and the bump-bonding of the modules were carried out at IZM (Germany). The front-end chips were thinned to a thickness of  $150 \mu m$  and flip-chipped to the sensors using Sn Ag solder bumps. Then a double copper layer flex circuitry (so called module-flex) was glued onto the sensors and a wire bonding connection was done to electrically connect front-end chips and module flexes. Figure 5 shows a photo of a dressed IBL two-chip (a) and a single-chip (b) module. All the

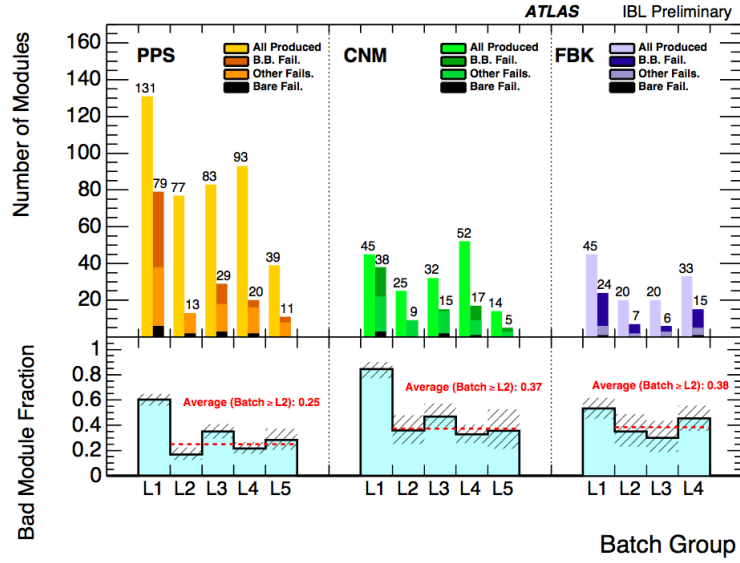
**Figure 6:** Yield of IBL module production for module types of two-chip (Planar, as PPS) and single-chip (3D as CNM, and FBK) per production batch group. In the top panel for failure modules, "B.B. Fail." stands for large bump-bonding failure, "Bare Fail." stands for the module not assembled due to mainly mechanical damages, and "Other Fails." stands for both electrical and sensor failures discovered after assembly [5].

produced modules have been mechanically, electrically and functionally qualified. The quality assurance procedure included short electrical and functional tests (e.g. IV-curves, threshold and noise scans) after the assembly at  $15^\circ C$ , thermal stress (ten cycles from  $-40^\circ C$  to  $+40^\circ C$ ), radioactive sources tests and intensive electrical and functional tests and calibration at  $-15^\circ C$ . During the modules production the first batch of both single- and two-chip modules had a large number of bump bonding failures which was traced back to the excessive flux in flip-chip process. Figure 6 summarizes the yield of the produced modules for both sensor technologies, where a yield of 75 % for the two-chip module, and 63% for single-chip (CNM) and 62% (FBK) modules. This production yields do not include the first production batch.

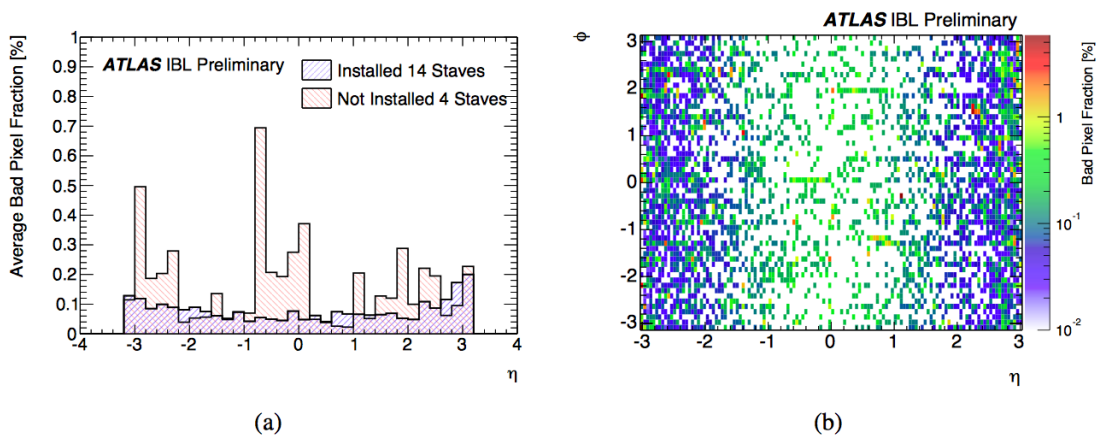
**Figure 7:** (a) Average bad pixel ratio distribution as a function of  $\eta$  for installed and not installed production staves and (b) in the  $\eta$  -  $\phi$  plane for the 14 IBL staves [7].

18 staves have been produced, qualified, and out of them the best 14 have been selected to be assembled in the IBL Detector. The quality assurance (QA) procedure allowed a detailed characterization of all the staves including calibration in cold conditions and data taking with radioactive sources. The pixel defects were classified by type of failures as pertaining to the front-end chip, the sensor or the bump bonding. Figure 7 shows the distribution of the bad pixel fraction for the produced staves, while Figure 8 the threshold and noise distributions after tuning all pixels to a target threshold of  $1500\text{ e}^-$  at  $-12^\circ\text{C}$  module temperature for the 14 IBL staves.

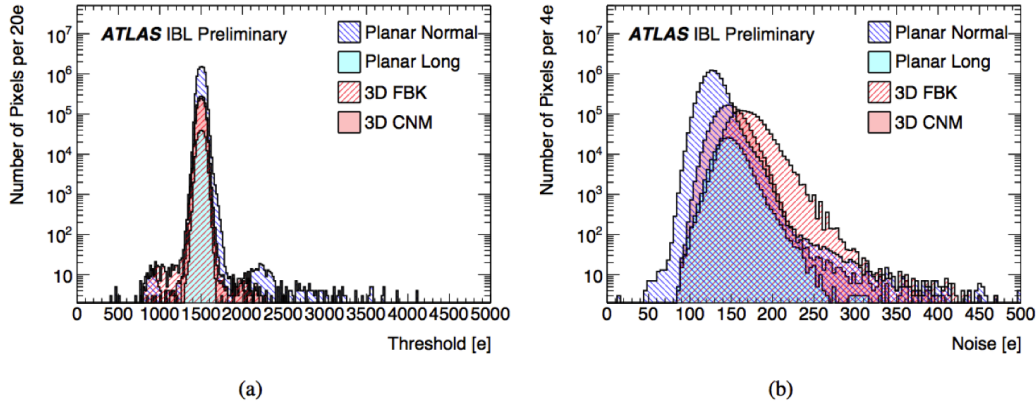
**Figure 8:** (a) Threshold and (b) noise distributions after tuning all pixels to a target threshold of  $1500\text{ e}^-$  at  $-12^\circ\text{C}$  module temperature for the 14 IBL staves. The pixels are displayed in four categories according to normal and long pixels on planar sensors as well as pixels on FBK and CNM 3D sensors. [7].
