Excimer laser cleaning of black sulphur encrustation from silver surface

Mohammad Shahid Raza, Sankha Shuvra Das, Parimal Tudu, Partha Saha* Department of Mechanical Engineering, Indian Institute of Technology Kharagpur, West Bengal, India-721302 *Email id: p.saha@iitkgp.ac.in

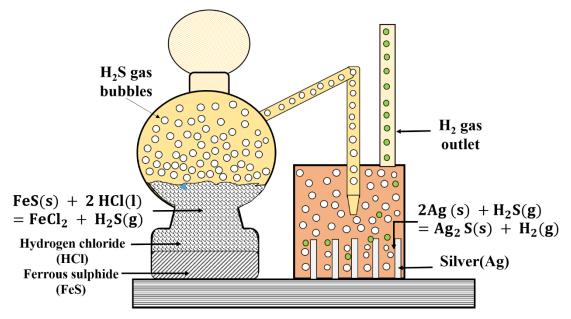
In order to produce the silver sulphide encrustation, Kipp's apparatus has been used. Kipp's apparatus setup (as shown in fig. 1) is a reliable media to transfer various gases on the surface. Generally, silver gets tarnish if it exposes to open environment (by reacting with hydrogen sulfide). The standard lab preparation of hydrogen sulfide gas can be a reaction of ferrous sulfide

Fig. 1. Schematic of Kipp's apparatus arrangement used to create silver sulphide encrustation.

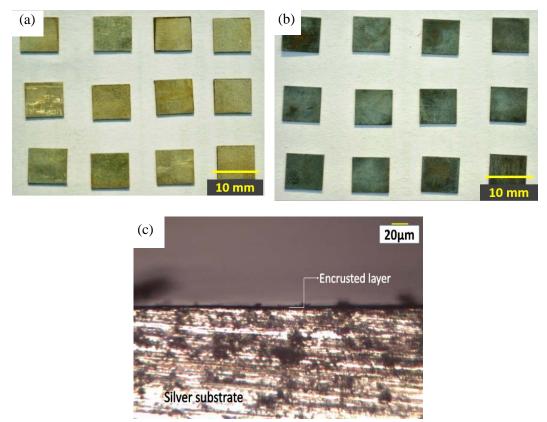
After the generation of silver sulphide on the surface, trial experiments were carried out. Optical images of the encrusted samples were taken to observe the tarnish developed on the surface. It was observed that a dull layer was formed with combined dark patches and light grey colour areas. The amount of encrustation depends on the exposure time of the surface to sulphide gas environment. Fig. 2 shows the optical images of the tarnished and non-tarnished surface. Crosssectional image of the tarnish as shown in fig. 2(c) shows a uniform encrustation of about 8-10 μ m developed on the surface.

Fig. 2. Images of silver samples (a) without tarnish (b) with tarnish (c) Cross section of tarnished surface showing encrustation

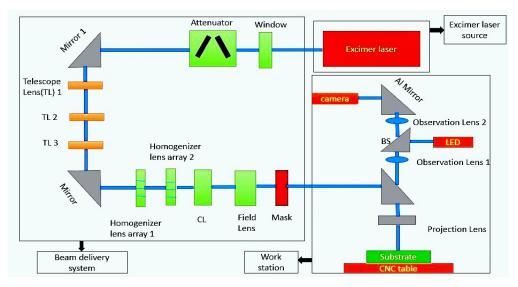
The experimentation was performed using excimer laser (Lambda-Physik) working with KrF chemistry having wavelength 248 nm, pulse width 25 ns, repetition rate 4 Hz, pulse energy (maximum) 650 mJ and rectangular beam profile. Since the output beam was not homogeneous [30], a beam delivery system has been incorporated in the laser as shown in fig. 3 so that a uniform intensity homogenous beam profile can be generated. Fig 4(a) shows the beam intensity profile for both x and y-axis while fig. 4(b) shows schematic of the cleaning process performed on the surface. The laser was operated in constant energy mode throughout the entire experiment.

Fig. 3. Experimental set up excimer laser used for laser ablation process

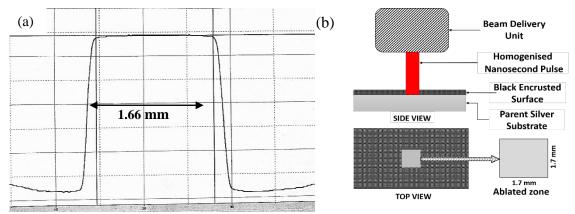
Fig. 4. (a) Laser beam profile (b) Schematic of laser cleaning process

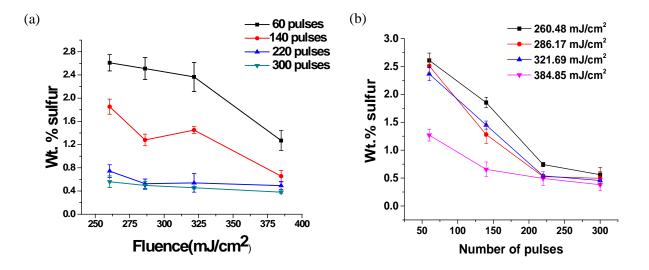
The effect of fluence on the sulphur content has been shown in fig. 5(a). Laser fluence has a direct role to play in the wt. % of sulphur. From the values of table 3, it is found that the sulphur present on the surface at 260.48 mJ/cm² with 60 pulses was 2.61 wt. % while sulphur present at 384.85 mJ/cm² with 300 pulses was 0.38 wt. %. As we increase the fluence keeping number of pulses constant the mean sulphur content decreases. The decrease in sulphur at a fluence of 260.48 mJ/cm² suggests that the fluence is above the threshold value to cause the dissociation of the bond of silver sulfides. Again it can be said that at 60 pulses the decrease in sulphur is not very drastic, but is uniform. As we increase the number of pulses to 140 and above, we observed the non-uniform changes in the sulphur content. As we know that the mechanism of ablation

changes with a change in fluence and intensity [29], so it can be said that the change in fluence value is causing the mechanism of the ablation to change causing the different rate of ablation. Both photochemical, as well as photo-thermal effects, are taking place over here as suggested from the SEM images obtained showing some melting of the substrate surfaces in fig.8(e) and fig.9(b).The optical and thermal properties of the surface are changing after each pulse and with different fluence values. These changes in the properties like absorptivity, reflectivity, conductivity etc. are causing a different amount of heat flow along the body. The surface roughness of the silver sulfide and the silver is also causing the ablation rate to change. Sulfide in the pin holes cannot be removed easily. These sulfides will cause the ablation rate to change. The evaporation threshold of the silver sulfide and the melting threshold of the silver plays a crucial role in the ablation rate [14]. As clear from previous literature [7], the sulphur gets dissociated from silver at around 838 K while the melting point of silver is around 1234 K. A good ablation rate can be achieved if applied fluence can generate temperature within this range. The trend of decrease of sulphur is present in all the cases. At 220 and 300 pulses the sulphur content changes at a slow rate with change in fluence value. Finally, the amount of sulphur in laser treated zone converges to around 0.35-0.55 wt. %.

Fig. 5. Effect of (a) fluence on wt. % of sulphur (after laser ablation) (b) number of pulses on wt. % of sulphur (after laser ablation).

The effect of number of pulses on the sulphur content has been shown in fig. 5(b). It was observed that 60 number of pulses the ablation rate is more controlled. At 140 number of pulses

the ablation rate increases at a faster rate with increase in fluence value. But at 220 pulses again it is getting approximately same for all the fluence values and the fluence increase is not causing any significant variation in the wt. % of sulphur. Overall it can be said that increase in pulse number is causing an increase in ablation and decrease in sulphur content on the surface. At 300 pulses, it can be seen that for the fluence value of 260.48 mJ/cm² the wt. % of sulphur is at a value of 0.56 and then by increasing the fluence very small change in wt. % of sulphur is taking place. Relatively less amount of sulphur present on it is one of the reason for such a low ablation at 300 pulses. But at a fluence of 384.85 mJ/cm², the change in sulphur content occurs at a faster rate.The removal of sulphur from the surface at higher fluence is relatively high.So the silver exposed after the sulphur is absorbing the high fluence value.Thus the ablation of silver is also taking place at a higher fluence of 384.85 mJ/cm².SEM images and EDS analysis (fig. 8(b) and fig. 9(c)) also confirms these findings.

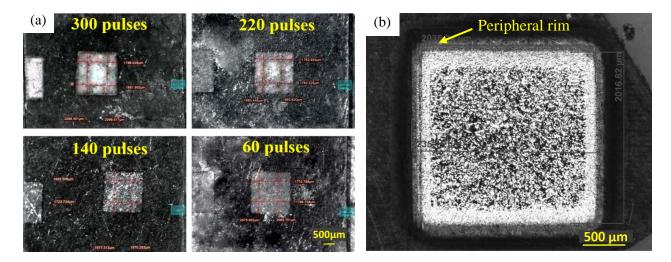
Optical imaging of the cleaned samples was done using a metallurgical microscope (Zeiss Zoom: Germany). Fig.6 (a) shows some of the lasers cleaned samples with 260.48 mJ/cm² for a different number of pulses such as 60, 140, 220 and 300 pulses. The boundary of the encrusted samples and cleaned samples is clearly visible. The size of the cleaned surface is around 1.7 mm \times 1.7 mm. There are some black patches present within the cleaned zone. These black patches are due to remaining silver sulphide present on the surface. Fig. 6(b) shows the optical images of the laser cleaned zone with 384.85 mJ/cm² and 220 pulses. The formation of a peripheral rim has taken place for higher fluence value (fig. 6(b)). However, such a rim structure was not observed in case of lower fluence like 260.48 mJ/cm². The black patches are less prominent in this case. We can say that for higher fluence, stronger shock waves are getting generated at higher fluence and they are causing an increase in ablation rate [14].

Fig. 6. Optical images of some of the laser cleaned at (a) 260.48 mJ/cm² for a different number of pulses, (b) Optical image of laser cleaned surface at 384.85 mJ/cm² with 220 pulses

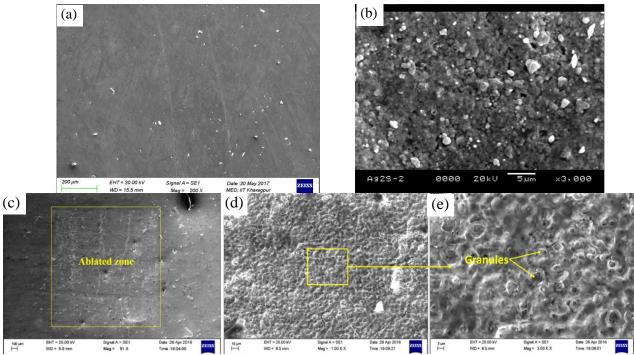
SEM was carried out in order to study the encrusted surface and the cleaned surface. Fig.7 shows the encrusted surface and cleaned surface for 260.48 mJ/cm² and 300 pulses. It can be seen from fig. 7(a) that the silver was having some initial surface roughness. After sulphur encrustation, we can see that surface bears particulates of silver sulphide and other particulates all over the surface (fig. 7(b)). After laser cleaning, it is generating a uniformly cleaned surface. A uniform cleaned surface can be observed which is assumed to be created by high pressure super quick ablation removal of material. If we look into the laser cleaned surface at higher magnification (fig. 7(e)), we will find that some small granules-like structure present on it. These structures are around $0.5-3 \,\mu m$ in size. These granular structures are unreacted silver sulfide particles present in the pit holes of the silver surface. It can be suggested that some photo-thermal effect is also taking place along with photo-chemical effect as discussed in the previous section. This effect occurs when there is a non-linear laser material interaction occurring in the laser treated zone. These nonlinear interactions can be due to surface roughness or due to change in thermal properties at a higher temperature. Some changes in molecular level may also be the cause of such phenomena. As we know that metallic forces exist between Ag-Ag molecules. These metallic forces vary in their nature from one material to other. In case of silver, the metallic forces are stronger with respect to the ionic compound which is held together with the help of electrostatic forces as in

$Ag_2S.So$ some photoionization and dissociation might be the reason for melting of the surface and more sulphur removal at high fluence value.

Fig. 7. SEM images of (a) silver surface (b) encrusted silver surface (c) laser cleaned surface with 260.48 mJ/cm^2 and 300 pulses at 81 X magnification (d) 1KX magnification (e) 3KX magnification.

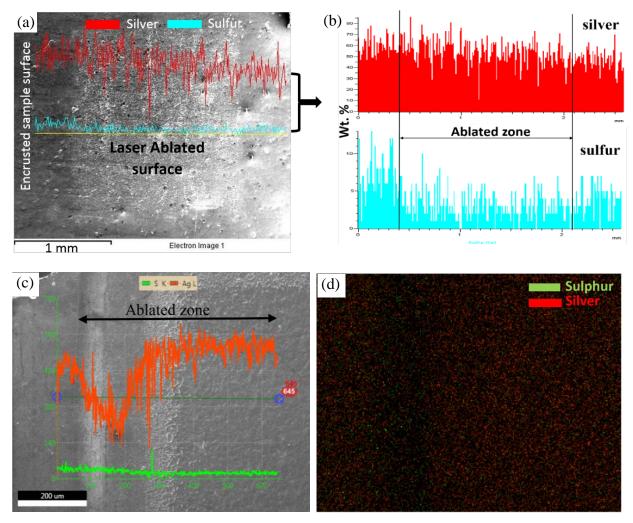
Table 4 shows the Energy Dispersive X-Ray Spectroscopy (EDS) report of the sulphur content (in wt. %) of the parent material, encrusted samples and the laser cleaned samples. It is found that the sulphur content has been reduced remarkably. Further, the line EDS was performed to study the change of sulphur content in the ablated and non-ablated zone. Fig. 9(a) and 9(b) shows the line EDS report of silver and sulphur present in the ablated zone for 260.48 mJ/cm² and 300 pulses while fig. 9(c) and 9(d)) shows the line EDS and EDS area mapping of the sulphur and silver content respectively for 384.85 mJ/cm² and 220 pulses. It is observed that the sulphur amount has decreased significantly after laser ablation, though the complete removal has not taken place. So, for complete removal, it is suggested that the fluence rate or the number of pulses should be increased. But as we increase the fluence rate we have seen some peripheral rim structure formations as discussed in section 3.3.This peripheral rim has relatively less silver exposed and more sulphur content on its surface(fig 9(c)).Area mapping of the sulphur and silver content (fig. 9(d)) also confirms this finding.

Fig. 9. EDS of laser cleaned (a), (b) changes in silver and sulphur amount in encrusted to cleaned surface at 260.48 mJ/cm² and 300 pulses. (c) Line EDS and (d) Area mapping of laser cleaned surface at 384.85 mJ/cm² and 220 pulses.

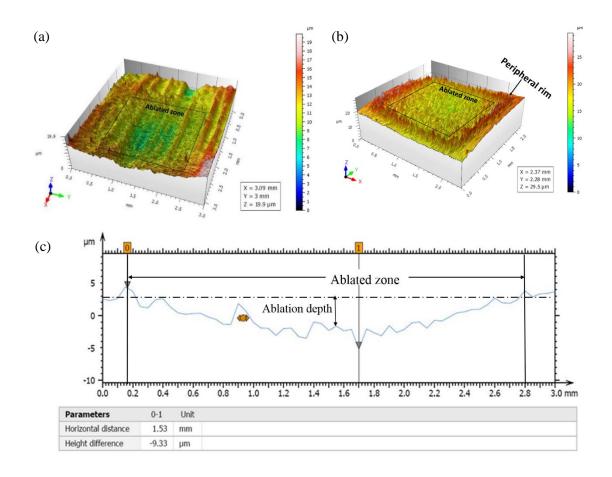
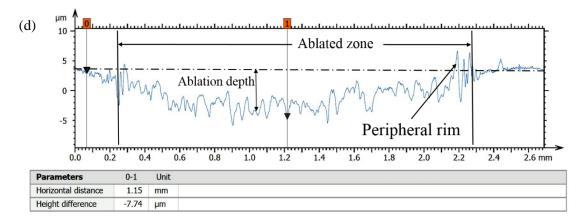
Three-dimensional contact type profilometer (Taylor-Hobson model-Form Talysurf 50 series, UK) was used to analyse the topography of the laser ablated surface. The topography as in fig. 10 shows the sample cleaned with a fluence of 260.48 mJ/cm² and 300 pulses (fig. 10(a) and 10(c)) and 384.85 mJ/cm² and 220 pulses (fig. 10(b) and 10(d)). It is found that 5-8 μ m thicker silver sulphide black layer has been removed during the cleaning operation. The surface topography of the ablated zone shows that the ablated zone has a higher roughness than that of the encrusted zone. This happened due to the partial melting and vaporization of the sulphur

content from the surface. Some of the process parameters generated a peripheral rim structure beside the ablated zone. The formation of peripheral rim is easily observed in case of fig. 10(b) and 10(d). With the increase in fluence, it was observed that the tendency of formation of peripheral rim got increased. There was a distinct fluence value (321.69 mJ/cm²) after which the peripheral rim structure formation was prominent (fig. 10(b)). Although the beam used was homogenised, yet the ablated area shows more material removal at the centre than the peripheral region. The reason can be attributed to the combined effect of photo-chemical as well as photo-thermal effect taking place in the ablated zone as discussed in section 3.2.

Fig. 10. (a) Surface topography of a laser cleaned at (a) 260.48 mJ/cm^2 and 300 pulses, (b) at 384.85 mJ/cm^2 and 220 pulses, (c) Cross section profile of the ablated zone for 260.48 mJ/cm^2 and 300 pulses, (d) Cross section profile of the ablated zone for roughness for 384.85 mJ/cm^2 and 220 pulses.

- The topography of the ablated surface showed a removal of 5-10 µm of the sulphide layer from the surface. But the roughness of the ablated surface has got increased.

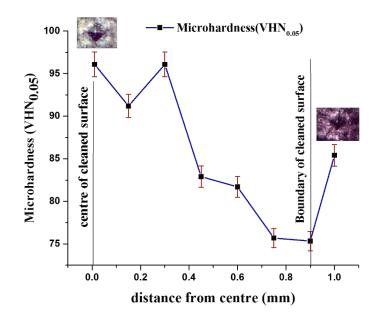
Vickers microhardness values were measured using Omnitech Semi-Automatic Microhardness Tester. A 50 gm load was applied for a dwell time of 10 seconds. The microhardness values of the laser cleaned areas were taken to compare the change in hardness between laser treated and untreated surface. The hardness was measured at 5 different points of the same location and the average value of the hardness was taken. Fig. 11 shows the change in microhardness from the centre of the ablated zone towards the encrusted sample surface. The uncoated silver showed a microhardness value of 75.12 $HV_{0.05}$. From the result of microhardness, we can observe that the microhardness difference from cleaned silver to encrusted sample is of about 10 HV_{0.05}. The cleaned surface showed an average hardness value of 96.07 HV_{0.05} while encrusted surface showed an average value of $85.39 \text{ HV}_{0.05}$. The change in hardness can be attributed to the partial melting and heating of the cleaned zone causing elemental compositional changes in the treated zone. The microhardness in the centre of the cleaned region is higher than the peripheral part. It can also be verified using the fig.10(c) where it is quite clear that the centre has more ablation depth than the surrounding areas. So more hardness is present at the centre as silver has more hardness than silver sulphide. The periphery of the ablated zone shows microhardness value of around 75 $HV_{0.05}$.

Fig 11. The variation of Vicker's microhardness with the position of the ablated surface for 260.48 mJ/cm2 and 300 pulses.

- Microhardness value showed a change of microhardness of the silver surface from 75.12 HV_{0.5} (uncoated parent silver) to 96.07 HV_{0.5} (centre of ablated zone).
