PV Modules and Their Backsheets - A Case Study of a Multi-MW PV Power Station

Degradation of backsheets (BS) and encapsulant polymer components of silicon PV modules is recognized as one of the main reasons for losses in PV plant performance and lifetime expectations. Here, we report first insights into the correlation between BS composition of PV-modules and PV power station performance by using a combination of lab- and field-imaging, as well as spectroscopic and electrical characterizations. Using field-suitable near-infrared absorption (NIRA) spectroscopy, the BS structure of 518 PV-modules, 2.5% of the PV-modules in a 5 MWp PV power station, was identified on-site. The variance of the BS composition was found to be heterogeneous across PV-modules of the same power class from the same manufacturer. Polyamide-based BS cause in 10 out of 100 inverters ground impedance values below 400 k Ω , which is a typical threshold for inverters connecting to the grid. For primer-based BS this low value is reached 20 times. We conclude these numbers best as possible from the available monitoring data of inverters associated with BS-types from NIRA. Challenging is the identification of degrad

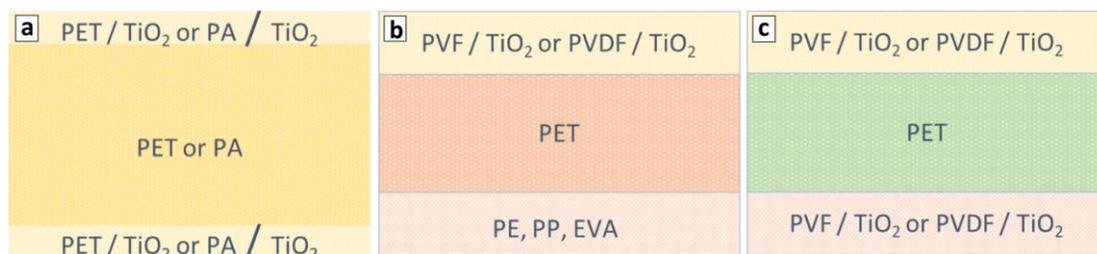
Figure 1: Schematic presentation of cross-sections of NF- (a), SF- (b), and DF- (c) BS classes

BSs found in PV-modules can be classified into three groups. The BSs of the first class are composed of a single component, polyamide (PA), while the BSs of the second and third classes are multi-layer BSs. The multilayer BSs comprise a polyethylene terephthalate (PET) core layer. The second class has a symmetric layer structure, that means at the inner layer as well as on the airside layer is a fluorinated polymer. In Contrast, the third BS class has an asymmetric structure, a PET core layer, a single fluorinated layer at the airsides and inner layers of polyolefines, such as polyethylene (PE), polypropylene (PP). The schematic structures of these three BS types, designated as non-fluoropolymer (NF), single-fluoropolymer (SF), and double-fluoropolymer (DF) are shown in Fig. 1. Since the layout of especially multi-layer BSs can vary strongly, we address different configuration as BS-types belonging to a certain BS-class.

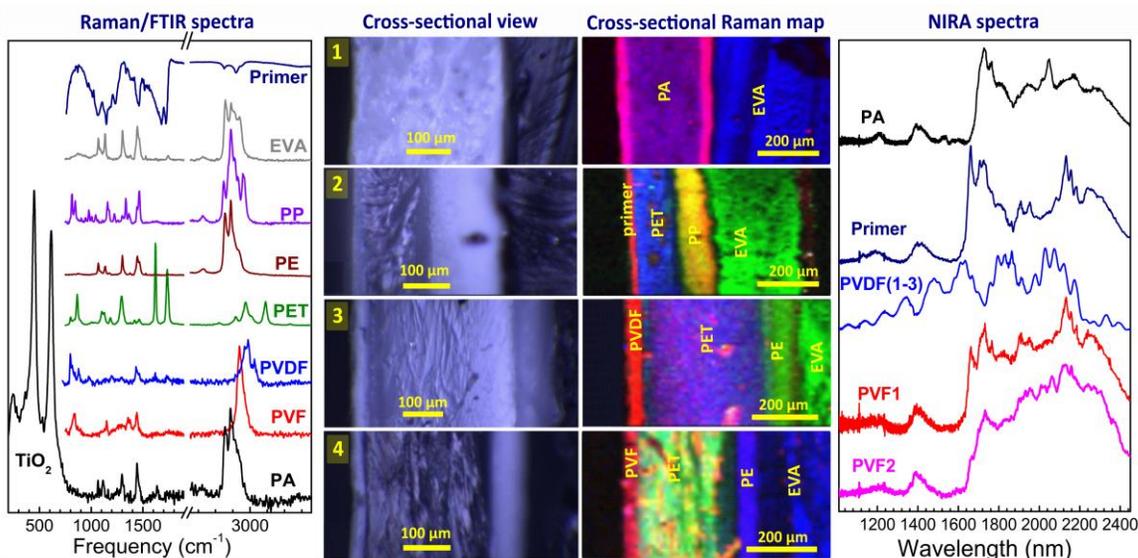
Figure 2. Left section - Raman spectra of typical components of BS cross-sections as well as FTIR spectrum of primer air-side (left). *Note:* rutile range is not shown for PVF, PVDF, PP, and PE. Middle section - cross-sectional optical images and multi-spectral Raman maps for different air-side materials. Right section - NIRA spectra of some of tested BSs and EVA encapsulant.

Spectral identification of BS composition. Typical Raman spectra of BS air-sides show intense bands at 200-750 cm^{-1} characteristic of rutile TiO_2 pigment (see spectra in Fig. 2, left part). In particular PA shows characteristic N-H (3300 cm^{-1}) and amide C=O (1620 cm^{-1}) vibrations, while fluorinated air-side polymers, such as polyvinyl fluoride (PVF) and polyvinylidene fluoride (PVDF) were recognized by characteristic C-F vibrations ($1000\text{-}1200 \text{ cm}^{-1}$) and differences in the C-H vibration series ($2700\text{-}3000 \text{ cm}^{-1}$). Some of the samples showed the presence of a very thin air-side fluorinated polymer layer which could be identified with FTIR spectroscopy revealed a series of C=O- and C-F-related vibrations characteristic for fluorinated polyurethane-polyacrylate copolymers called “primers”.

PET intermediate (core) layers were identified by a characteristic C=C/C=O doublet at $1620/1730 \text{ cm}^{-1}$. Inner layers of polyolefines (PE or PP) were found in multi-layer BSs, PE in the modules with PVF air-sides and PP in the modules with primer air-sides. The BS cross-sections were cut for Raman analysis along with a layer of EVA encapsulant which can be recognized by

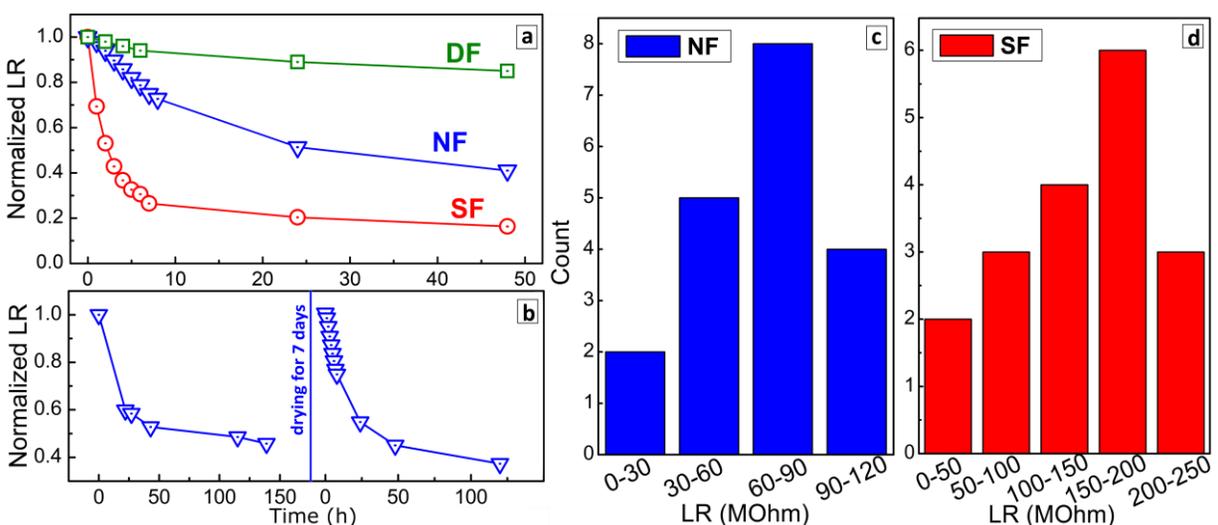
A reduction in wet LR is observed upon the electrolyte immersion for any kind of PV-module, but the reduction extent varied strongly for different BS types. In particular, PV-modules with the more robust DF BSs showed only about 10% LR reduction after 48 h of immersion (Fig. 3a, curve DF). PV-modules with polyamide-based NF BS revealed typically 40-50% LR reduction after 48 h (curve NF), while the PV-modules with primer-based SF BSs lost more than 80% of the original wet LR (curve SF).

Figure 3. (a) Kinetic curves of LR loss during the electrolyte immersion of PV-modules with primer-based SF BS (1), a PA-based NF BS (2), and a DF BS (3). (b) Changes of wet LR for a PV-module NF BS during two cycles of electrolyte immersion interrupted by a 7-day drying pause. (c,d) distributions of wet LR of PV-modules with NF BSs (c) and SF BSs (d) measured immediately after the electrolyte immersion.

Wet LR losses were found to be reversible. On the example of a NF BS-based PV-module, we found that LR returns roughly to the original value after a 7-day drying of the module at 24-25°C and 60% humidity but then drops again as the module is immersed into the electrolyte for the second time (Fig. 3b). This reversible wet LR change is observed for many “immersion-drying” cycles supporting our assumption on a humidity-driven cyclic effect of insulation resistance of PV-modules.

We collected also a set of LR values measured immediately after the electrolyte immersion for a series of PV-modules with NF and SF BSs (Fig. 3c,d). In general, the SF-type modules show higher LR values than NF-based ones, but reveal a much broader LR distribution, from about 40 to 220 MΩ, as compared to NF-type PV-modules (35-95 MΩ). We can take this fact as an additional evidence that SF-type BSs are more susceptible to humidity-related failures than NF-type BSs.

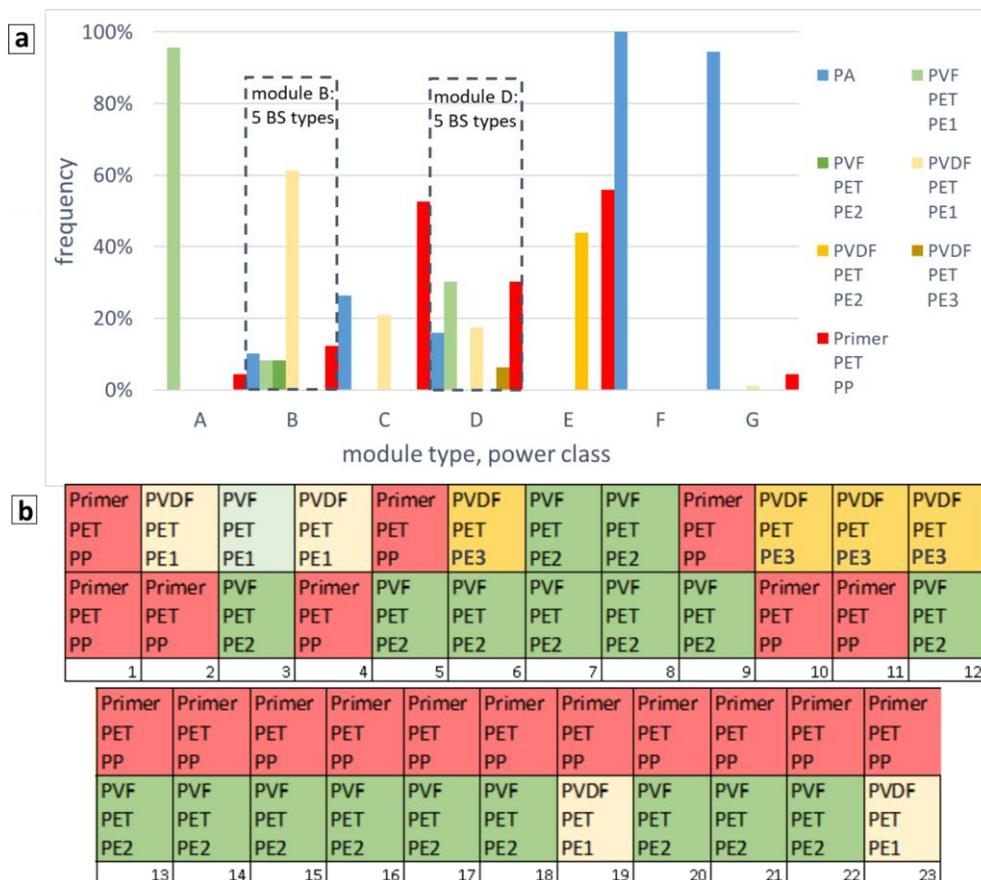
The second observation made on the basis of NIRA tests is the variety of possible BS types within power classes. As many as seven BS were found within the same power class (Fig. 4a) Power classes B and D featured five and six different types of BSs.

Figure 4. (a) Distribution of BS types over the PV-modules of different power classes. (b) An example of two strings (23 modules in each) showing the extreme versatility of BS types for PV-modules type D.

variety of PV-modules of the same power class but with different BS types were united into single strings (see examples in Fig. 4b). Such mixed strings can also potentially be subject to failures because of differences in rates and mechanisms of BS degradations that can cause separate PV-modules to fall out of performance earlier than those with more robust BSs. Seven different BSs is an extreme case, while at least two types of BS were found regularly in the inspected PV-module strings.

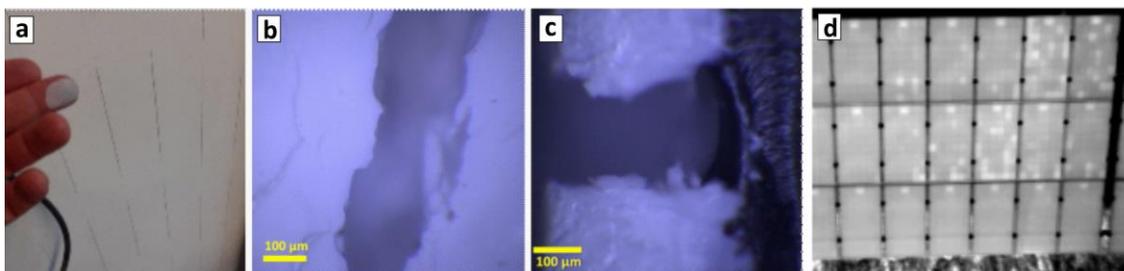
Polyamide BSs - defects and failures. A visual inspection of PV-modules with PA-based NF BSs revealed numerous cases of extensive cracking of the BS air-sides, approx. 50%-60% of investigated PA PV-modules, and strong chalking (Fig. 5a). Typically, cracks were observed along the metal busbars hidden behind the BS (Fig. 5a). This type of PA cracking was observed throughout the solar plant indicating the same mechanism of PA degradation. Such behavior appears to be of general character for PA-BSs of silicon PV-modules [14]. A cross-sectional study of a cracked BS showed that the cracks to be hundreds of micrometers wide (Fig. 5b) and going through the entire BS till the layer of EVA encapsulant (Fig. 5c). At the same time, a NIRA inspection found no spectral differences between PA-BSs with and without cracks.

Figure 5. (a) Photograph illustrating cracking and “chalking” phenomena typical for PA-BSs. (b,c) microphotographs of a crack in a PA-BS take from the air-side (b) and BS cross-section (c). (d) Aerial thermographic image of a table section with PID-affected PV-modules with PA-BSs.

Almost all tested strings with PV-modules of power classes F and G having PA-BSs showed signs of PID with the number of affected PV-modules close to 25% of all tested PA-based PV-modules, while only 6% of PV-modules with other BS types were affected by PID. At that, the signs of PID were detected for PV-modules with both intact and cracked PA BSs.

PV-modules with PA-BS show clearly visible signs of degradation as severe cracking and chalking of the BSs occurs. Measuring the IV-curve reveals no significant power loss, though. PID was detected frequently in this module type, see Figure 5, and we find a connection with susceptibility to water ingress, see Figure 3.

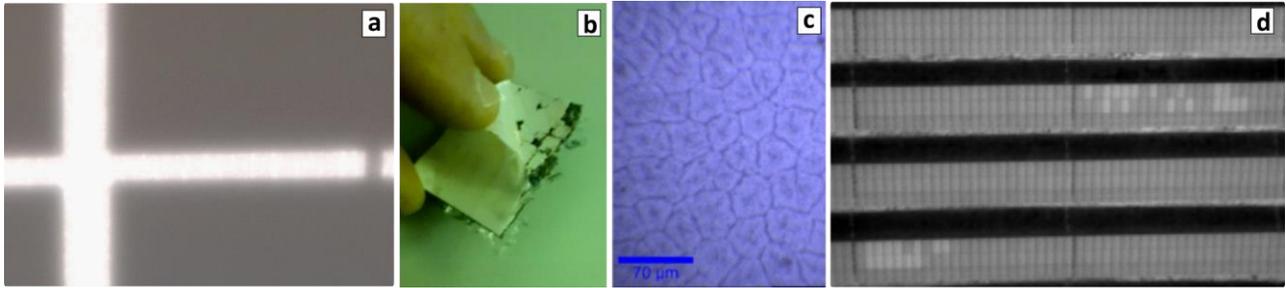
PET-based PV-modules - defects and failures. Other than PV-modules with PA-BS, PV-modules with SF-type BSs typically show uniform glossy air-sides with no macroscopic cracks on the air-side, but reveal inner cracks when observed using transmitted solar light (Fig. 6a). The inner cracks were assumed to be located either in the PET core layer or in the inner polyolefine layer.

Figure 6 (a) Photograph of a PV-module with a primer-based SF-type BS taken in transmitted solar light. (b) Photographs of a cut section of a discarded PV-module with a primer-based SF-BS showing signs of drastic degradation of the inner polyolefine layer. (c) Microphotograph of the air-side of a SF-BS showing extensive micro-cracking. (d) Aerial thermographic photograph of a section of solar field showing multiple instances of “bridged” PV-modules.

The latter assumption is also supported by observations made on the samples cut from discarded PV-modules with primer-based BSs intended for cross-sectional Raman studies. Many of these samples showed drastic deterioration of the interior polyolefine layers, which was degraded to a crumbling condition resulting in the delamination of the PET component (Fig. 6b). As these effects were observed for discarded non-functional PV-modules we may conclude this state to be a serious degradation state of the inner layer, observed for other functional PV-modules on the initial stage as the internal cracking (Fig. 6a).

The air-side of the primer-based SF-BSs typically shows a micro-cracking pattern (Fig. 6c), that is, a surface network of microcracks (several micrometers wide) making the internal layers potentially accessible to humidity and atmospheric gases.

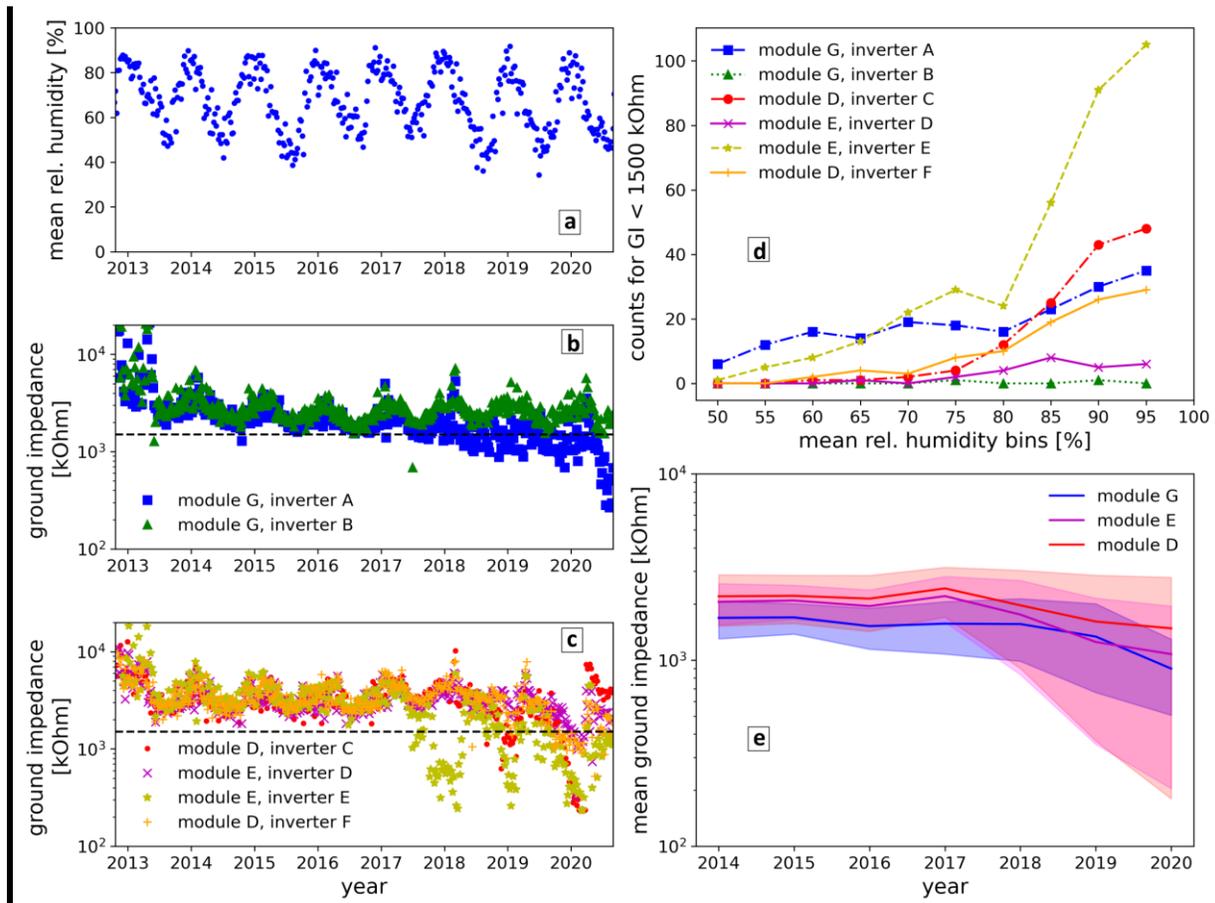
power station. The data in Fig. 7a show the minimum daily GI for inverters with different PV-module types: inverters with PV-modules G predominantly with PA-based BS (Fig. 7b) and inverters with PV-modules D and E mostly with SF-based BS (Fig. 7c).

Figure 7: Time-series of minimum ground impedance for various PV-module types and differing BSs, a) mean daily relative humidity, b) inverters of PV-modules G with most likely a PA-BS, c) inverters of PV-modules B and D with most-likely SF-BS (PV-modules D, inverter C corresponds to the inverter shown in Fig. 8, PV-modules D, inverter F corresponds to the inverter shown in Fig. 5b), d) influence of mean daily relative humidity on ground impedance for 2013 to 2020, and e) mean ground impedance for the populations of PV-modules D, E, and G.

In the first years of operation the minimum daily GI was constantly above 1500 kΩ, independent on the weather conditions, irrespective of the humidity [31]. After several years, GI starts to react to humidity, with the exact reaction depending on the BS-type. The GI of PV-modules with NF-BS varies between remaining constant or decreasing slowly but constantly. Here, the drop of GI below 1500 kΩ seems to be dependent of humidity after the onset in the fifth year of operation. The peak at high humidity for inverter A may be due to the fact that here at least four modules F have a primer-based BS (known from the NIRA-analysis). In

contrast, inverters with PV-modules with mainly SF-BS deviate in performance, see Fig. 7c, the GI for inverters with module types D and E varies strongly between constantly high (comparable to those with PA-based BS, Fig. 7b) or spontaneously decreasing strongly, especially during the more humid winter seasons. The drop of GI depends strongly on the humidity, as Fig. 7d shows. At days of high humidity, GI drops often below 1500 k Ω but recovers for dry day of low humidity.

The distribution for the minimum ground impedance for the populations of module types D, E, and G in shown in Fig. 7e. At that, 20% of the inverters with almost exclusively NF-BS PV-modules reach values lower than 1000 k Ω , only 11% fall under 400 k Ω , although BS cracks were seen in at least 60% of these PV-modules. The GI drop is moderate.

Considerable amounts of inverters with PV-modules D (44.5%) and E (47.8%) reached as low values as 1000 k Ω . GI values lower than 400 k Ω were registered for 20% of the inverter with PV-modules D or E, signalling on severe insulation issues. As data in Table 4 point out, severe GI drop is observed for module types with mainly identified SF-BSs.

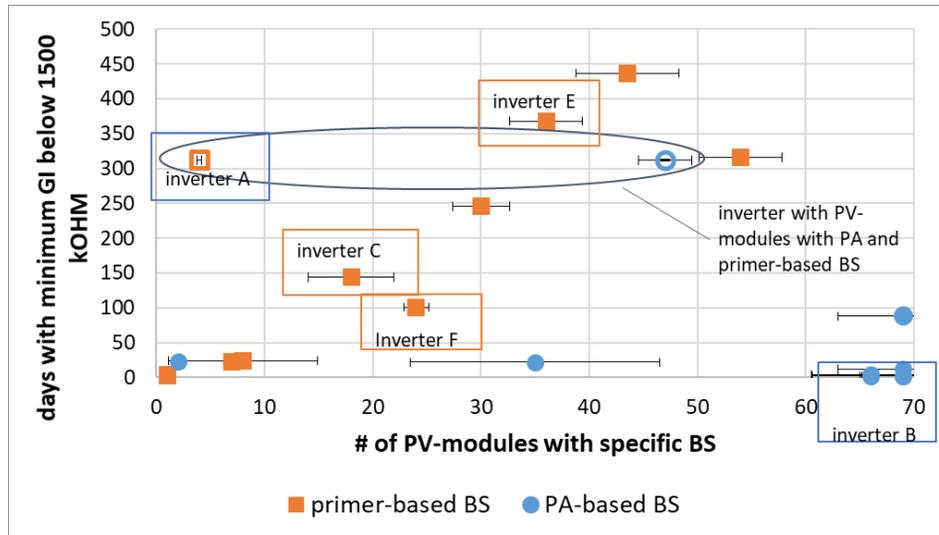
Figure 8: Evaluation of GI for inverters with measured and known BS for more than ten PV-modules, error bars visualize the uncertainty of the number of PV-modules due to the varying number of analyzed PV-modules (between 4 and 51 PV-modules per inverter), 2434 days of total operation time.

For inverter with PV-modules with mixtures of SF-BS-types, e. g. primer-based BS with PVF-based and / or PVDF-based BS, we see indications the GI drop increases with the number of modules with primer-based BSs exceeding eight of such modules per inverter. The worst case observed, is an inverter with 42 modules with primer-based BS. Here the GI was lower than 1500 k Ω for 20% of the total operation days. This GI drop indicates existing or upcoming

insulation issues which can lead to future inverter issues as soon as lower values are reached. Most-likely inverters with PV-modules with SF-BS will lead to more alerts due to ground faults than PV-modules with PA-BS do. The collected and analyzed GI data provide valuable information on the BS material and enable first interferences on material-specific properties and performance.

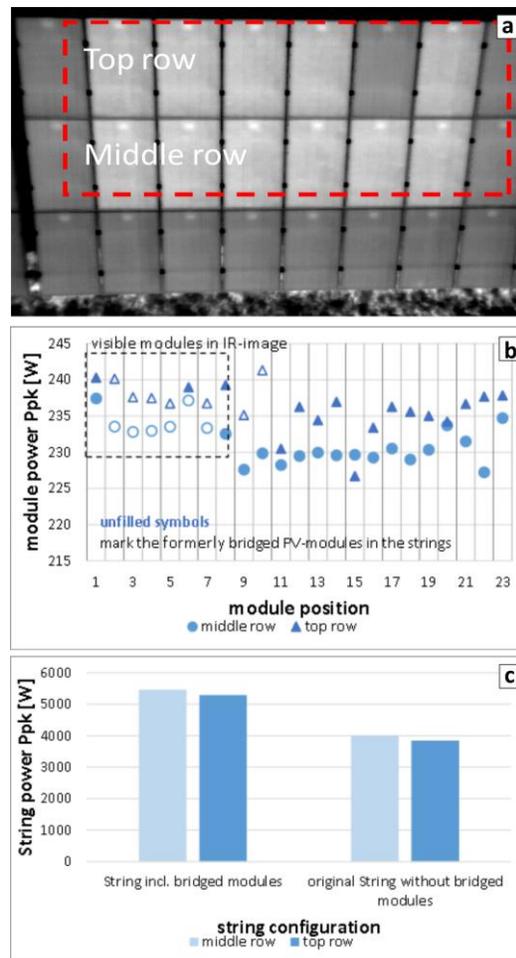
than the surrounding, electrically connected PV-modules, and are clearly visible (Fig. 9a).

However, the measured power lies within the range of the normally operating PV-modules (Fig. 9b). When all PV-modules in the tested strings are considered in the string power measurement, the power gain corresponds to the number of bridged PV-modules (Fig. 9c).

Figure 9: IV-measurements of bridged and un-bridged PV-modules in a PV-array with PV-modules D with a mostly primer-based BS, a) IR-image showing bridged PV-modules at an increased temperature, b) measured P_{pk} of bridged and un-bridged PV-modules, and c) comparison of measured string power for the original string (without bridged PV-modules) and the string including the originally bridged -PV-modules (top row: in total seven bridged PV-modules, middle row: in total six bridged PV-modules)

This observation indicates that the insulation problems resulting in the PV-module bridging can only be observed at relevant conditions, for example, at an elevated humidity. We found 137 bridged modules affecting the energy yield of 16 strings. Between one PV-module bridged in one string and the entire string disconnected from the inverter, everything occurs. In line with this expectation, we do observe severe yield losses in the yearly monitoring data when the bridged PV-modules are accounted for along with unbridged ones.
