# dacl10k: Benchmark for Semantic Bridge Damage Segmentation

Johannes Flotzinger   Philipp J. Rösch   Thomas Braml  
University of the Bundeswehr Munich

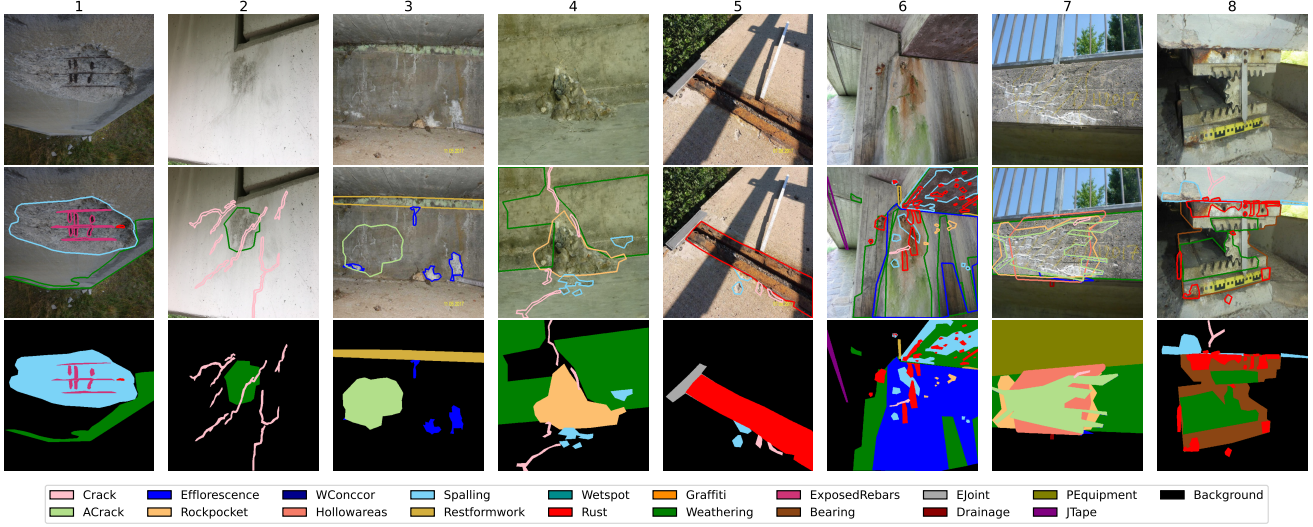
Figure 1. Example annotations from dacl10k. Top row: original image. Middle row: polygonal annotations. Bottom row: stacked masks. The following classes are abbreviated: *Alligator Crack* (ACrack), *Washouts/Concrete corrosion* (WConccor), *Expansion Joint* (EJoint), *Protective Equipment* (PEquipment) and *Joint Tape* (JTape). From left to right, the images display the individual classes: 1. Weathering, Spalling, Exposed Rebars, Rust; 2. Weathering, Crack; 3. Alligator Crack, Restformwork, Efflorescence; 4. Weathering, Crack, Spalling, Rockpocket; 5. Crack, Rust, Expansion Joint, Spalling; 6. Weathering, Rockpocket, Spalling, Efflorescence, Crack, Rust, Restformwork, Joint Tape; 7. Weathering, Protective Equipment, Rockpocket, Efflorescence, Crack, Hollowareas, Alligator Crack, Drainage; 8. Weathering, Spalling, Crack, Rust, Bearing.

Within the last six years, major contributions in the field of damage classification on built structures have been made through the introduction of datasets for binary classification [14, 23, 27, 44], multi-class classification [8, 22], multi-label classification [30], object detection [30], and semantic segmentation [6, 7, 26]. In the following, we discuss datasets for the last three named tasks. Examples for the subsequently named damage types can be obtained from Figure 1.

According to the definition of Cordts *et al.* [12] our dataset comprises coarse pixel-level annotations. We border each defect and object on a given image with one polygon (shape) and assign its label. Furthermore, we include polygons of the same class that overlap with each other in one shape. With respect to inspection standards and application, for all the defect classes, it is not important to differentiate between instances of a given class. Instead, their size and localization on a class-basis is important. Thereby, we utilize the open-source labeling tool LabelMe [34, 41]. Example annotations are shown in Figure 1. It often appears that shapes of different damage or object classes overlap with each other, e.g., *Spalling* with *Exposed Rebars* covered by *Rust* (see example 1 in Figure 1). Consequently, the under-

The two main components during labeling are the class guideline and the annotation guideline. The class guideline clearly defines the visual appearance, most commonly occurrence and cause of each defect, *e.g.*, *Efflorescences* (see example 7 in Figure 1):

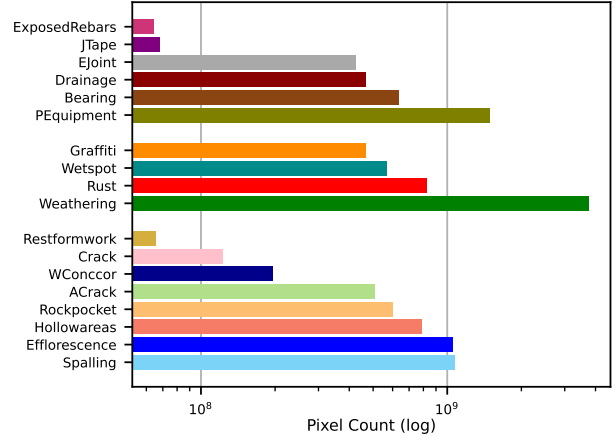
Figure 2. Pixel counts with respect to each class in dacl10k based on the original image sizes. The bars are arranged according to the group affiliation.

Regarding the pixel counts over the whole dataset (see Figure 2), it can be stated that *Weathering*, followed by *Protective Equipment*, are the most dominant classes with nearly four and 1.5 billion pixels. Within the range of 0.1 billion and 1 billion pixels, the majority of defects and objects with respect to the number of pixels can be found. Clearly underrepresented are the defects *Restformwork* (66 million) and the objects *Joint Tape* (68 million) and *Exposed Rebars* (65 million).

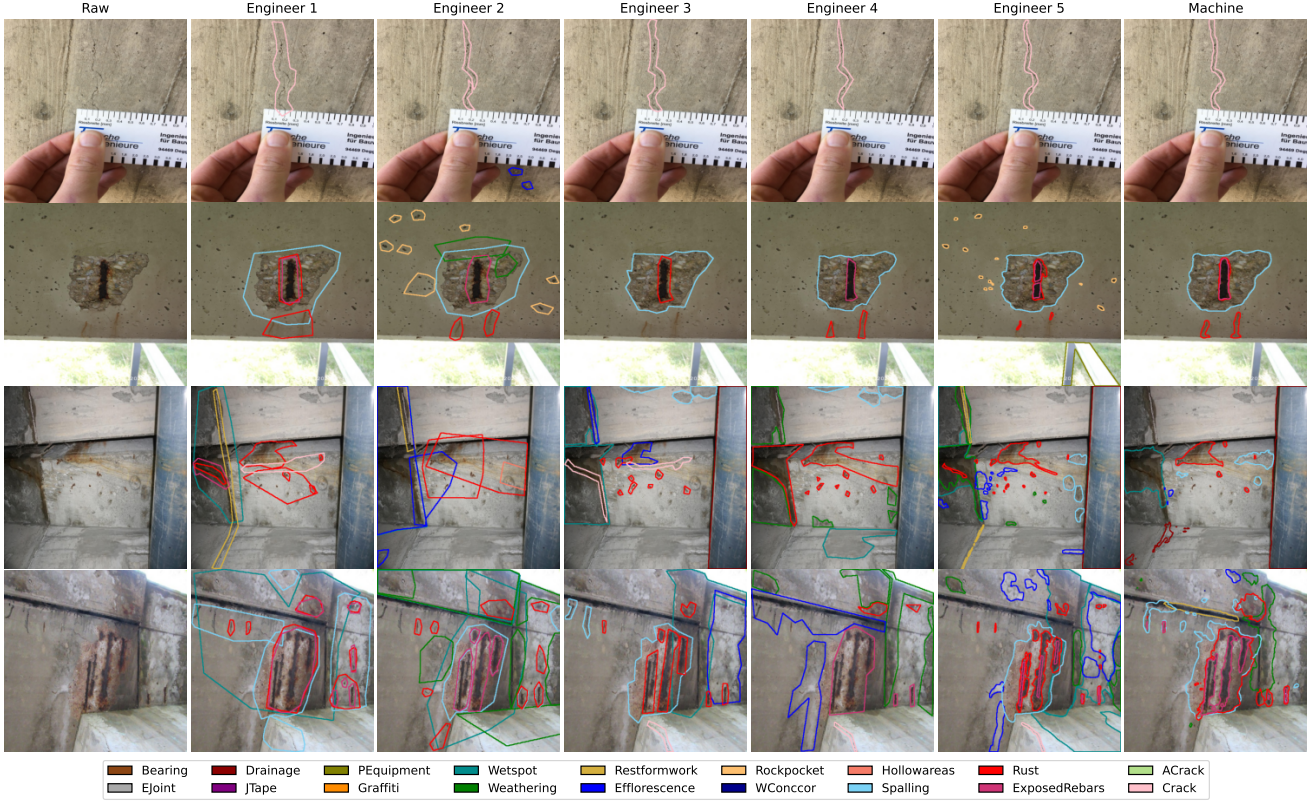
Figure 3. Qualitative evaluation of the best model on four samples (Raw) from the testdev split by comparing annotations of five civil engineers (Engineer 1-5) with the best model’s predictions (Machine). From top to bottom, the samples show: *Crack*; a few tiny cavities which are considered as *Rockpockets* and *Spalling*, *Exposed Rebars*, *Rust*; *Wetspot*, *Weathering*, *Efflorescence*, *Crack*, *Spalling*, *Exposed Rebars* and *Rust*; *Wetspot*, *Weathering*, *Efflorescence*, *Restformwork*, *Drainage*, *Rust*, *Spalling*.

neers with the network’s predictions. Therefore, we asked the five experts, two of whom perform bridge inspections frequently, to annotate four representative samples drawn from dacl10k’s testdev split. Two samples are considered easy and the others difficult to evaluate because of their low resolution, diversity regarding the lighting condition, camera pose as well as defect types and objects. After an introduction to the class guideline, the experts were instructed to annotate the images with the same quality they would expect an application to highlight defects during a close-up or hands-on bridge inspection. Compared to other inspection types, hands-on inspections require the highest quality with respect to defect classification, measurement and localization, which also includes the detection of *Hollowareas* by hammering the concrete surface. Regarding the differences among engineers, it can be stated that with increasing complexity of the samples also the variance of the chosen labels rises. Engineer 5 annotated at the highest quality level. Thus, especially his annotation is used as a qualitative benchmark for our baselines prediction. For the first two samples, which contain fewer classes compared to the last two, the prediction of the machine is better than the average annotation of the five engineers. Only in the second image the small cavities that are part of the defect *Rockpocket* and the *Protective Equipment*, which is overexposed, are not recognized. The last two images reveal the limits of our baseline. For the third sample the classes *Wetspot*, *Rust*

and *Drainage* are well predicted, whereas, areas of *Efflorescence* and weak *Spallings* are not segmented. *Weathering* is not present at all in the model’s prediction. On the last image the model doesn’t predict the defects *Crack* at the center bottom and the *Wetspot* which is located mainly on the wall. Furthermore, the model classifies *Restformwork* which is not present on the image, while *Spalling* and *Exposed Rebars* are correctly recognized. The remaining classes are partially classified.

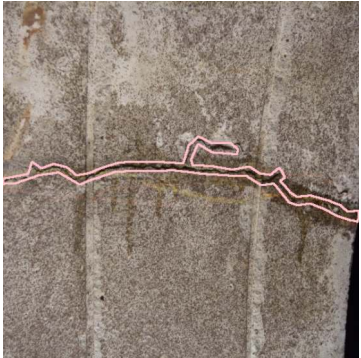
Damage	Visual appearance	Cause	Example
Crack	<ul style="list-style-type: none"> <li>Elongated and narrow zigzag line</li> <li>Clearly darker compared to the surrounding area or black</li> </ul>	<ul style="list-style-type: none"> <li>Concrete's tensile strength is exceeded</li> <li>Too high bending or shearing load</li> <li>Settlement of the substructure</li> </ul>

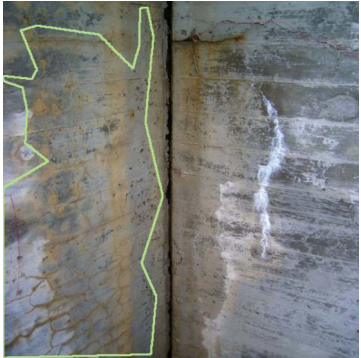
Alligator Crack (ACrack)	<ul style="list-style-type: none"> <li>Many branched cracks</li> <li>Mostly arbitrarily orientated</li> <li>Usually with a small crack width (compared to <i>Crack</i>)</li> </ul>	<ul style="list-style-type: none"> <li>Inadequate post-treatment or concrete recipe (shrinkage)</li> <li>Too high temperatures during hardening of the concrete</li> <li>Formation of expansive phases leading to a volume increase in the concrete as a result of chemical action</li> </ul>

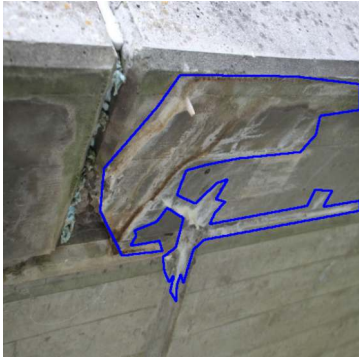
Efflorescence	<ul style="list-style-type: none"> <li>Mostly roundish areas of white to yellowish or reddish color</li> <li>Strong efflorescence can look similar to stalactites.</li> <li>Often appears in weathered (<i>Weathering</i>) or wet areas (<i>WetSpot</i>) of the building and in combination with <i>Crack</i> and/or <i>Rust</i></li> </ul>	<ul style="list-style-type: none"> <li>Dissolving of salts (calcium, sodium, potassium) from the cement stone or aggregate by humidity changes or water ingress, <i>e.g.</i> constantly running water through the building part or along its surface</li> <li>The salts consequently carbonate leading to the final visual appearance.</li> <li>Note: Water ingress can be caused by other defects imposing the draining of water, <i>e.g.</i>, <i>Restformwork</i> or damaged <i>Drainage</i>. <i>Efflorescences</i> are also called Calcium leaching.</li> </ul>

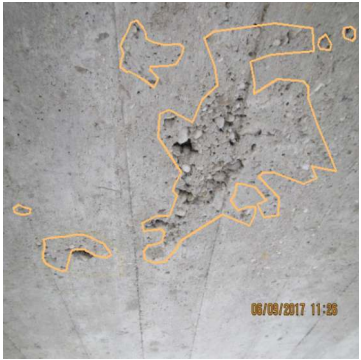
Damage	Visual appearance	Cause	Example
Rockpocket	<ul style="list-style-type: none"> <li>Visible coarse aggregate</li> <li>Often in tilts of the formwork and the bottom of building parts (opposite side from which the concrete is poured into the formwork)</li> </ul>	<ul style="list-style-type: none"> <li>Inadequate rheological properties (viscosity, yield point) of the concrete</li> <li>Appears due to bad compacting after having poured the concrete into the formwork. Therefore, insufficient deaeration of the concrete follows, causing areas where the cement paste didn't fill the volume between the coarse aggregate completely (<i>Rockpocket</i>).</li> <li>Note: Hence, the concrete cover of the reinforcement as well as the bond between the bars and the concrete is not provided or reduced. <i>Rockpockets</i> are also called Honeycombing.</li> </ul>

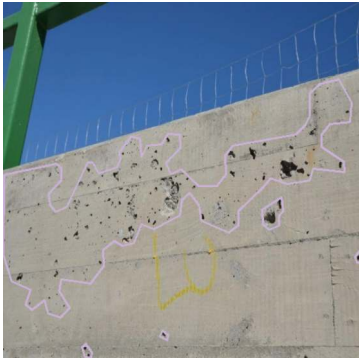
Cavity <sup>1</sup>	<ul style="list-style-type: none"> <li>Small air voids</li> <li>Mostly on vertical surfaces</li> </ul>	<ul style="list-style-type: none"> <li>Inadequate rheological properties (viscosity, yield point) of the concrete</li> <li>Appears due to bad compacting after having poured the concrete into the formwork. Therefore, insufficient deaeration of the concrete follows causing small "dots" on the surface.</li> <li>Note: At these spots the concrete cover is reduced. Cavities of usual size have no impact on the building assessment.</li> </ul>

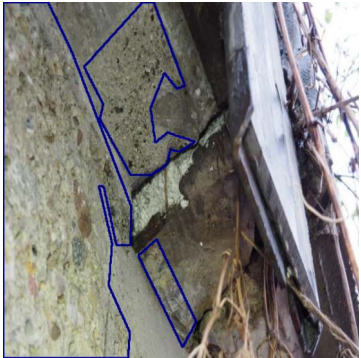
Concrete Corrosion (ConcreteC)	<ul style="list-style-type: none"> <li>Includes the visually similar defects: Washouts, Concrete corrosion and generally all kinds of planar corrosion/erosion/abrasion of concrete.</li> <li>Note: We summarize all these "planar corrosion defects" in this class because they are visually hard to differ. According to inspection standards they have to be subdivided which requires strong expertise in building defects.</li> </ul>	<ul style="list-style-type: none"> <li>Washouts appear on building parts that are constantly in contact with running water leading to the erosion of the concrete, e.g., abutment walls or bridge piers in rivers.</li> <li>Concrete corrosion can appear as a result of frost-thaw cycles, loss in succession to chemical attacks or abrasion (mechanical or action of acid and salt solutions).</li> <li>Note: In dacl10k_v1 <i>Concrete Corrosion</i> (ConcreteC) was called "Washouts/Concrete corrosion" (WConccor).</li> </ul>

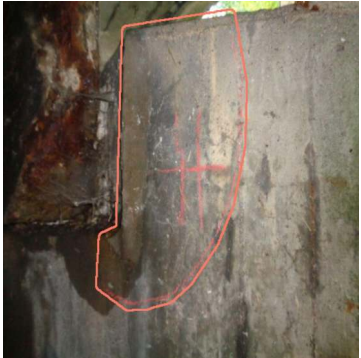
Damage	Visual appearance	Cause	Example
Hollowarea	<ul style="list-style-type: none"> <li><i>Hollowareas</i> are not visually recognizable but their markings made with crayons (mostly yellow, red or blue) during close-up/hands-on inspections.</li> <li>Note: The outer edge of the marking is considered as the boundary of the according area. We annotate every chalk marking that approximately forms a closed geometric figure. Single lines are not labeled as <i>Hollowarea</i> as they are often used for the marking of <i>Cracks</i>.</li> </ul>	<ul style="list-style-type: none"> <li>Corrosion of the subjacent reinforcement which leads to a volume increase surrounding the reinforcement bar and detaching of the concrete area that covers the bars.</li> <li><i>Hollowareas</i> are usually the preliminary stage of <i>Spallings</i> and <i>Exposed Rebars</i>.</li> <li>Note: Recognizing <i>Hollowareas</i> is very important as the falling concrete parts can cause severe damage. Therefore, hollow sounding areas are usually removed instantly.</li> </ul>

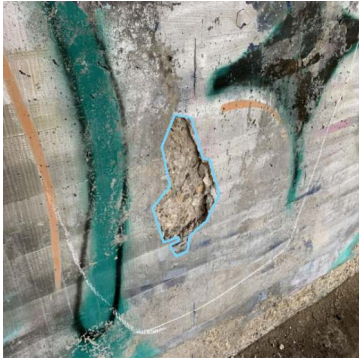
Spalling	<ul style="list-style-type: none"> <li>Spalled concrete area revealing the coarse aggregate</li> <li>Significantly rougher surface (texture) inside the <i>Spalling</i> than in the surrounding surface</li> </ul>	<ul style="list-style-type: none"> <li>Corrosion of the subjacent reinforcement leading to an increase in volume and consequent spalling of the concrete cover</li> <li>Frost-thaw cycles of intruded water (deeper than <i>Washouts/Concrete corrosion</i>)</li> <li>Impact from vehicles, damaging during assembly of the building part or removal of the formwork, manufacturing faults</li> </ul>

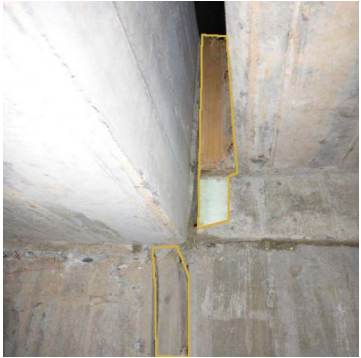
Restformwork	<ul style="list-style-type: none"> <li>Left pieces of formwork in joints or on the structure's surface</li> <li>Restformwork can be made of wood and polystyrene (PS).</li> <li>PS is often used as a placeholder in joints during concreting.</li> </ul>	<ul style="list-style-type: none"> <li>After the concrete hardening has ended, PS is often forgotten to be removed (e.g., in the joint between the abutment wall and the superstructure).</li> <li>Note: If <i>Restformwork</i> is not removed, water may be hindered to drain which can lead to other defects (e.g. <i>Spalling</i>, <i>Exposed Rebars</i>, <i>Rust</i>).</li> </ul>

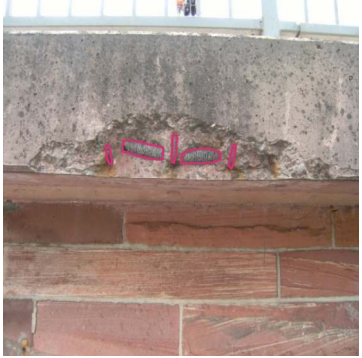
Object	Visual appearance	Functionality	Example
Exposed Re-bars	<ul style="list-style-type: none"> <li>Exposed Reinforcement (non-prestressed and prestressed) and cladding tubes of tendons</li> <li>Often appears in combination with <i>Spalling</i> or <i>Rockpocket</i>, and <i>Rust</i></li> </ul>	<ul style="list-style-type: none"> <li>In reinforced concrete structures, the reinforcement's task concerning the load transfer is to absorb the tensile forces.</li> <li><i>Exposed Rebars</i> occur due to insufficient concrete cover or corrosion and the consequent <i>Spalling</i> of the concrete cover.</li> <li>The reduction of the reinforcement's cross section due to <i>Rust</i> significantly influences the structural integrity of the according building.</li> </ul>

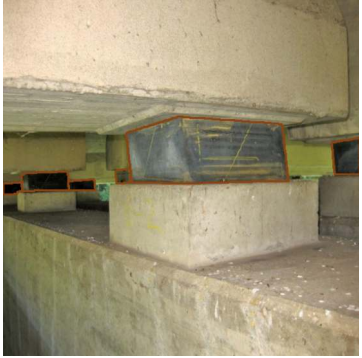
Bearing	<ul style="list-style-type: none"> <li>All kinds of bearings, such as rocker-, elastomer- or spherical-bearings</li> </ul>	<ul style="list-style-type: none"> <li>Bearings transfer the load from the superstructure to the substructure.</li> <li>Note: Bearings can show <i>Rust</i> and <i>Cracks</i> as well as deformation due to settlements in the abutments, overloading or creeping of the bridge. The deformation or damaging of bearings can result in load redistribution which is not considered in the structural design of the bridge.</li> </ul>

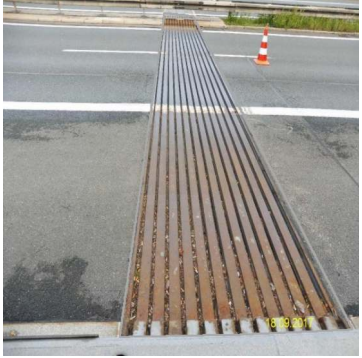
Expansion Joint (EJoint)	<ul style="list-style-type: none"> <li>Located at the beginning and end of the bridge</li> <li>Assembled cross to the longitudinal bridge axis</li> </ul>	<ul style="list-style-type: none"> <li><i>Expansion Joints</i> compensate the thermal longitudinal expansion of the bridge deck and superstructure.</li> <li>Note: Mostly, <i>Expansion Joints</i> are corroded (<i>Rust</i>) and weathered (<i>Weathering</i>) which hinders their ability to compensate the enlargements due to changes in temperature.</li> </ul>

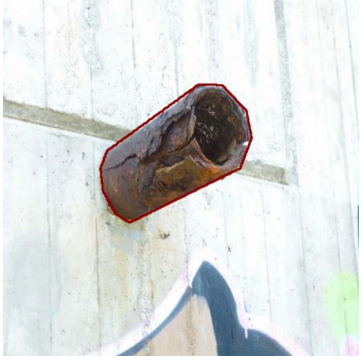
Object	Visual appearance	Functionality	Example
Drainage	<ul style="list-style-type: none"> <li>All kinds of pipes and outlets made of Polyvinylchlorid or metal mounted on the bridge.</li> </ul>	<ul style="list-style-type: none"> <li>The <i>Drainage</i> directs water (often contaminated with deicing salt) away from the bridge.</li> <li>The draining of water is important for the durability of the bridge. If the water can't drain properly, especially when it's contaminated with deicing salts, the bridge's deterioration is accelerated leading to defects, such as <i>Spalling</i>, <i>Exposed Rebars</i> or <i>Rust</i></li> </ul>

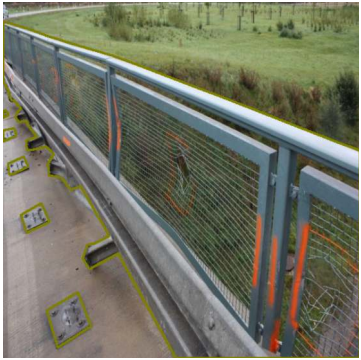
Protective Equipment (PEquipment)	<ul style="list-style-type: none"> <li>Railings, traffic safety features (e.g., steel rail, guide rails, impact attenuation device)</li> </ul>	<ul style="list-style-type: none"> <li>Geometric adequacy and structural capacity of the <i>Protective Equipment</i> is important with respect to the traffic safety.</li> <li>The rail types and installation heights and minimum clearances must be checked.</li> <li>Note: Mostly, they are corroded (<i>Rust</i>) or deformed due to vehicle impact.</li> </ul>

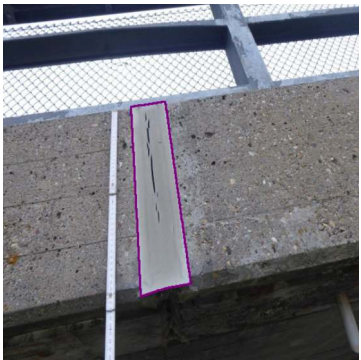
Joint Tape (JTape)	<ul style="list-style-type: none"> <li>All joints that are filled with elastomer or silicon</li> <li>Note: Originally, <i>Joint Tape</i> means an elastomer strap at the end and beginning of relatively small bridges.</li> </ul>	<ul style="list-style-type: none"> <li><i>Joint Tapes</i> compensate longitudinal enlargements due to changes in temperature (like <i>Expansion Joint</i>).</li> <li>Note: A <i>Joint Tape</i> is damaged when it's ruptured or twisted. <i>Joint Tape</i> is also called Bridge Seal.</li> </ul>

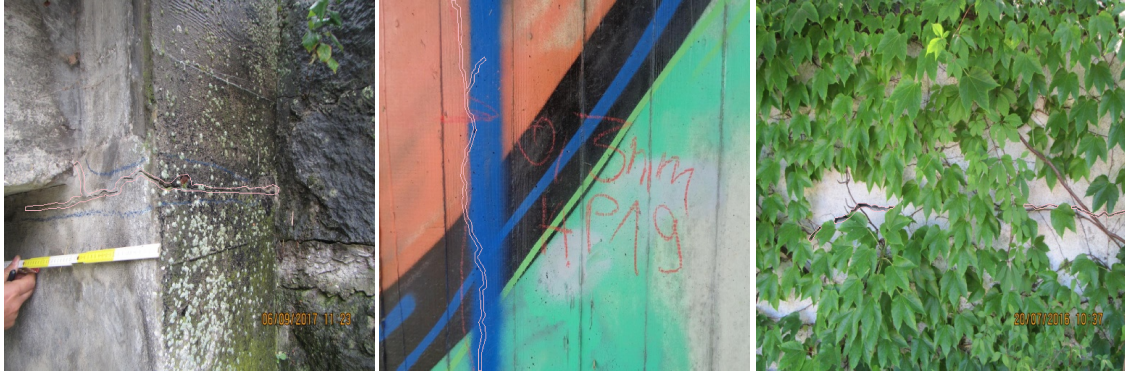
(a) Challenging samples showing a *Crack*: in combination with strong *Weathering*, in combination with *Graffiti* and partially overlapped by vegetation (*Weathering*).

Figure 4. Challenging defects. All subcaptions describe the images from left to right.

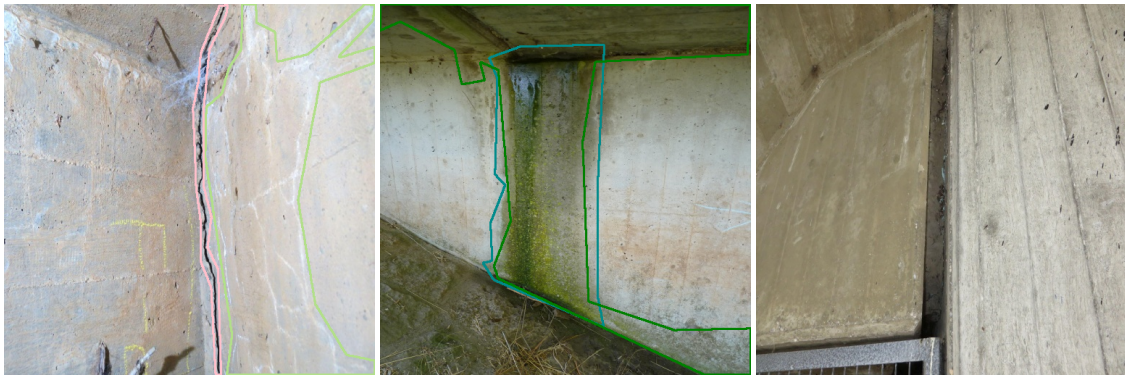
(b) *Crack* vs. *Alligator Crack*, *Weathering* vs. *Wet spot*, *Restformwork* covered with concrete slurry (no ground-truth annotation for better visibility).

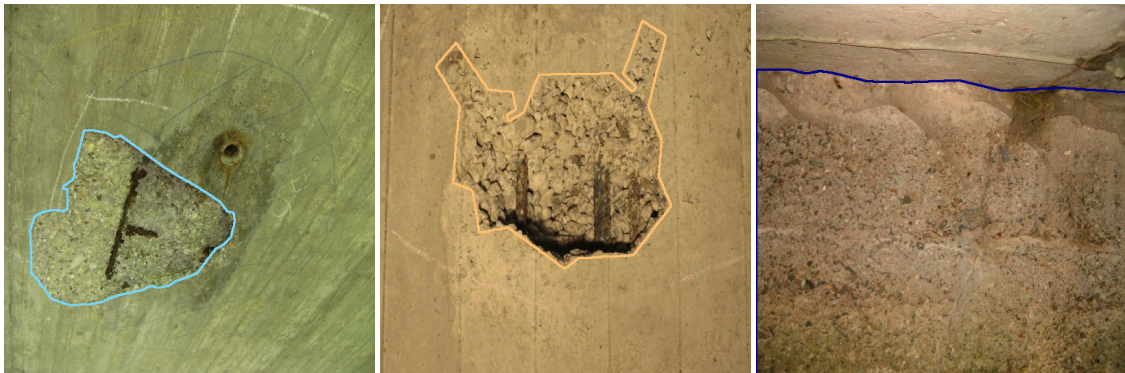
(c) *Spalling*, *Rockpocket*, *Washouts/Concrete corrosion*.

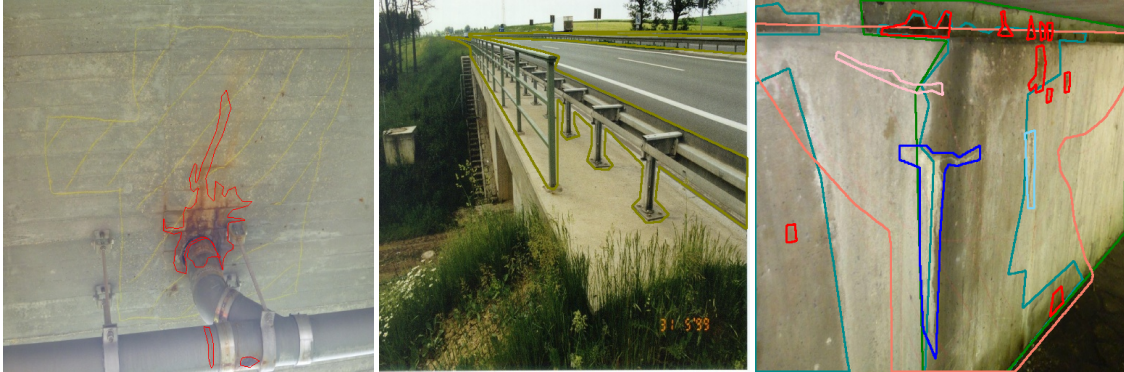
(a) No clear border of the defect (*Rust*), the class (*Protective Equipment*) is stretched from fore- to background. Many overlapping classes with partially low contrast like the border and hatching of the *Hollowarea* (pale red), and the *Efflorescence* (dark blue) next to the bright, dry and healthy concrete surface.

Figure 5. General problems across the dataset. All subcaptions describe the images from left to right.

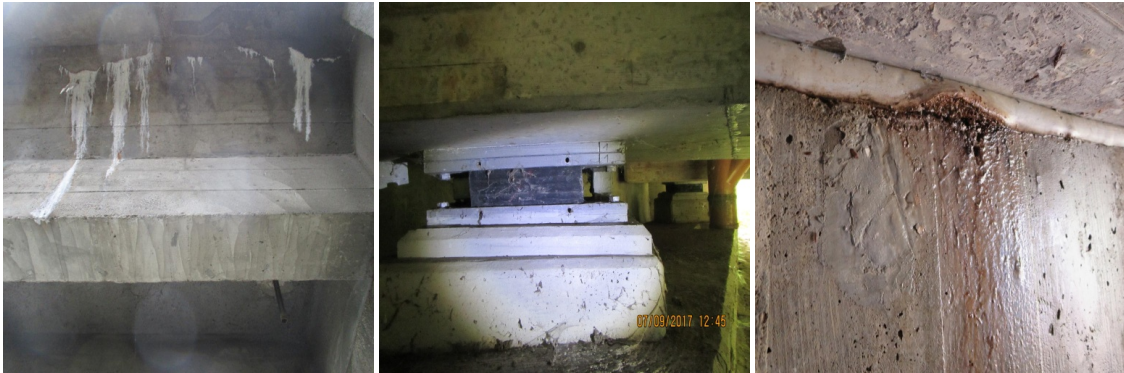
(b) Image quality problems: lens flares, partial overexposures due to flashlight, and sunlight.

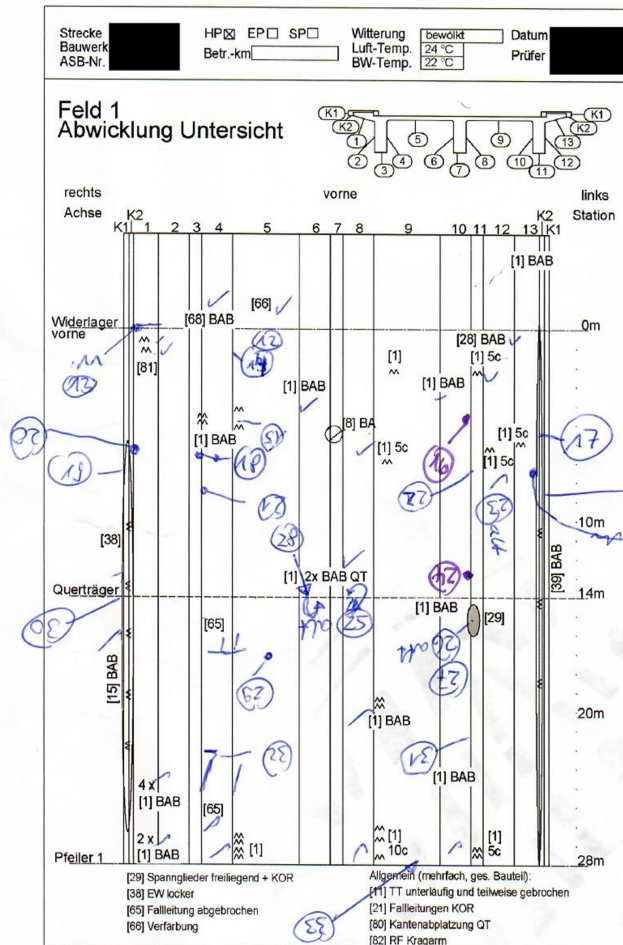
Figure 6. Damage sketch from a real bridge inspection with three T-beams. The sketch represents the bridge flipped-open along its longitudinal axis. Thus, the “vertical lines” represent the edges of the bridge cross-section. The defects are numbered in chronological order. Exemplary damage-information separated by comma (damage-number, damage-class, longitudinal, and cross-section dependent localization): #28, *Spalling* (“BAB”) with *Exposed Rebars* (“freiliegende Bewehrung”), at the cross girder (“Querträger”), on the left side of the web (6); #29, *Hollowarea* (“Hohlstelle”), approximately 3m from the cross girder (“Querträger”), on the flange (5); #31, *Drainage* (“Fallrohr”) with *Rust* (“korrodiert”) which is leaking (“undicht”), approximately 7m from the cross girder (“Querträger”), on the bottom of the web (11).
