Quality assurance tests and techniques to investigate and improve hermeticity of ATLAS Phase II Resistive Plate Chamber detectors

Abstract

Keywords: ATLAS, RPC, Thermal QC, Gas Leak Tests

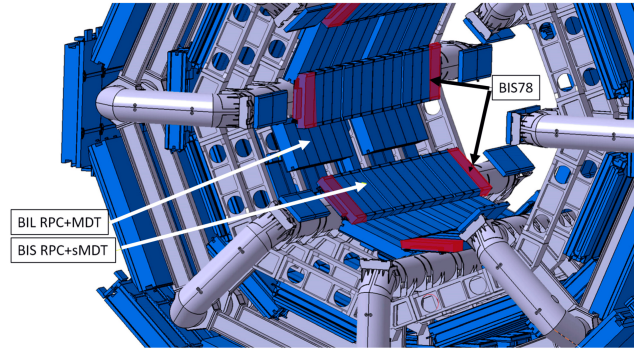
Figure 1: The ATLAS Muon Spectrometer. The blue regions indicate the locations of the Resistive Plate Chambers (RPCs) and Monitored Drift Tube (MDT) chambers, while the grey areas depict the toroidal solenoid magnet and the overall mechanical structure of the experiment [4].

The ATLAS Muon Spectrometer, shown in Figure 1, is undergoing upgrades as part of the Phase II upgrade program, in preparation for the high-luminosity phase of the Large Hadron Collider (HL-LHC) [1, 2]. A key component of this upgrade is the enhancement of the Resistive Plate Chamber (RPC) system, which involves installing over 300 Phase II RPC chambers. This includes 226 Barrel Inner (BI) chambers and 80 Barrel Outer (BO) and Middle (BM) chambers, which are designed to handle rates of up to 10 kHz/cm² in the high-radiation environment of the HL-LHC [3].

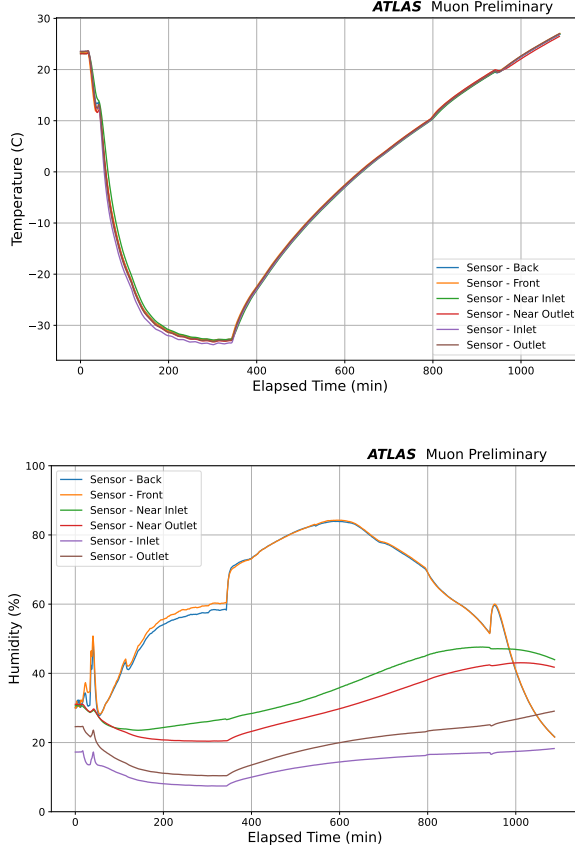
Figure 3: Example of a thermal cycle performed in the Cambridge climate chamber over several hours, with recorded temperature conditions (top). Sensors at multiple positions – including within the gas gap inlet and outlet – track the temperature response in relation to the separately controlled climate chamber conditions. Recorded humidity conditions during the same thermal cycle (bottom), displaying relative humidity measurements at the gas gap inlet and outlet, as well as positions near the inlet and outlet on the outside of the gas gap. Additional sensors on the front and back surfaces provide a broader view of the climate room ambient conditions.

Figure 2 shows the experimental setup within the climate chamber room at the University of Cambridge. This setup includes five ATLAS Phase II BIS-type gas gaps and one complete RPC singlet, all placed in a climate-controlled environment designed to facilitate TC. The chamber room, equipped with two compressors, allows temperature variations from -40°C to $+35^{\circ}\text{C}$, though for our tests, it was operated within a range of -33°C to $+35^{\circ}\text{C}$. An example of a thermal cycle between -33°C and $+25^{\circ}\text{C}$, conducted using this setup, is shown in Figure 3 (top). Here, it can be observed that all sensors closely track the climate room’s temperature variations. Meanwhile, Figure 3 (bottom) illustrates the relative humidity at various points on one of the gas

gaps. The sensors labelled Inlet and Outlet are housed in 3D-printed fittings connected to gas lines, recording internal gas conditions within the gap. Notably, the inlet sensor shows lower humidity than the outlet, as dry CO_2 gas was continuously flushed through the gas gap, and the outlet sensor captures a slight humidity increase due to exposure to the chamber's humid environment. This small exchange of moisture with ambient air is further verified by the Near Inlet and Near Outlet sensors. These sensors start with similar humidity levels; however, the Near Outlet sensor shows a gradual decrease in humidity as it interacts with the gas flow, which becomes more humid as it picks up moisture within the gas gap. The Front and Back sensors provide additional readings of the external humidity surrounding the gas gap and within the broader climate room environment.

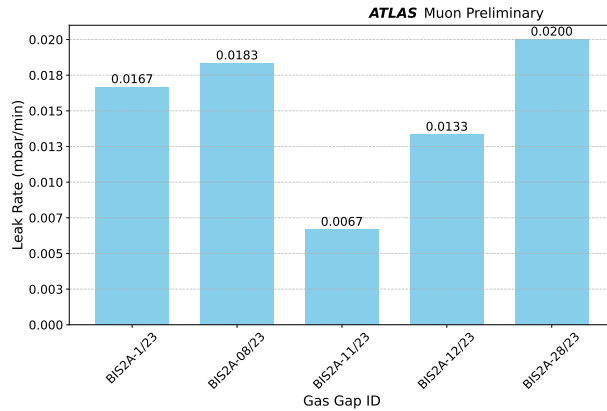
Figure 5: Leak rates for different gas gaps measured at Cambridge using a semi-automatic setup following thermal cycles.

The main finding of the QA tests carried out at Cambridge is that the TC protocol ranging from -33° and $+35^{\circ}$ C is found to have a notable ageing effect on the gas gaps, as shown in Table 1. The results after the TC protocol are also presented in Figure 5.

For subsequent assessments, slightly longer-duration measurements were acquired with a semi-automatic setup, allowing for more precise monitoring. However, these measurements only provide initial observations for the first few minutes after inflating the gas gaps to 5 mbar and should not be compared with the long-duration measurements presented later in this study. The semi-automatic setup used multiple cross-calibrated pressure and temperature sensors connected to a Raspberry Pi, enabling sensor control and data acquisition. The setup allowed better monitoring of gas gap conditions throughout the testing process.

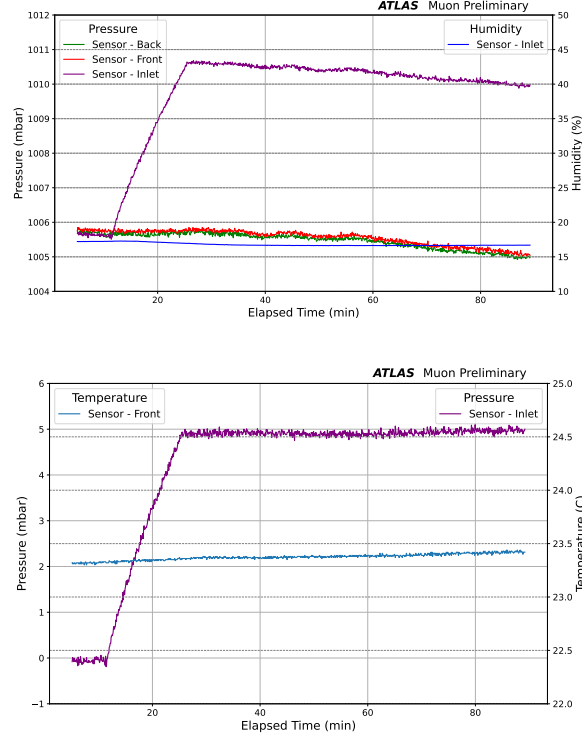
Figure 6: Pressure drop over time for gas gap BIS2A-11/23 after 16 thermal cycles, measured using a semi-automatic setup with multiple sensors. (top) Absolute pressure values recorded over time, showing the initial inflated pressure of 5 mbar within the gas gap, ambient pressure from the Front and Back sensors, and internal pressure within the gas gap monitored by the Inlet sensor. Relative humidity is also shown for reference. (bottom) Pressure drop inside the gas gap over time, corrected for ambient pressure variations. The temperature trend is included, illustrating how a slight temperature increase affects the apparent pressure drop by masking it, a trend more clearly seen in Figure 8.

As an example for a “good” gas gap, Figure 6 presents the pressure drop for gap BIS2A-11/23 as a function of time after 16 TCs, with an initial overpressure of 5 mbar. The figure (top) shows concurrent ambient pressure fluctuations recorded alongside the pressure drop, while the figure (bottom) offers a corrected view of the pressure drop, adjusted for ambient pressure variations. Notably, the pressure remains largely stable, showing no signs of ageing, consistent with manual checks and measurements from CERN. A

slight pressure decrease over time is observed; however, this is not immediately apparent in the figure due to a gradual temperature increase that obscures it.

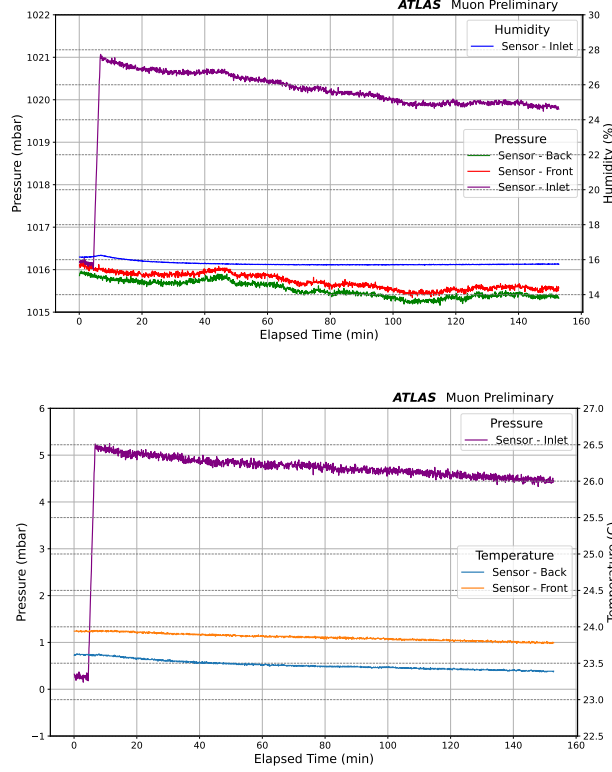
Figure 7: Pressure drop over time for gas gap BIS2A-08/23 after 16 thermal cycles, recorded using the same setup and parameters described in Figure 6. This figure highlights the presence of leaks. In addition, relative humidity variations from the Inlet sensor are also included for reference in the figure at the top while the bottom figure includes temperature variations over a longer period recorded by Front and Back sensors, which track climate room conditions.

To illustrate the behaviour of a “bad” gas gap, Figure 7 shows pressure drop measurements for gap BIS2A-08/23 as a function of time after 16 TCs with stable temperature and humidity levels throughout. This gas gap exhibited a noticeable leak that worsened after thermal cycling. It is interesting to note that the leakrate is fairly high in the first $\mathcal{O}(10)$ min, and stabilises somewhat afterwards. A potential explanation for this could be that the micropores that have opened are partially sealed by not fully polymerised linseed oil within the gap.

The rapid pressure drop in the first $\mathcal{O}(10)$ min observed for gas gaps BIS2A-08/23 and BIS2A-01/23 may be attributed to a subtle effect: micro-pores that open up with the pressure increase are partially sealed again by not fully polymerised linseed oil or not fully cured glue within the gap. If confirmed, this would be a clear indication where the production process of the gas gaps should be improved.

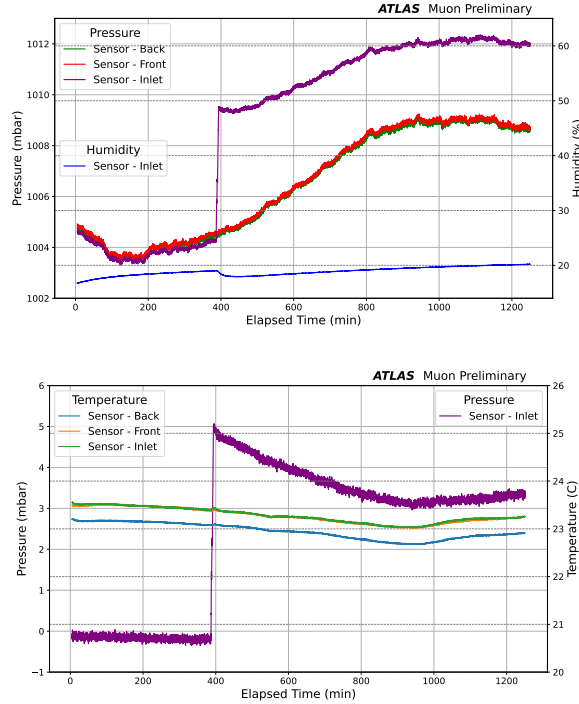
Figure 8: Pressure drop over time for gas gap BIS2A-01/23 after 16 thermal cycles, recorded using the same setup and parameters described in Figure 6. This figure highlights threshold effects, suggesting that leaks may occur at higher pressures (above 3 mbar), whereas the gas gap maintains adequate performance at lower pressures (approximately 3 mbar or less). Relative humidity variations are also included for reference in the figure at the top while the lower bottom one includes temperature variations over a longer period recorded by Front, Back, and Inlet sensors. The Front and Back sensors track external climate room conditions, while the Inlet sensor monitors internal temperature fluctuations within the gas gap. The slight increase in pressure drop measurements toward the end is attributed to an overall temperature rise both inside and outside the gas gap.

Another interesting result is presented in Figure 8, which depicts the

leak rate for gas gap BIS2A-01/23 as a function of time after 16 TCs. It is apparent that over a period of more than 12h ambient pressure (top) and a subtle temperature differences (bottom) affect the leak rate. Specifically, a rapid initial decline in pressure is observed as the gas gap's pressure drops from around 5 mbar, levelling off closer to 3 mbar. Similar to BIS2A-08/23 shown in Figure 7, the leak rate is significantly higher in the first $\mathcal{O}(10)$ min and decreases somewhat after that, although it remains intolerably high. Additionally, a positive slope in the leak rate aligns with minor temperature increases in the bottom graph, suggesting some thermal sensitivity, although the trend stabilises briefly before rising again with temperature.

sure decreases from 5 to 3 mbar for gap BIS2A-01/23 suggests that micro-pores or channels within the material may open or close only above certain pressure thresholds. As the pressure in the gas gap falls below a certain pressure (in the current case approximately 3 mbar), the leak rate stabilises, potentially indicating that these threshold-sensitive pathways are no longer active at lower pressures. These observed threshold effects, where certain pores open only at higher pressures (middle), are of particular interest. Identifying these threshold pressures is essential to optimise RPC performance in fluctuating pressures near operational levels. Such understanding could further enhance the RPCs' reliability, especially under varying pressure conditions close to their standard operating range.

- First, the leak measurements were performed at an overpressure of 5 mbar at Cambridge versus 3 mbar at Frascati. As the results from of gap BIS2A-01/23 shown in Fig. 8 indicate, micropores or other effects that become measurable above 3 mbar are likely to play an important role in this comparison.
- Furthermore, thermal cycles spanned a maximum temperature range of -20° and $+30^{\circ}\text{C}$ at Frascati, with only three cycles performed in this maximum temperature excursion. By contrast, the tests at Cambridge involved a broader temperature range, from -33° to $+35^{\circ}\text{C}$; seven cycles were completed, including additional cycles at conditions closer to the maximum temperature excursions.

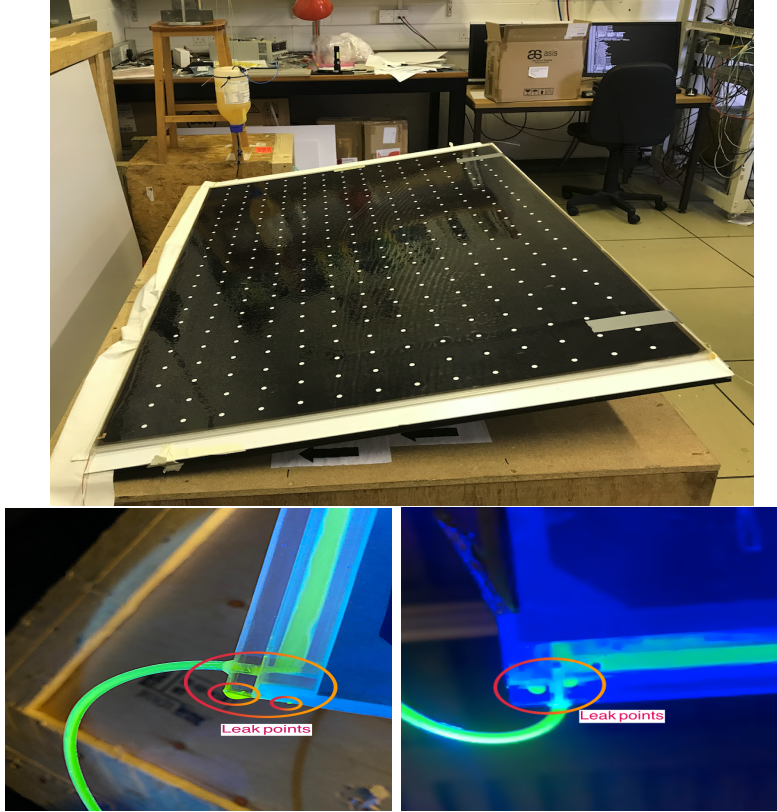
Figure 9: (top) A gas gap being filled with the fluorescent tracer solution using a bottle, with the height of the bottle gradually raised from the bottom, following Archimedes' principle. (bottom) Gas gaps filled with the fluorescent tracer solution illuminated with UV light (external lights switched OFF), illustrating the process of leak detection. The concentration and path of the tracer (in green) highlighted in these images indicate the presence of leaks or potential defects near the gas inlet/outlets and within the gas distribution manifold.

After initial assessments revealed leaks in the gas gaps in one of the test campaigns, a gas sniffer – Heated Diode Refrigerant Leak Detector (Model DR58) [9] – was employed to roughly locate these leaks. To identify the critical points where the leaks occurred more accurately, additional tests were conducted using a solution with a fluorescent tracer ‘Fluorescein’. This solution was prepared by mixing Fluorescein powder with isopropyl alcohol, creating a detectable medium that could highlight effectively the path of leaks when illuminated with ultraviolet (UV) light. The two gas gaps that were considered for this test at Cambridge were BIS2A-28/23 and BIS2A-08/23, as these had higher leak rates, as depicted in Figure 5. The gas gaps were filled with the fluorescent tracer solution, and a UV torch was used to illuminate the tracer within the gas gaps allowing for the visualisation of the tracer’s path, as shown in Figure 9. Under UV light, any critical areas such as micro-cracks, weak joints, or potential leak sites would be illuminated, revealing regions where the fluorescent light was more concentrated or where it visibly seeped out of the gas gap. Similar tests were also conducted at Frascati. The results from the tracer tests were consistent with those from the sniffer leak detection tests and assessments, identifying specific leaks and weak points that were primarily associated with the gas distribution manifolds within

the gas gaps. These issues were promptly followed and addressed by the ATLAS Muon Community.
