Quality assurance tests and techniques to investigate and improve hermeticity of ATLAS Phase II Resistive Plate Chamber detectors

Abstract

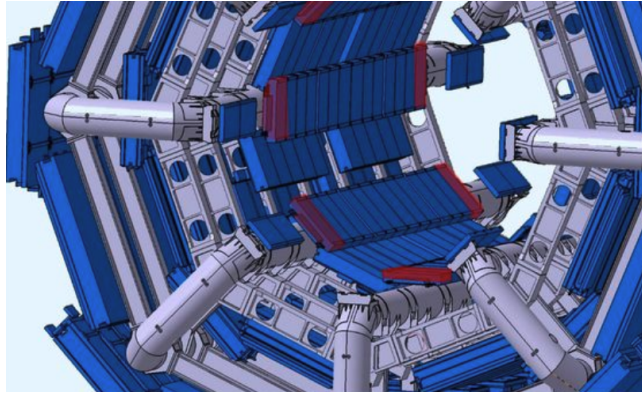
Figure 1: The ATLAS Muon Spectrometer. The blue regions indicate the locations of the Resistive Plate Chambers (RPCs) and Monitored Drift Tube (MDT) chambers, while the grey areas depict the toroidal solenoid magnet and the overall mechanical structure of the experiment [4].

The ATLAS Muon Spectrometer, shown in Figure 1, is undergoing upgrades as part of the Phase II upgrade program, in preparation for the high-luminosity phase of the Large Hadron Collider (HL-LHC) [1, 2]. A key component of this upgrade is the enhancement of the Resistive Plate Chamber (RPC) system, which involves installing over 300 Phase II RPC chambers. This includes 226 Barrel Inner (BI) chambers and 80 Barrel Outer (BO) and Middle (BM) chambers, which are designed to handle rates of up to 10 kHz/cm² in the high-radiation environment of the HL-LHC [3].

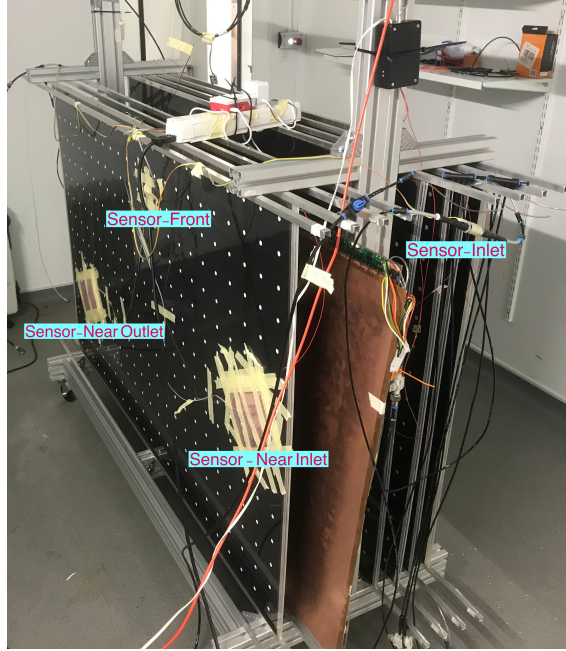
Figure 2: Gas gaps, five in total, plus one complete Resistive Plate Chamber detector, placed in a climate chamber room at University of Cambridge, with multiple sensors to monitor their conditions. The Inlet and Outlet sensors are positioned inside the gas gap tubing at entry and exit points to measure internal gas conditions directly. Near Inlet and Near Outlet sensors (with the Outlet sensor not visible in this view) are externally attached to gas gap close to the inlet and outlet and are covered to monitor its conditions at these locations. Additionally, Front and Back sensors (Back sensor not visible) are externally attached to the gas gap to assess the climate room ambient conditions and track environmental variables across its surface.

Furthermore, two additional sensors were placed on the front and back faces of one of the gas gaps, uncovered, to measure ambient conditions within the climate room and across the gas gap. For clarity, the sensors are labelled as Inlet, Outlet, Near Inlet, Near Outlet, Front, and Back, as shown in the setup in Figure 2. This terminology is consistently used throughout the results presented in this study.

Figure 2 shows the experimental setup within the climate chamber room at the University of Cambridge. This setup includes five ATLAS Phase II Barrel Inner Small (BIS)-type gas gaps and one complete RPC detector, all placed in a climate-controlled environment designed to facilitate TC. The chamber room, equipped with two compressors, allows temperature variations from -40°C to $+35^{\circ}\text{C}$, though for our tests, it was operated within a range of -33°C to $+35^{\circ}\text{C}$. An example of a thermal cycle between -33°C and $+25^{\circ}\text{C}$, conducted using this setup, is shown in Figure 3 (top). Here, it can be observed that all sensors closely track the climate room’s temperature variations. Meanwhile, Figure 3 (bottom) illustrates the relative humidity at

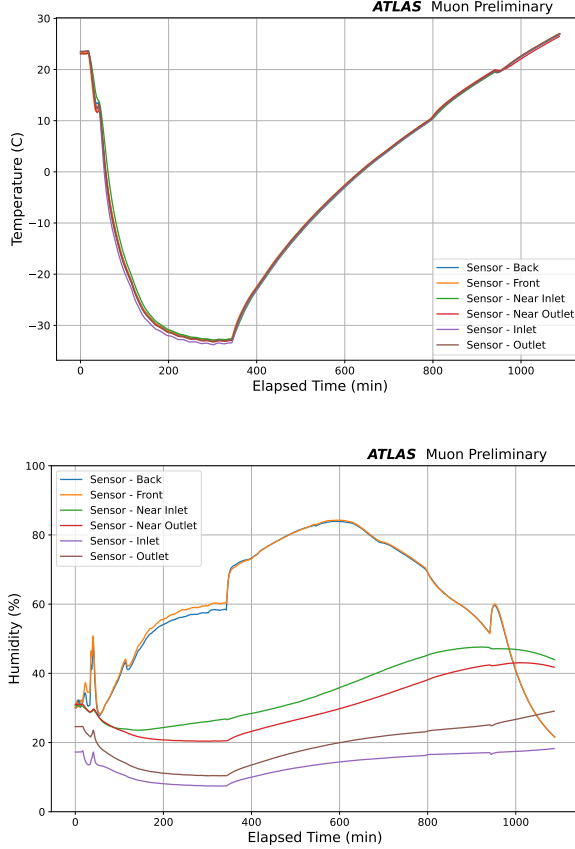
Figure 3: Example of a thermal cycle performed in the Cambridge climate chamber over several hours, with recorded temperature conditions (top). Sensors at multiple positions – including within the gas gap inlet and outlet – track the temperature response in relation to the separately controlled climate chamber conditions. Additional sensors on the front and back surfaces provide a broader view of the climate room ambient conditions. (bottom) Recorded relative humidity conditions during the same thermal cycle within the gas gap inlet and outlet, as well as positions near the inlet and outlet on the outside of the gas gap.

various points on one of the gas gaps. The sensors labelled Inlet and Outlet are housed in 3D-printed fittings connected to gas lines, recording internal gas conditions within the gap. Notably, the inlet sensor shows lower humidity than the outlet, as dry CO_2 gas was continuously flushed through the gas gap, and the outlet sensor captures a slight humidity increase due to exposure to the chamber's humid environment. This small exchange of moisture with ambient air is further verified by the Near Inlet and Near Outlet sensors. These sensors start with similar humidity levels; however, the Near Outlet sensor shows a gradual decrease in humidity as it interacts with the gas flow, which becomes more humid as it picks up moisture within the gas gap. The Front and Back sensors provide additional readings of the external humidity surrounding the gas gap and within the broader climate room environment.

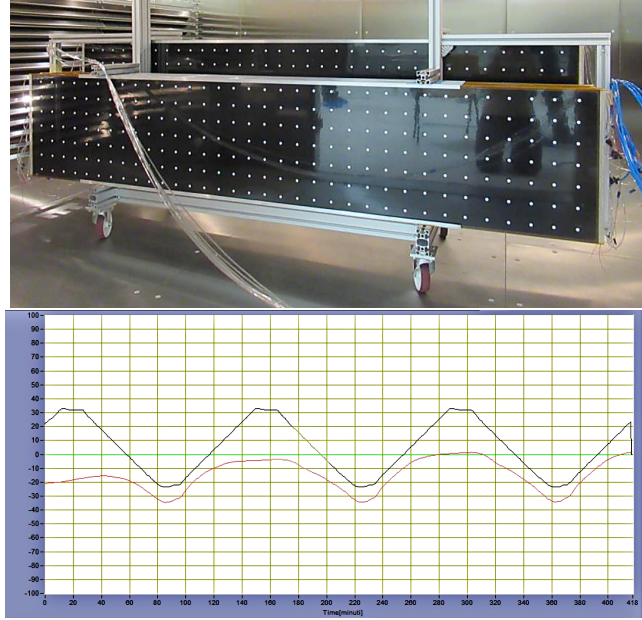
Figure 4: BIL-type gas gap undergoing thermal cycling tests at INFN Frascati (top). Recorded conditions within the test chamber (bottom), illustrating temperature variations (black) between +30°C and -20°C across multiple thermal cycles, along with dew point variations (red), indicating humidity changes within the test chamber.

A similar approach but a slightly different setup was used at the INFN Frascati to perform TCs on Phase II Barrel Inner Large (BIL) chambers. Figure 4 shows BIL chambers being thermally cycled along with the recorded temperature and humidity variations during the process.

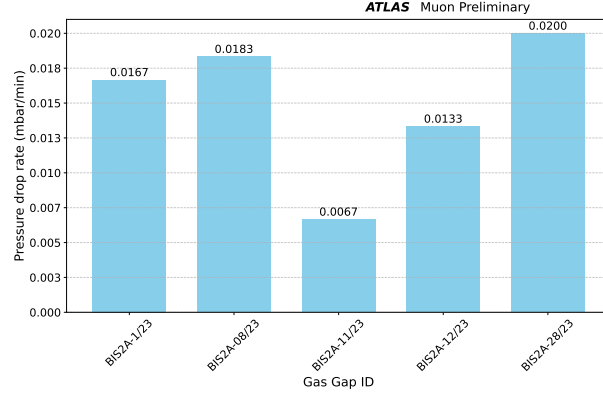
Figure 5: Pressure drop rates for different gas gaps measured at Cambridge using a semi-automatic setup following thermal cycles.

For subsequent assessments, slightly longer-duration measurements were acquired with a semi-automatic setup, allowing for more precise monitoring. The semi-automatic setup used multiple cross-calibrated pressure and temperature sensors connected to a Raspberry Pi, enabling sensor control and data acquisition. The setup allowed better monitoring of gas gap conditions throughout the testing process. The results after the TC protocol are presented in Figure 5. These measurements provide initial observations within the first few minutes after inflating the gas gaps to 5 mbar and are consistent with those obtained using the differential manometer (Table 1). However, these should not be compared with the long-duration measurements presented later in this study.

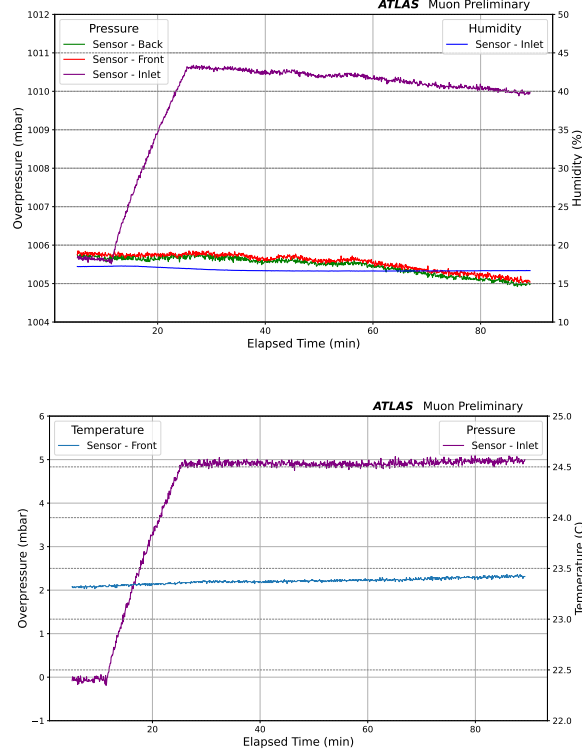
Figure 6: Pressure drop over time for gas gap BIS2A-11/23 after 16 thermal cycles, measured using a semi-automatic setup with multiple sensors. (top) Absolute pressure values recorded over time, showing the initial inflated pressure of 5 mbar within the gas gap, ambient pressure from the Front and Back sensors, and internal pressure within the gas gap monitored by the Inlet sensor. Relative humidity is also shown for reference. (bottom) Pressure drop inside the gas gap over time, corrected for ambient pressure variations. The temperature trend is included, illustrating how a slight temperature increase affects the apparent pressure drop by masking it, a trend more clearly seen in Figure 8.

As an example for a “good” gas gap, Figure 6 presents the pressure drop for gap BIS2A-11/23 as a function of time after 16 TCs, with an initial overpressure of 5 mbar. The figure (top) shows concurrent ambient pressure fluctuations recorded alongside the pressure drop, while the figure (bottom) offers a corrected view of the pressure drop, adjusted for ambient pressure variations. Notably, the pressure remains largely stable, showing no signs of ageing, consistent with manual checks and measurements from CERN. A slight pressure decrease over time is observed; however, this is not immediately apparent in the figure due to a gradual temperature increase that obscures it.

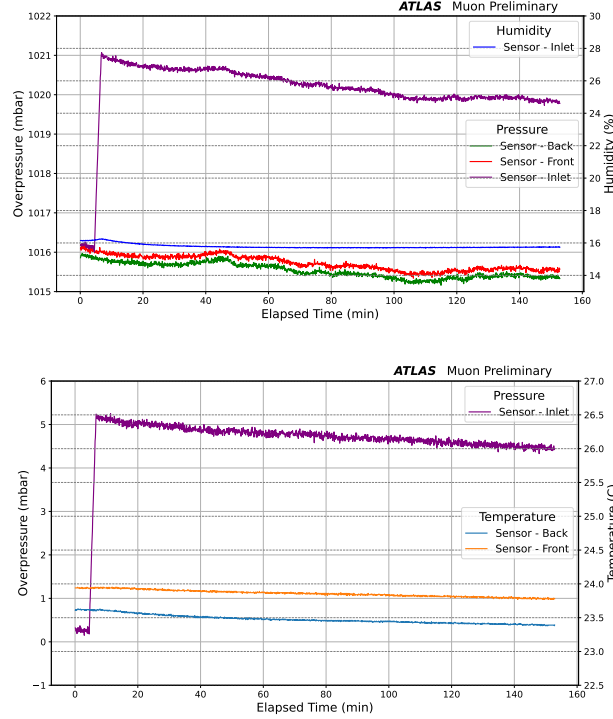
Figure 7: Pressure drop over time for gas gap BIS2A-08/23 after 16 thermal cycles, recorded using the same setup and parameters described in Figure 6. This figure highlights the presence of leaks. In addition, relative humidity variations from the Inlet sensor are also included for reference in the figure at the top while the bottom figure includes temperature variations over a longer period recorded by Front and Back sensors, which track climate room conditions.

To illustrate the behaviour of a “bad” gas gap, Figure 7 shows pressure drop measurements for gap BIS2A-08/23 as a function of time after 16 TCs

with stable temperature and humidity levels throughout. This gas gap exhibited a noticeable leak that worsened after thermal cycling. It is interesting to note that the leakrate is fairly high in the first $\mathcal{O}(10)$ minutes, and stabilises somewhat afterwards. A potential explanation for this could be that the micropores that have opened are partially sealed by not fully polymerised linseed oil within the gap.

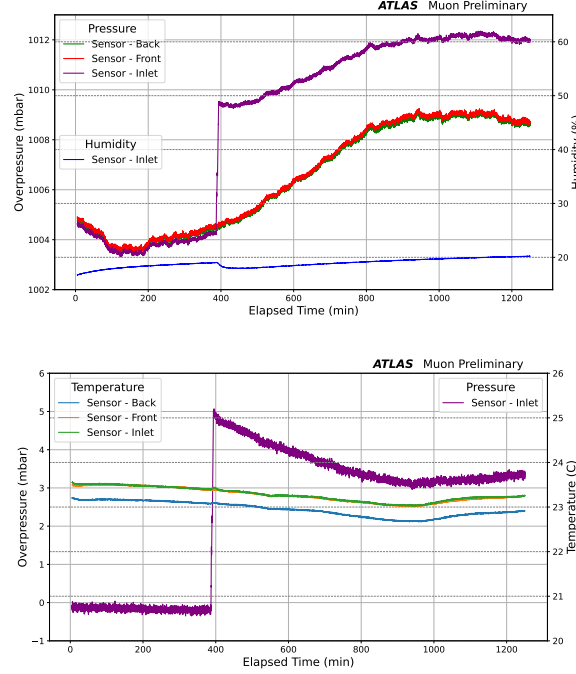
Figure 8: Pressure drop over time for gas gap BIS2A-01/23 after 16 thermal cycles, recorded using the same setup and parameters described in Figure 6. This figure highlights threshold effects, suggesting that leaks may occur at higher overpressures (above 3 mbar), whereas the gas gap maintains adequate performance at lower overpressures (approximately 3 mbar or less). Relative humidity variations are also included for reference in the figure at the top while the lower bottom one includes temperature variations over a longer period recorded by Front, Back, and Inlet sensors. The Front and Back sensors track external climate room conditions, while the Inlet sensor monitors internal temperature fluctuations within the gas gap. The slight increase in overpressure measurements toward the end is attributed to an overall temperature rise both inside and outside the gas gap.

Another interesting result is presented in Figure 8, which depicts the leak rate for gas gap BIS2A-01/23 as a function of time after 16 TCs. It is apparent that over a period of more than 12h ambient pressure (top) and a subtle temperature differences (bottom) affect the leak rate. Specifically, a rapid initial decline in pressure is observed as the gas gap pressure drops from around 5 mbar, levelling off closer to 3 mbar. Similar to BIS2A-08/23 shown in Figure 7, the leak rate is significantly higher in the first $\mathcal{O}(10)$ minutes

and decreases somewhat after that, although it remains intolerably high. Additionally, a positive slope in the leak rate aligns with minor temperature increases in the bottom graph, suggesting some thermal sensitivity, although the trend stabilises briefly before rising again with temperature.

The occurrence of a noticeable initial decline in the leak rate as the pressure decreases from 5 to 3 mbar for gap BIS2A-01/23 suggests that micropores or channels within the material may open or close only above certain pressure thresholds. As the pressure in the gas gap falls below a certain pressure (in the current case approximately 3 mbar), the leak rate stabilises, potentially indicating that these threshold-sensitive pathways are no longer active at lower pressures. These observed threshold effects, where certain pores open only at higher pressures (middle), are of particular interest. Iden-

- First, the leak measurements were performed at an overpressure of 5 mbar at Cambridge versus 3 mbar at Frascati. As the results from of gap BIS2A-01/23 shown in Fig. 8 indicate, micropores or other effects that become measurable above 3 mbar are likely to play an important role in this comparison.

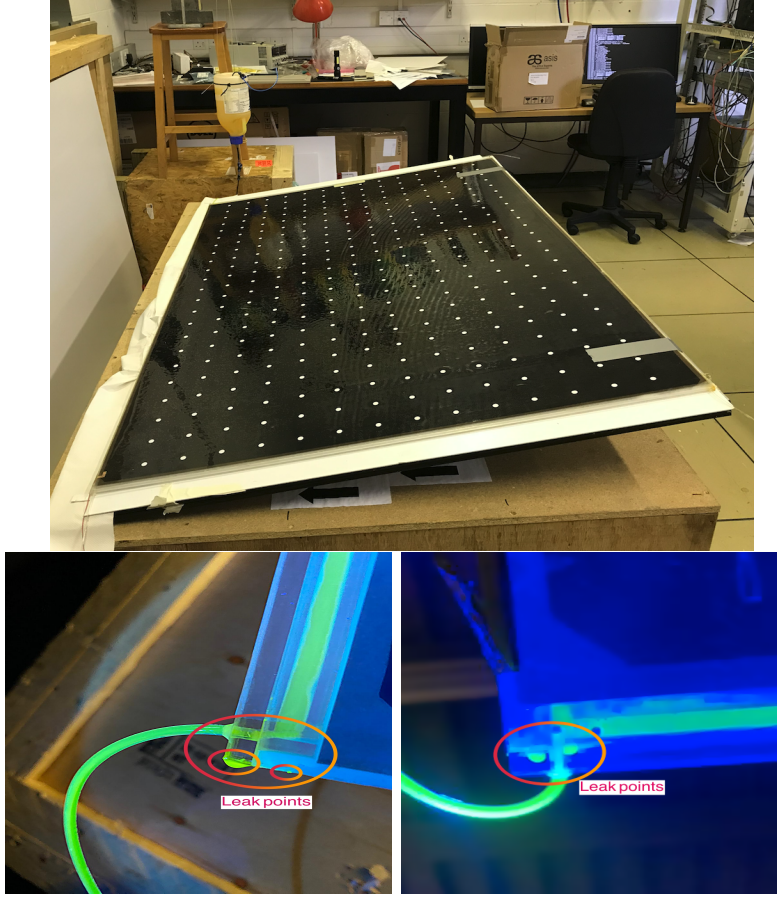
Figure 9: (top) A gas gap being filled with the fluorescent tracer solution using a bottle, with the height of the bottle gradually raised from the bottom. (bottom) Gas gaps filled with the fluorescent tracer solution illuminated with UV light (external lights switched OFF), illustrating the process of leak detection. The concentration and path of the tracer (in green) highlighted in these images indicate the presence of leaks or potential defects near the gas inlet/outlets and within the gas distribution manifold.

After initial assessments revealed leaks in the gas gaps in one of the test campaigns, a gas sniffer – Heated Diode Refrigerant Leak Detector (Model DR58) [13] – was employed to roughly locate these leaks. To identify the critical points where the leaks occurred more accurately, additional tests were conducted using a solution with a fluorescent tracer ‘Fluorescein’. This solution was prepared by mixing Fluorescein powder with isopropyl alcohol, creating a detectable medium that could highlight effectively the path of leaks when illuminated with ultraviolet (UV) light. The two gas gaps that were considered for this test at Cambridge were BIS2A-28/23 and BIS2A-08/23, as these had higher leak rates, as depicted in Figure 5. The gas gaps were filled with the fluorescent tracer solution, and a UV torch was used to illuminate the tracer within the gas gaps allowing for the visualisation of the tracer’s path, as shown in Figure 9. Under UV light, any critical areas such as micro-cracks, weak joints, or potential leak sites would be illuminated, revealing regions where the fluorescent light was more concentrated or where it visibly seeped out of the gas gap. Similar tests were also conducted at Frascati. The results from the tracer tests were consistent with those from the sniffer leak detection tests and assessments, identifying specific leaks and weak points that were primarily associated with the gas distribution manifolds within the gas gaps. These issues were promptly followed and addressed by the ATLAS Muon Community.
