A visualization of the damage in Lead Tungstate calorimeter crystals after exposure to high-energy hadrons

G. Dissertori, D. Luckey, F. Nessi-Tedaldi, F. Pauss, R. Wallny

Institute for Particle Physics, ETH Zurich, 8093 Zurich, Switzerland

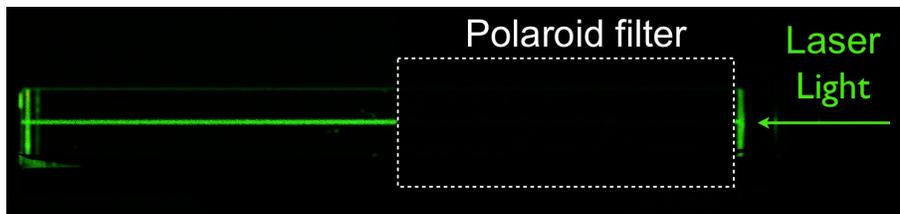
Figure 1: Laser light (here at 543.5 nm) is scattered, and thus becomes visible, when shone through a hadron-irradiated Lead Tungstate crystal. A polaroid filter (indicated by the dashed line) blocks the scattered light, revealing its linear polarization.

The features of hadron-induced changes in Light Transmission published in [1] are the peculiar ones of Rayleigh scattering, which implies the presence of dipole-shaped regions acting as scatterers for the light. When green 543.5 nm LASER light is shone through a hadron-irradiated crystal, as exemplified in the photograph of Fig. 1, its light gets scattered, making the beam visible. In the same photograph, a Polaroid filter was introduced between the observer and the crystal, as indicated by the dashed rectangle, so as to cover the right half of the crystal: the

scattered LASER light is not transmitted by the filter. This demonstrates how the scattered light is polarized, yet another feature that is distinctive for Rayleigh scattering, and thus for the presence of localized regions of damage acting as scatterers for the light. All these observations were also observed at different wavelengths, as verified with 633 nm LASER light.

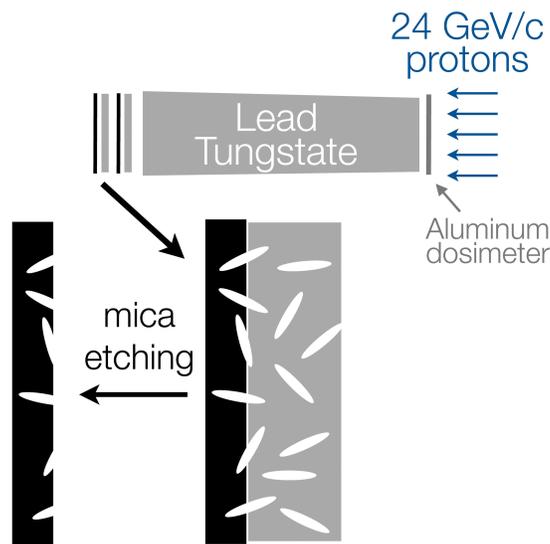
Figure 2: Irradiation setup for fission-track visualization (see Sec. 4 for a detailed description)

For each irradiation, two samples have been prepared, where a Lead Tungstate slide, 2 mm thick and $1\text{ cm} \times 2\text{ cm}$ in cross section, has been placed in intimate contact with a high-purity muscovite mica ($\text{KAl}_2(\text{AlSi}_3\text{O}_{10})(\text{F}, \text{OH})_2$) slide of same cross section, 0.1 mm thick. The contact was ensured by a heat-shrinkable plastic wrapping. The samples have been placed behind a 7.5 cm long Lead Tungstate crystal for the irradiation, to make sure the running conditions are reproduced, that are encountered in homogeneous high-energy physics calorimetry, where energetic hadrons cause penetrating hadron showers, i.e. a cascade of nuclear interactions which are at the origin of the observed hadron-specific damage. The schematics of the irradiation setup is visible in Fig. 2. For the hadron irradiation, the proton beam was broadened to cover the whole crystal cross section, and the fluence for each irradiation was determined following the method described in [1], from the activation of a high-purity aluminum foil covering the crystal front face.

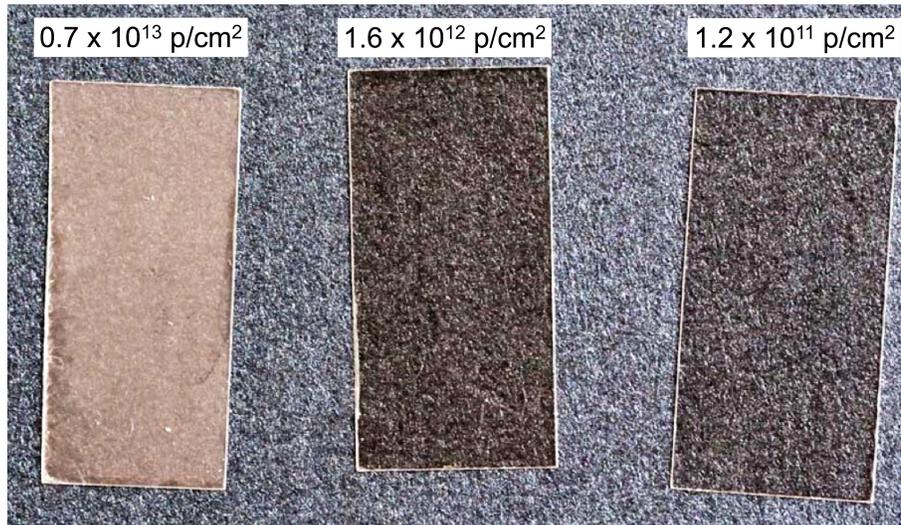
Figure 3: Mica slides, after chemical etching, that were irradiated up to three different fluences in intimate contact with Lead Tungstate, as an external detector for fission tracks.

Fission damage in mica changes its crystalline structure into a metamict state, that is easily etched according to a well-known recipe [15], whereby the slides are immersed in HF at 40% for 45 min at 20° C. The procedure allows to remove the material of the damaged region, leaving the surrounding crystalline matter intact. Examining by eye the mica slides after chemical etching (Fig. 3), one notices a coloration that intuitively correlates with the applied irradiation fluence.

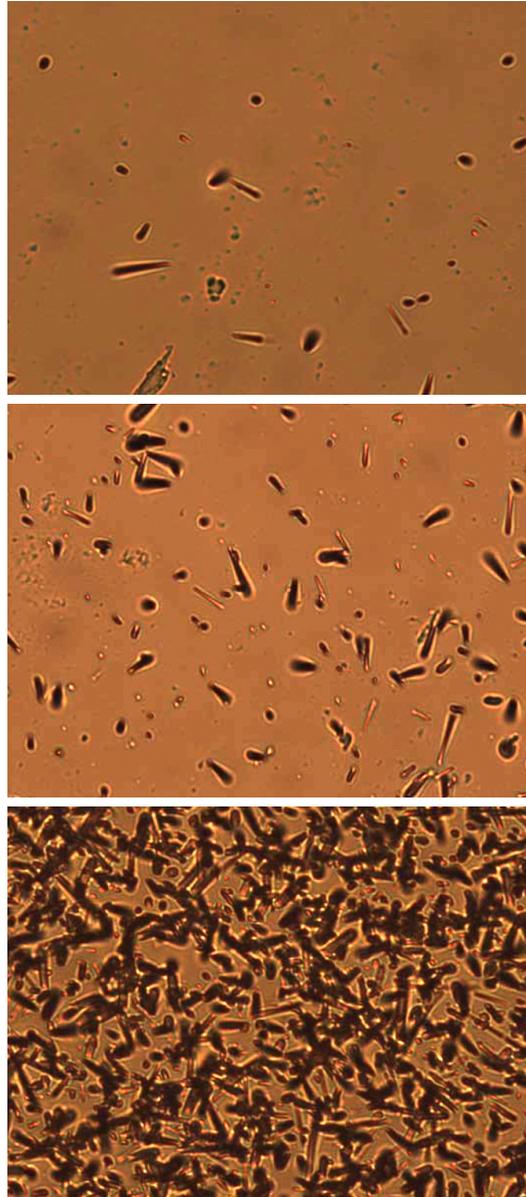
Figure 4: Transmitted-light optical-microscopy images of fission tracks in the mica slides from Fig. 3 for the three irradiation fluences, Φ_p^1 (top), Φ_p^2 (middle) and Φ_p^3 (bottom).

The mica slides were then examined with an Axio Imager Z1M optical microscope from Zeiss [16]. Transmitted light images are shown in Fig. 4. Linear damage tracks are visible, and they were counted at 1000x magnification but at the highest fluence, where individual tracks couldn't be visually resolved. Their surface densities clearly correlate with the irradiation fluences, as listed in Table 1. Even where, for the highest fluence, no accurate count was possible, the proportionality is visually striking.

It can be qualitatively observed how the damage tracks are straight and occur in random orientations, as expected due to fission fragments produced by interactions in a hadron shower, and that they do not follow any pre-existing fabric in the mica.

Additional information can be obtained from a comparison of images obtained in transmitted (Fig. 4) and reflected (Fig. 5) light. The two sets of images give consistent pictures. In particular, no etched, confined tracks are visible, as one would observe, if present, through the occasional intersection with surface tracks. Further, no tracks penetrate through the mica, as revealed by etch pits being present at all track terminations: the source of the tracks is external to the mica. From all these observations, the origin is clearly established to lie in the projection of break-up fragments from nuclei in the Lead Tungstate that underwent fission.

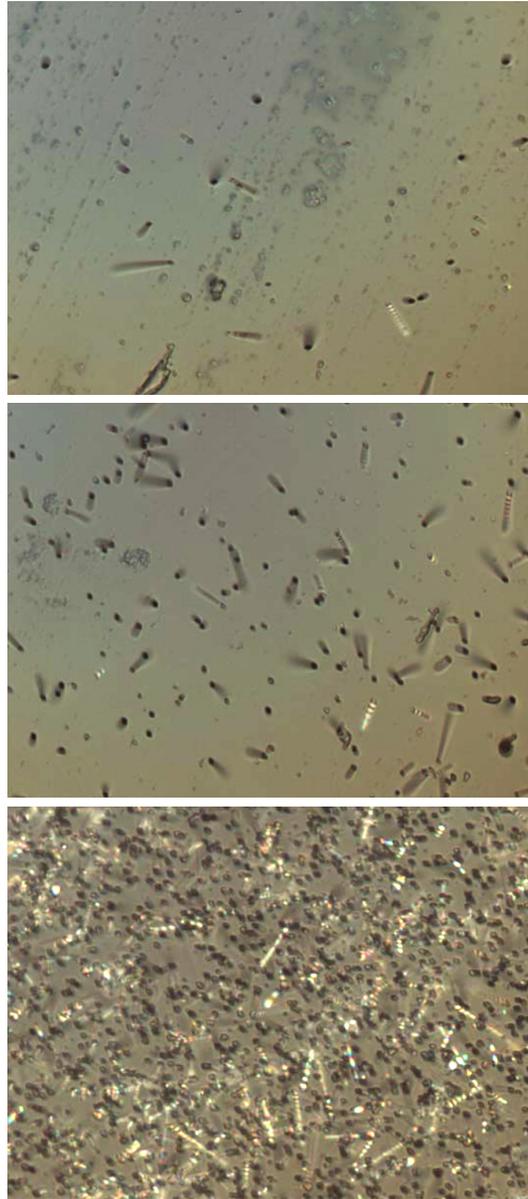
Figure 5: Reflected-light optical-microscopy images of fission tracks in the mica slides from Fig. 3 for the three irradiation fluences, Φ_p^1 (top), Φ_p^2 (middle) and Φ_p^3 (bottom).

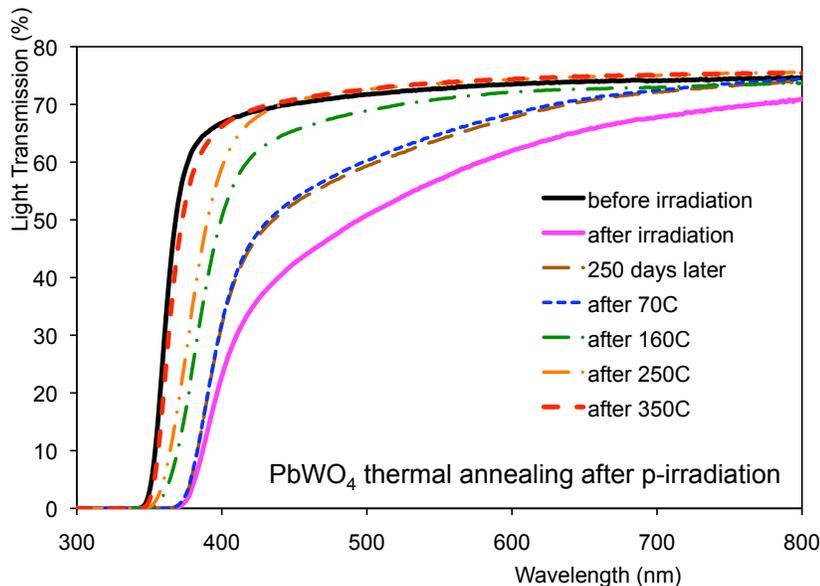
Figure 6: Transmission curves for a proton irradiated crystal, 23 cm long, after heating in air up to different temperatures

It might be interesting to note that the scattering centers can be eliminated by heating the crystals up to 350 °C [1], and that such a heating treatment is also used after ingot production to anneal mechanical stresses before cutting and polishing [21]. The progressive recovery of crystal light transmission through heating up to different temperatures is visible in Fig. 6, where transmission curves are shown after the crystal was subjected to various heating cycles performed in an increasing temperature order. The crystal, labelled “d” in [1], was annealed 240 days after irradiation. The annealing temperature was reached in a programmable oven, by increasing the temperature linearly over 2 hours. The crystal was then kept at the target annealing temperature for 8 hours. The temperature of the oven was then reduced to room temperature over two hours. While essentially no recovery of the crystal was observed at 160 °C, partial recovery took place at 250 °C. At a temperature of 350 °C almost complete recovery was reached, except for a small residual shift of the band-edge. Shining LASER light through the crystal after the damage annealing by heating, no scattering centers are observed.
