# BEAM LOSS MONITORING WITH FIXED AND TRANSLATING SCINTILLATION DETECTORS ALONG THE FERMILAB DRIFT-TUBE LINAC\*

J. Stanton, R. Sharankova, K. Seiya, M. Wesley  
Fermi National Accelerator Laboratory, 60510 Batavia, USA

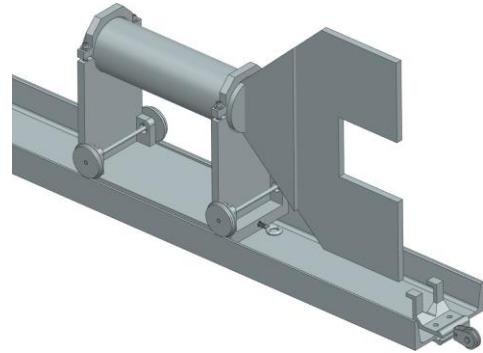
Figure 1: Paddle detector on the translating cart and track with the pulley and buffer stop assembly.

the tank while translating. Figure 1 displays the CAD model of the paddle mounted in the translating cart on the track as well as the pulley system which doubled as buffer stop to prevent the cart from rolling off of the track.

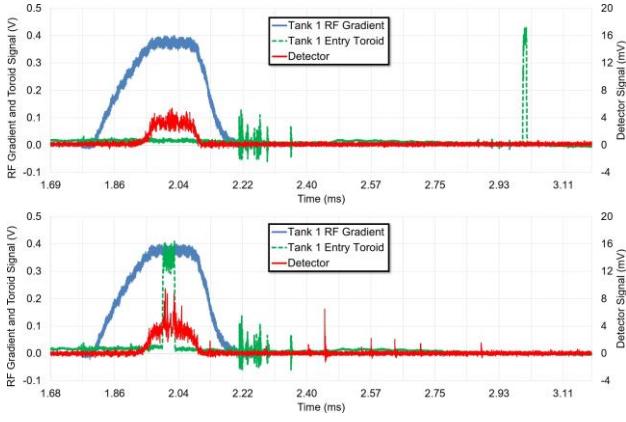
Figure 2: Plots of the detector, Tank 1 RF gradient and Tank 1 entry toroid signals in two scenarios, RF pulse asynchronous with beam (top plot) and RF pulse synchronous with beam (bottom plot).

The detector signal structure consisted of a rising and falling edge connected by a flat top, which is referred to as a “shoulder”. A step up to a higher flat top when beam was present was also observed. To better understand the cause of the shoulder structure, measurements of the detector signal, the Tank 1 RF gradient and the Tank 1 entry toroid were taken simultaneously in two scenarios. The first scenario injected beam asynchronously with respect to when the RF is pulsed, and the other, injected beam synchronously with the RF pulse as shown in Figure 2.

In both measurements, the shoulder in the detector signal was synchronous with the RF gradient signal. This data indicates the shoulder is caused by the detector picking up X-rays generated by the RF in the tank and is not related to beam.

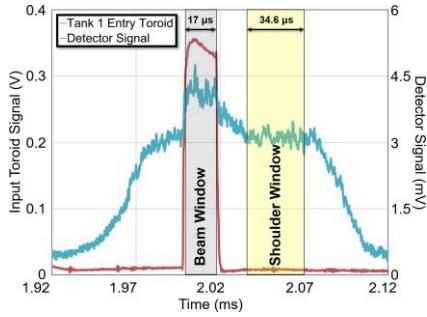
Figure 3: Plot of a single measurement with the beam window and shoulder window highlighted.

The paddle detector was pulled, in 10 cm increments, along a 2.3 m length of Tank 1. At each measurement location, an upstream horizontal dipole corrector (L:MDQ2H) was varied between three current settings to tilt beam trajectory and induce scraping loss. For each measurement, waveforms of the paddle detector and Tank 1 entry toroid were recorded at a sample rate of 5 mega samples per second. The toroid signal was used to help identify the time in which beam was present in the tank. Using this information, the paddle detector signal could be broken up into two different time spans called the beam and shoulder windows as shown in Figure 3. The length of these windows and their timing with respect to the trigger of the oscilloscope was held constant.

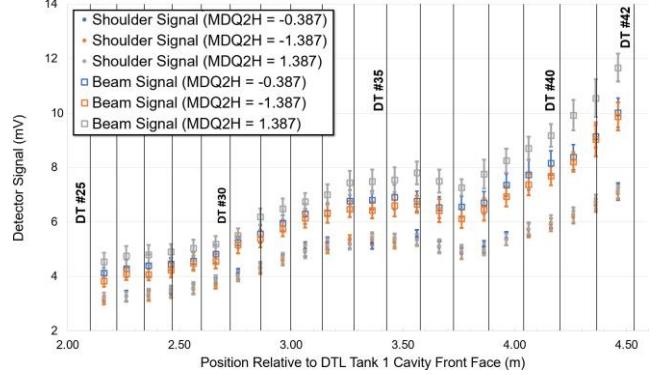
Figure 4: Plot of the beam window and shoulder window averages, for three different dipole corrector settings at 24 longitudinal positions along Tank 1. Drift tube positions are the black vertical lines.

Averages of the detector signal over the beam and shoulder windows were calculated for three dipole corrector current settings at 24 measurement positions. Figure 4 is a plot

of these averages. Error bars represent plus or minus one standard deviation in the detector signal over each window.

Figure 4 shows that both the beam and shoulder window averages scale with longitudinal position with the exception of the dip in all traces that takes place near 3.5 m. Upon further inspection, this was found to be correlated with when the scintillator plate of the paddle was adjacent to a steel alignment fixture on the side of the tank. This additional material would have blocked any products of the RF and beam induced loss leading to the observed dip. An interesting characteristic of this plot is that the beam window averages scale with dipole corrector current while the shoulder window averages do not. This indicates that the shoulder signal is not related to beam. Furthermore, Tank 1 was designed such that the average field gradient is not constant along its length. Over the length in which the paddle was pulled, the average field gradient increases from 5.51 MV/m to 5.82 MV/m as shown in Figure 5. As the average field gradient increases, so does the contribution of the RF induced X-rays to the detector signal.

The difference between the beam window and shoulder window averages in Figure 4 is not covered by the error in either. This shows that the paddle detector is capable of detecting the products of beam loss. To decouple the effects of RF and beam on the paddle detector signal, the shoulder

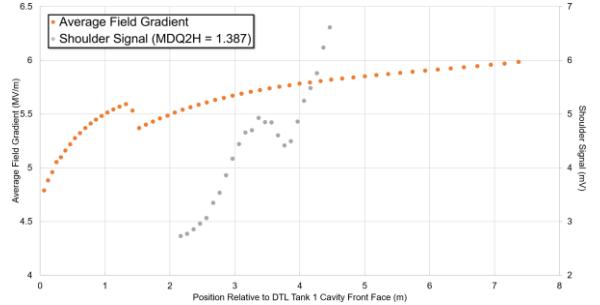
Figure 5: Plot of average shoulder signal with dipole corrector setting equal to 1.387 A and the average field gradient in Tank 1.

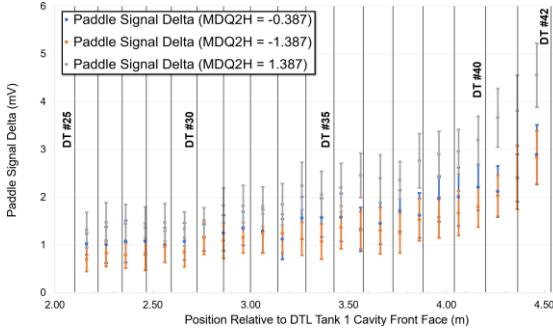
Figure 6: Plot of the paddle signal delta for three different dipole corrector settings at 24 longitudinal positions along Tank 1. Drift tube positions are the black vertical lines.

window averages were subtracted from the beam window averages as an offset. The result, called the paddle signal delta, is plotted in Figure 6. Error in the paddle signal delta is propagated through as the square root of the sum of the squares of the standard deviations in the beam and shoulder window data.

From Table 1a it is clear that the highest beam loss of 8.33 mA was recorded when the dipole corrector current setting was equal to 1.387 A. The paddle signal delta values for this

dipole corrector setting are represented by the gray trace in Figure 6. The paddle signal delta values for this trace are higher than the values for the other two dipole corrector settings at every longitudinal position which is expected due to the higher measured beam loss in Table 1a. However, the errors in these values overlap at most positions which makes this result inconclusive in most cases. The separation between the gray trace and the other two increases with position. Lengthening the translation range of the paddle may reveal a more significant difference in paddle signal delta values at higher beam energies, further down the tank.

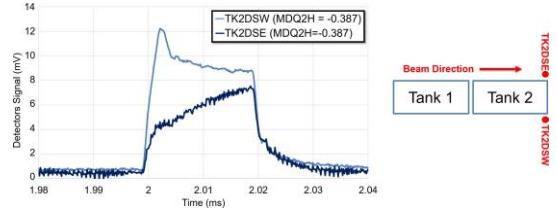
Figure 7: Plot of both stationary detector signals, exhibiting opposite slopes.

Data was also taken from two small scintillator plate detectors that were positioned on either side of the downstream end of Tank 2. The signals captured were sloped in opposite directions, as shown in Figure 7. This indicates that the beam pulse is tilting from head to tail horizontally, resulting in an asymmetrical loss pattern and, as a result, asymmetry in the detector signals.
