Non-destructive sub-surface inspection of multi-layer wind turbine blade coatings by mid-infrared Optical Coherence Tomography

In this article, we demonstrate NDI of wind turbine blade (WTB) coatings using an MIR OCT scanner employing light around 4 μm from a supercontinuum source. We inspected the top two layers of the coating (topcoat and primer) in two different samples. The first is to determine the maximum penetration depth, and the second one is to emulate defect identification. The results of our study confirm that MIR OCT scanners are highly suitable for coating inspection and quality control in the production of WTBs, with performance parameters not achievable by other technologies.

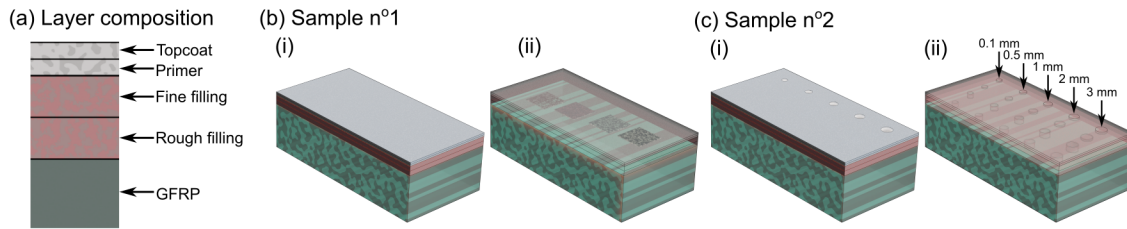
Figure 1: (a) Schematic of the layer composition of the samples visualised in (b,c). (b) Sample with aluminium foil patches placed at the interfaces between layers. (c) Sample with punch defects in different layers. For (b-c), (i) and (ii) show opaque and transparent 3D illustrations of the samples.

Two sets of samples were tested, denoted n°1 and n°2. Figure 1(a) shows a schematic of the layer composition above the GFRP, and Fig. 1(b-c) presents 3D illustrations of both samples. During the process of fabrication, the layers are subsequently applied and dried in a controlled environment. Each layer is sanded before the application of the next one. The materials used for each layer are as follows:

Sample n°1, presented in Fig. 1(b), was used to benchmark the penetration depth of the MIR OCT scanner and the refractive index of the layers. Different aluminium foils were inserted in all the layer interfaces as seen in the transparent 3D view in Fig. 1(b-ii).

Sample n°2, presented in Fig. 1(c), was made to mimic the defect that can appear inside the coating during the manufacturing process, in our case, it was a hole defect. Fig. 1(c-i) and (c-ii) show an opaque and a transparent 3D visualisation of this sample. For each layer, 5 holes with different diameters were made by punching the paint in staggered rows with metallic needles with different diameters: 0.1 mm, 0.5 mm, 1 mm, 2 mm, and 3 mm.

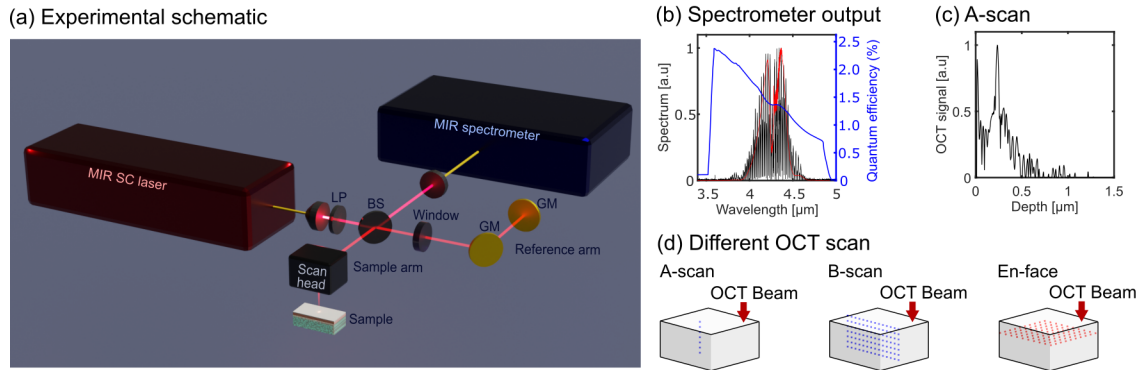
Figure 2: (a) 3D representation of the MIR OCT system, SC: supercontinuum, LP: 3.2 μm long pass filter, BS: beam splitter, GM: gold mirror, Window: dispersion compensation. (b) Reference spectrum in red, measured interference spectrum in black, upconversion efficiency in blue, and (c) the corresponding calculated A-scan. (d) Schematic of the different OCT scans used in this article.

The MIR OCT scanner is presented in Fig. 2(a). The light source is an in-house fabricated MIR supercontinuum (SC) source covering a spectrum from 1 to 4.8 μm [27] coupled to a Michelson interferometer. Due to the range of the spectrometer and to minimise the amount of unnecessary power, there is a long-pass filter at the input of the interferometer, which removes light at wavelengths shorter than 3.2 μm (cf. Fig. 2). At the output of one arm of the interferometer, the scanning is achieved using a two-axis silver-coated mirror galvanometric scanner coupled to an achromatic germanium lens with a focal length of 30 mm. The average power on the sample arm was about 20 mW.

The scanning parameters for the characterisation of the sample n°1 were the following, 500 cross-sectional images (B-scans) composed of 500 depth scans (A-scans). For sample n°2, 1000 B-scans composed of 1000 A-scans were used. Both sets of scan parameters covered an area of $\sim 5.73 \times 5.73\ \text{mm}^2$, with each A-scan and B-scan being separated by $\sim 11.49\ \mu\text{m}$ for the sample n°1, and by $\sim 5.73\ \mu\text{m}$ for the sample n°2. Each A-scan took $2500\ \mu\text{s}$ to be acquired. As the lens adds curvature to the cross-sectional image, a flattening post-processing procedure was applied for correcting this effect. The different types of OCT scans presented in this article are illustrated in Fig. 2(d).

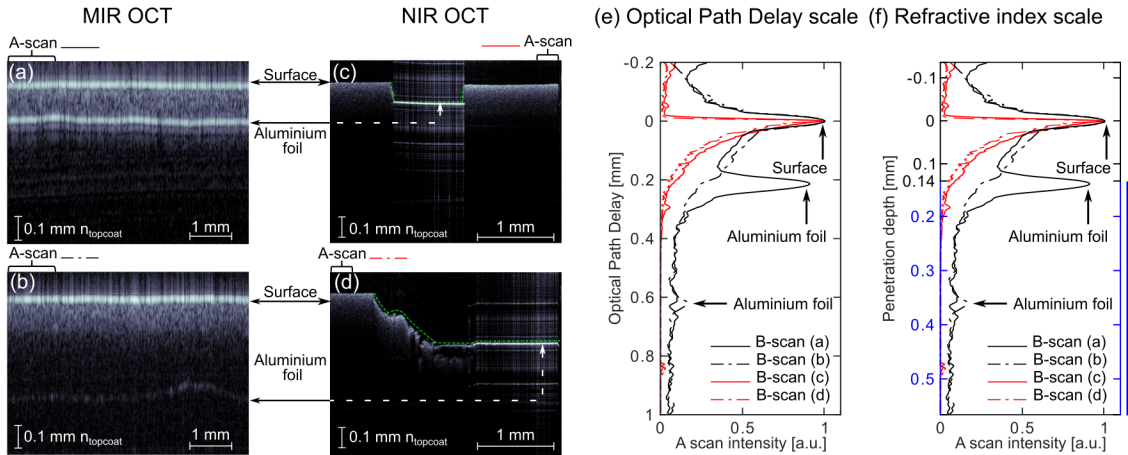
Figure 3: (a-b) Comparison of penetration depth between B-scans in MIR OCT ($4 \mu\text{m}$ centre wavelength) and (c-d) in NIR OCT ($1.3 \mu\text{m}$ centre wavelength). The dashed green line in (c-d) shows the part where the coating was intentionally removed for the NIR OCT measurement to find the presence of aluminium foil. For each B-scan, the physical distance in depth was calculated with $n_{\text{topcoat}} \simeq 1.49$.

(e-f) Comparison of the A-scan average of each B-scan is depicted in (a-d). (e) Present the results with the Optical Path Delay (OPD) scale and (f) scale with $n_{\text{topcoat}} \simeq 1.49$ (from 0 to $0.14 \mu\text{m}$) and then scale with $n_{\text{primer}} \simeq 1.84$ (blue scale from $0.14 \mu\text{m}$).

Sample n°1, containing interface aluminium foil markers, was used to assess the penetration depth of MIR OCT against conventional NIR OCT. The MIR OCT scanner could penetrate both the topcoat and the primer, detecting a clear reflection from the surface and the top two aluminium foils between the topcoat and primer and between the primer and the fine filling. This is observed in Fig. 3(a,b) where respective layer interface foil signals are mapped out. These signals present a bright depth boundary resembling the signal of a mirror below the bright surface signal. The foil between fine filling and rough filling was not detected with the MIR OCT system, presenting a penetration depth limit in terms of layer interfaces. For NIR OCT scan tests, penetration performance was expected to be inferior due to the significant scattering. For this reason, in a small area, the coating was entirely removed until the foils in order to locate them in the B-scans. The part where the coating above aluminium foil was removed is highlighted by a dashed green line in Fig. 3(c,d).

the OPD were extracted from the MIR OCT B-scans (Fig. 3(a,b)), $OPD_{\text{topcoat}} = 215 \mu\text{m}$, and $OPD_{\text{topcoat+primer}} = 618 \mu\text{m}$.

Figures 3(e) and (f) present the A-scan average of each B-scan depicted in Fig. 3(a-d) with the OPD scale, and with the scale calculated with $n_{\text{topcoat}} \simeq 1.49$ (from 0 to $0.14 \mu\text{m}$) and then calculated with $n_{\text{primer}} \simeq 1.84$ (blue part from from $0.14 \mu\text{m}$). The black curves present the A-scan averages of the MIR OCT B-scan, solid line (a) and dashed line (b), while the two red curves present the A-scan averages of the NIR OCT B-scan, solid line (c) and dashed line (d). The average was made over 100 A-scans, which represent 1.146 mm for MIR OCT and 0.29 mm for NIR OCT. MIR OCT allows us to characterise the sample through the primer and slightly into the fine filling until around $360 \mu\text{m}$. For the NIR OCT evaluation, the signal is completely attenuated after a physical depth of $100 \mu\text{m}$ due to strong scattering. In the NIR, the signal is dominated by multiple scattering, so the real OCT signal penetration depth is most likely significantly shorter [24].

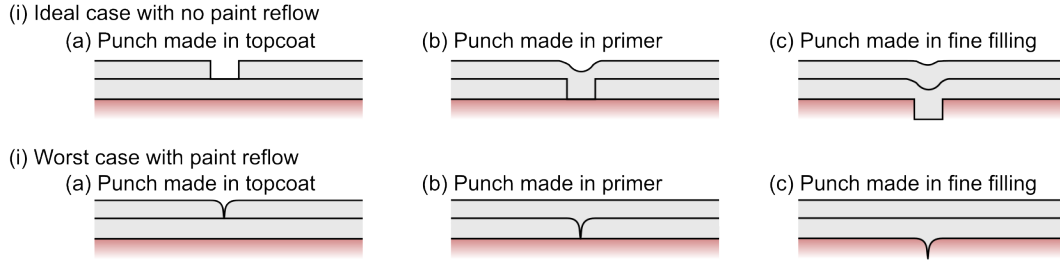
Figure 4: Illustration of the impact of introducing punch defects at different layers in the production with (i) an ideal case without any reflow, and (ii) the worst case of reflow of wet paint, (a) in the topcoat, (b) in the primer, and (c) in the fine filling.

The resultant defects after processes (i) and (ii) are illustrated in Fig. 4(i) and Fig. 4(ii) for the three punched layers corresponding to (a), (b), and (c), respectively. The deeper the layer the punch is made, the less severe the disturbance in the surface of the coating is expected. In contrast, punches in the topcoat are not remedied by subsequent coating layer deposition and are most likely to persist. For this reason, punches in the topcoat will only be remedied by process (ii).

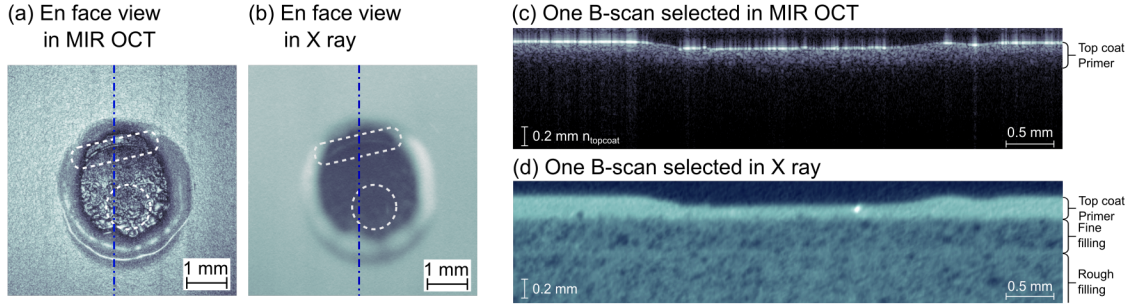
Figure 5: Comparison between MIR OCT and X-ray CT measurements made of the defect made in the topcoat part with a diameter of 3 mm. (a-b) *En face* view of the surface of the sample. (c-d) Selected B-scan in approximately the same place. The blue dashed lines in (a-b) show where the B-scans were extracted.

Figures 5-6 show comparisons between X-ray CT and OCT measurements from the sample n°2 made inside the topcoat with a 3 mm diameter needle. The X-ray CT machine was a *Zeiss Xradia*

520 Versa, with a resolution of 1-50 μm in samples of size 1-50 mm. The *En face* view from OCT and X-ray CT is presented in Fig. 5(a,b), respectively, from which it was possible to identify the same areas on the sample, highlighted by the white dashed boxes. The resolution of X-ray CT is lower than OCT due to the large scanning area, chosen to avoid too long scanning time. Indeed, the total time for the characterisation of an area that contains 3 defects, $\sim 10 \times 1 \times 1.5$ cm, was around 6 hours. For the OCT, the scanning time was 40 min for each defects area $\sim 5.73 \times 5.73$ mm². With the resolution of MIR OCT, it is possible to detect the surface bump.

To further compare the two technologies, we selected one B-scan from MIR OCT and one B-scan from X-ray CT (cf. Fig. 5(c,d)) approximately at the same location, shown by the dashed blue line in Fig. 5(a,b). On both, on the right, the brackets show the different layer positions. The penetration depth is better in X-ray CT, however, the issue here is the resolution. This resolution is correlated to the sample size and so scanning area, and the larger the sample, the lower the resolution of the X-ray CT with a fixed time [5]. The resolution of OCT in depth depends only on the laser source, and the transverse resolution depends on the scanning head, and for our case, the imaging lens used. The smallest granular visuals in Fig. 5(a) and (c), come from the presence of speckles within the measurements.

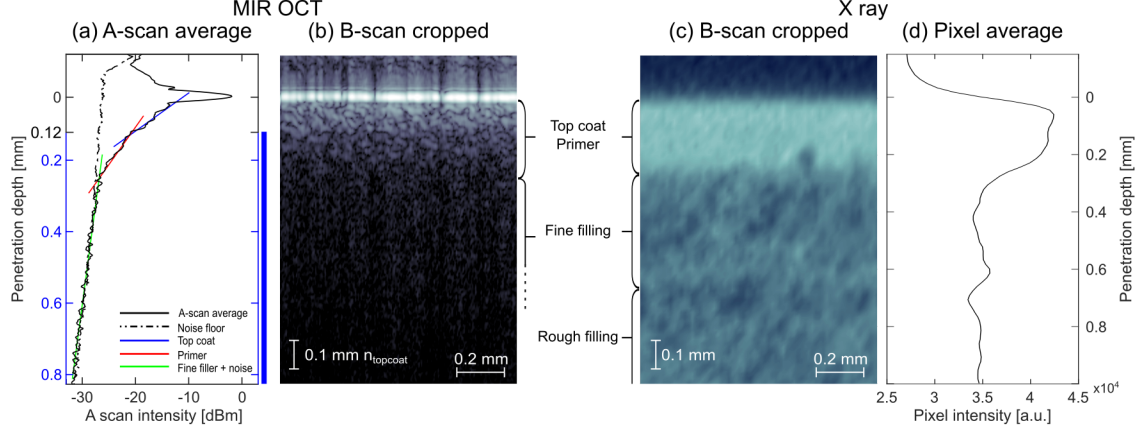
Figure 6: Comparison between (b) MIR OCT B-scan and (c) X-ray CT B-scan. (a) is the A-scan average of (b) and (d) is the pixel average of (c). For (a) the penetration depth is calculated with the n_{topcoat} (from 0 to 0.12 μm) and then n_{primer} (blue scale from 0.12 μm). The solid lines blue, red, and green are the fit of topcoat, primer, and fine-filling combine with the noise floor.

To achieve a better comparison between MIR OCT and X-ray CT, we selected the first millimetre of Fig. 5(c,d) and show this in Fig. 6(b,c). An average A-scan is associated with the B-scan from MIR OCT (cf. Fig. 6(a)), and a pixel average is associated with the B-scan from X-ray CT (cf. Fig. 6(d)). For Fig. 6(a), the spatial average was made over 0.99129 mm (173 A-scan), and for Fig. 6(d), over 0.9984 mm (66 A-scan). In both cases, it is possible to distinguish the topcoat and the primer part, represented by the first two slopes in (a) and the first two plateaus in (d). The third slope in the MIR OCT A-scan plot is the beginning of the fine filling layer, continuing until the noise floor ((black dashed curve) in Fig. 6) at around 0.36 mm. Beyond this point, the losses are too pronounced to detect the bottom part of the fine filling. Blue, red, and green solid lines in Fig. 6(a) are, respectively, the fit of the topcoat, primer, and combination of fine filler plus noise. The fitting value are:

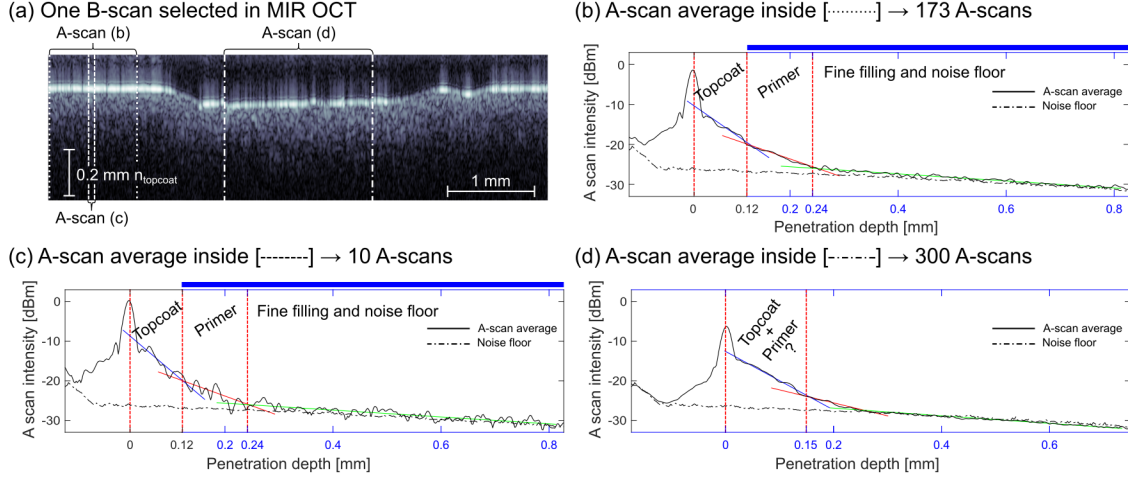
Figure 7: (a) The B-scan selected is the same as in Fig. 5, the dashed boxes show where the A-scan was extracted to calculate the average in (b-d). For (b-c) the penetration depth is calculated with the n_{topcoat} (from 0 to 0.12 μm) and then n_{primer} (blue scale from 0.12 μm), and for (c) the penetration depth is calculated with n_{primer} .

We conducted a study of coating thickness, topcoat, and primer on sample n°2 (cf. Fig. 7) by tracking the bottom interface of the topcoat and the primer layer. Figure 7(a) shows on the B-scan where are the different average A-scan regions, while Fig 7(b-d) present the corresponding A-scan averages (black solid curves). The average parameters are for (b) 173 neighbouring A-scan (~ 0.9913 mm), (c) 10 neighbouring A-scan (~ 0.0573 mm), and (d) 300 neighbouring A-scan (~ 1.719 mm). The beginning of the fine filling part can be detected up to a depth of approximately 0.36 mm, where the noise floor intersects with the A-scan averaging.

The average A-scans depicted in Fig. 7(b) and (c) present the limitation of averaging. As shown in Fig. 7(c), the fluctuations caused by speckles are significant enough to affect the curves fitting if too few A-scans are use in the averaging. For Fig. 7(d), the averaging was performed inside the intentional defect part. In this region we expect a certain amount of topcoat was removed after the intentional defect was made with the needle. In an ideal world, all the topcoat should be removed in this region, but the fitting slop does not correspond to the primer fit in Fig. 7(b). It is possible that there was a non-uniform topcoat residue above the primer on the 300 A-scans. As we expect to have only primer in an ideal case, the scale for penetration depth was calculated only with n_{primer} .
