***In situ* 2D visualization of hydrogen entry into Zn-coated steels in NaCl solutions:**

**Roles of Zn dissolution and potential distribution**

Hiroshi Kakinuma<sup>a,\*</sup>, Saya Ajito<sup>a,\*</sup>, Koki Okumura<sup>a,b</sup>, Makoto Akahoshi<sup>c</sup>, Yu Takabatake<sup>c</sup>,  
Tomohiko Omura<sup>c</sup>, Motomichi Koyama<sup>a</sup>, and Eiji Akiyama<sup>a</sup>

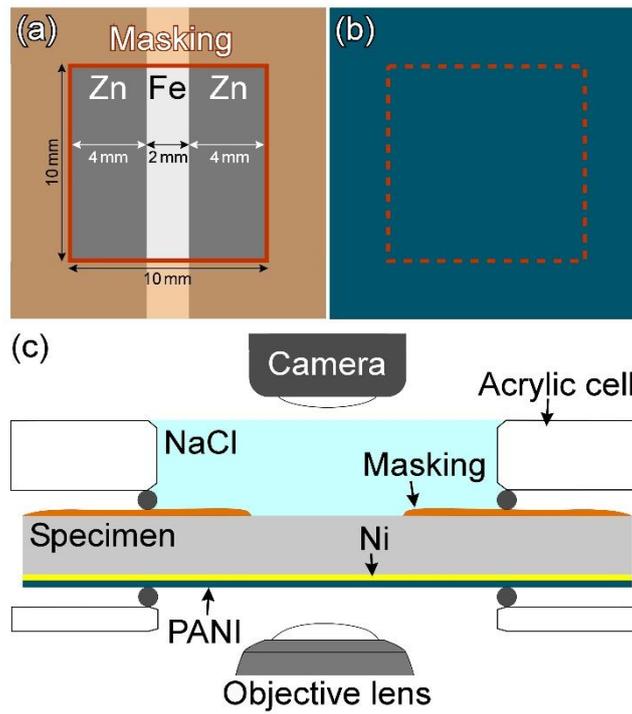
**Figure 1.** Schematics of (a) hydrogen entry and (b) detection sides of the Zn-coated steel. The red square in (a) indicates the electrode area, and the corresponding area is indicated by the dashed red square in (b). (c) Experimental setup for hydrogen visualization test.

Hydrogen visualization tests were performed using bare and Zn-coated steels to analyze the hydrogen flux distribution in the specimens immersed in NaCl solutions. The condition of the hydrogen entry side was identical to that described in Section 2.2.2. Figure 1b shows a schematic of the hydrogen detection side, where the dashed red square indicates the position of the electrode area on the hydrogen entry side. The sensor initially appeared blue before the test. Figure 1c illustrates the experimental setup for the hydrogen

visualization test. The specimen was set in an acrylic cell and placed horizontally relative to the ground. Optical images of the hydrogen detection side were captured every 300 s using an inverted optical microscope equipped with  $\times 1$  objective lens. After the hydrogen visualization test, the hydrogen entry side was rinsed with distilled water and dried with  $N_2$  gas. The specimen surface was then analyzed using a micro-focused X-ray fluorescence spectrometer ( $\mu$ XRF). Elemental mapping of Fe was performed under vacuum conditions at an accelerating voltage of 50 kV and an irradiation current of *ca.* 1 mA. A Rh tube was used as the X-ray source, with a spot size of 10  $\mu$ m. Additionally, surface profiles of the hydrogen entry side of specimens were examined using a one-shot 3D measuring microscope.

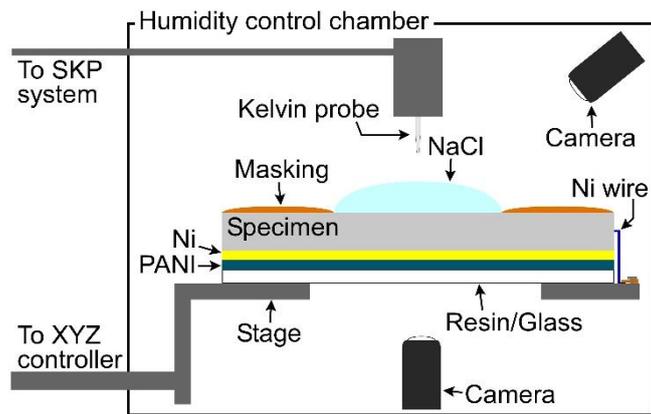
**Figure 2.** Experimental setup for measurement of potential distribution and hydrogen visualization.

described in Section 2.1. To prevent galvanic corrosion of the PANI and Ni layers under high humidity conditions, this layer was sealed with resin and a thin glass sheet [43]. The experimental setup is illustrated in Figure 2. The specimen was placed on the SKP stage and electrically connected to it via a Ni wire. A 200  $\mu\text{L}$  droplet of either 0.1 or 0.01 M NaCl solution was placed on the electrode area. The SKP chamber was maintained at approximately 95% relative humidity (RH) by purging a mixture of humidified and dry air through external humidification and dehumidification system. A stainless-steel probe with a diameter of 500  $\mu\text{m}$  was used for the potential measurement. The scan was performed with a step size of 254  $\mu\text{m}$  and a step number  $40 \times 40$ , respectively. Prior to each SKP scan, optical images of both the hydrogen entry and detection sides were captured using digital cameras.

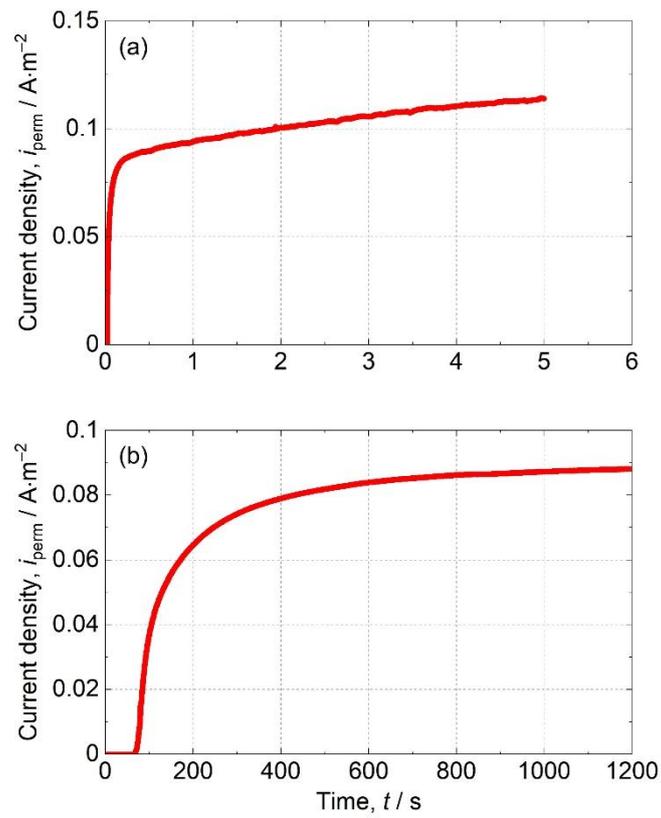
**Figure 3.** (a) Time variation of the  $i_{perm}$  of the bare steel and (b) enlarged view of the initial portion of (a).

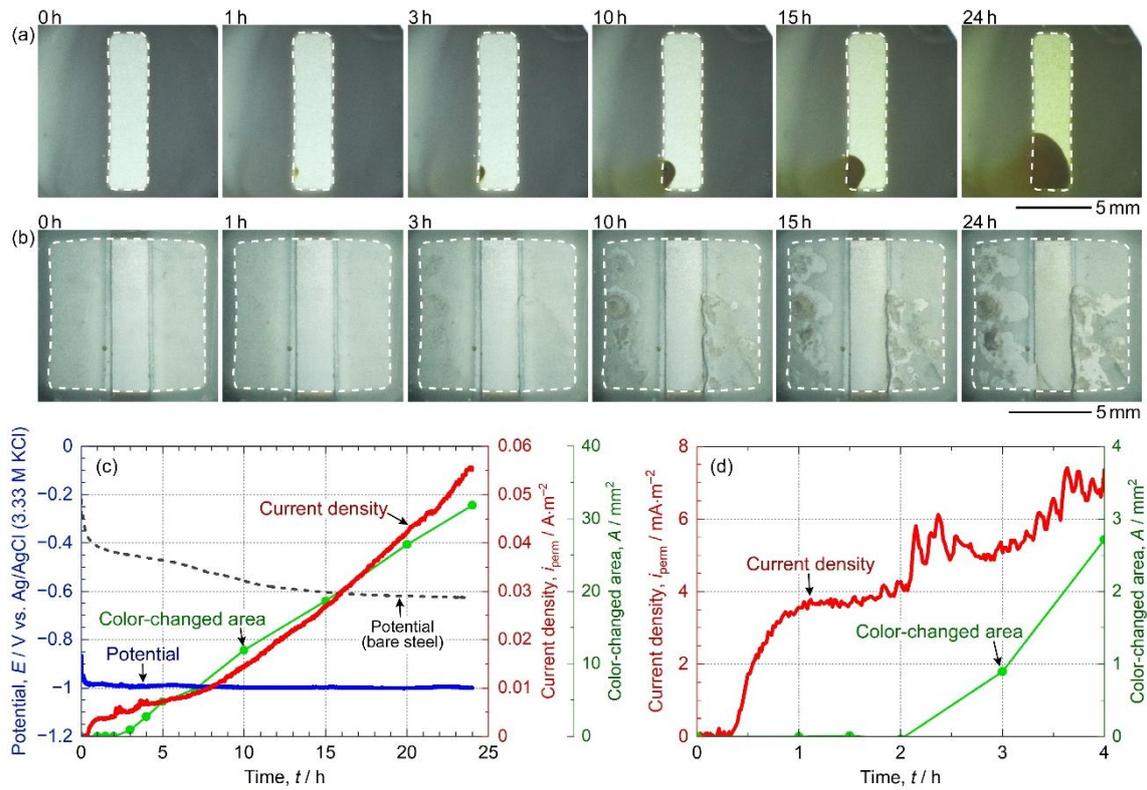
**Figure 4.** Optical images of the hydrogen entry side of (a) the bare and (b) Zn-coated steels during corrosion tests in 0.1 M NaCl. (c) Time variations of OCP (blue),  $i_{perm}$  (red), and color-changed area (green) of Zn-coated steel during the corrosion test shown in (b). The OCP of the bare steel is indicated by the black dotted curve for reference. (d) Enlarged view of  $i_{perm}$  and color-changed area shown in (c).

To examine the effect of Zn coating on hydrogen entry,  $i_{\text{perm}}$  of the bare and Zn-coated steels immersed in the 0.1 M NaCl solution was measured for 24 h using the Devanathan–Stachurski cell. Figure 4a shows the optical images of the bare steel during the corrosion test. The white dotted curve indicates the electrode area. Corrosion initiated within 1 h and progressed over time, generating corrosion products. However,  $i_{\text{perm}}$  was not detected during the test. This result suggests that the amount of hydrogen atoms

entering the bare steel was so small that  $i_{\text{perm}}$  was much smaller than the background current, which was *ca.*  $20 \text{ nA cm}^{-2}$ . Figure 4b displays the optical images of the Zn-coated steel during the corrosion test. A visible color change in the Zn coating was observed after 3 h, presumably due to the dissolution of Zn coating. Figure 4c presents the time variations in OCP,  $i_{\text{perm}}$ , and the color-changed area of the Zn coating. The OCP of the Zn-coated steel decreased to *ca.*  $-1 \text{ V}$  immediately after immersion and then stabilized. For reference, the OCP of the bare steel during the same period (from Figure 4a) is shown as a black dotted curve; it reached  $-0.62 \text{ V}$  at 24 h. The Zn coating reduced the OCP by approximately  $0.38 \text{ V}$ . Since the electrode potential for Zn dissolution is  $-1.14 \text{ V}$  (concentrations of soluble species:  $1.0 \times 10^{-6} \text{ mol kg}^{-1}$ ) [47], the observed decrease in OCP of the Zn-coated steel can be attributed to Zn dissolution. Notably,  $i_{\text{perm}}$  was detected during the corrosion test of the Zn-coated steel and increased over time. These results confirm that the electrode potential of the steel substrate decreased below the electrode potential of the HER ( $-0.53 \text{ V}$  at pH 5.5), thereby enhancing both HER and hydrogen entry into the steel substrate [27, 28].

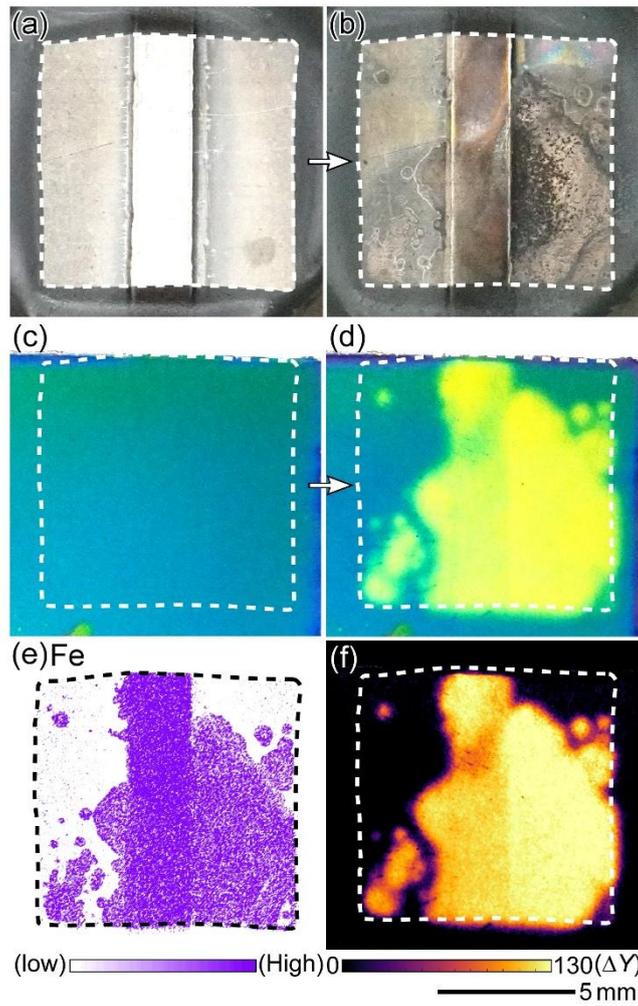
**Figure 5.** Optical images of (a, b) hydrogen entry and (c, d) detection sides before and after the hydrogen visualization test in 0.1 M NaCl. (e) Elemental map of Fe on the hydrogen entry side corresponding to (c). (f) Contour map of  $\Delta Y$  on the hydrogen detection side, calculated using (c) and (d).

The hydrogen entry into Zn-coated steel was observed to accelerate as the Zn coating dissolved. However, the hydrogen entry site cannot be determined via the electrochemical hydrogen permeation tests. Therefore, the hydrogen entry behavior in 0.1 M NaCl was visualized using a hydrogenochromic sensor. Figures 5a and 5b show optical images of the hydrogen entry side of the Zn-coated steel before and after the hydrogen visualization test, respectively. Figures 5c and 5d present optical images of the hydrogen detection side. The color of the PANI layer changed from blue to yellow due to

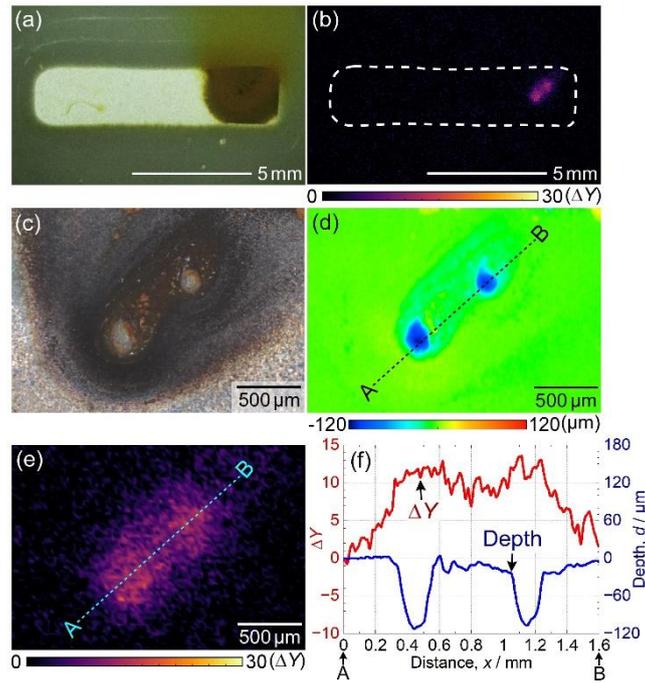
**Figure 6.** (a) Optical image of hydrogen entry side of bare steel and (b) the corresponding  $\Delta Y$  contour map of the hydrogen detection side after 24 h during the hydrogen visualization test. The white dotted curves indicate the electrode area on the hydrogen entry side. (c) Optical micrograph of the corroded area after the test shown in (a). (d) Surface roughness profile and (e)  $\Delta Y$  contour map of the area corresponding to (c). (f) Line profiles of surface depth and  $\Delta Y$  value along the line A–B indicated in (d) and (e).

To evaluate the effect of the Zn coating on hydrogen entry behavior, hydrogen visualization tests were also performed using bare steel specimens. Figure 6a shows an optical image of the hydrogen entry side of the bare steel after immersion in 0.1 M NaCl for 24 h, and Figure 6b displays the corresponding  $\Delta Y$  contour map of the hydrogen detection side. Hydrogen entry was observed to occur locally within the rust-formed surface; however, the hydrogen entry sites were smaller than the rust-formed area. This observation is consistent with findings from our previous study, which reported that hydrogen entry behavior into an Fe sheet in 3wt% NaCl solution [39]: hydrogen entry does not occur on the non-corroded Fe surface, but rather through the dissolved Fe surface under the rust-formed area. Following the hydrogen visualization test, surface roughness measurements were performed. Figure 6c shows the enlarged optical image of the corroded area from Figure 6a, captured after the hydrogen visualization test. Figure 6d shows the surface roughness profile of the area shown in Figure 6c, revealing two pits

with depths of *ca.* 120  $\mu\text{m}$ . Figure 6e displays the  $\Delta Y$  contour map of the hydrogen detection side, corresponding to the region shown in Figures 6c and 6d. An increase in  $\Delta Y$  was observed at the pit locations. Figure 6f illustrates the line profiles of  $\Delta Y$  and surface depth along the line A–B, as indicated in Figures 6d and 6e. High hydrogen flux was detected at the pits and in the adjacent areas approximately 200–300  $\mu\text{m}$  from the pits. The  $\Delta Y$  peaks corresponded to the pit centers, confirming that in the case of bare steel, localized decreases in pH and potential occurred within the pits, thereby promoting hydrogen entry at these locations [39].

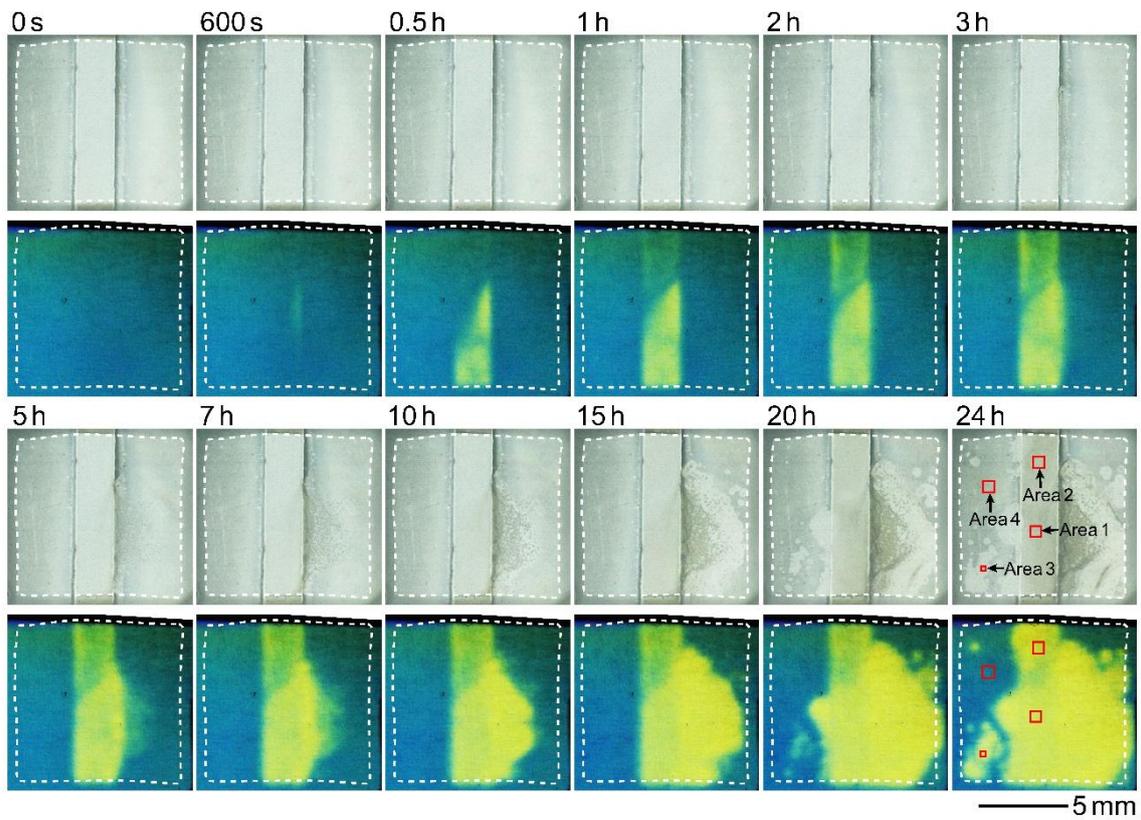
**Figure 7.** Optical images of hydrogen entry (upper row) and detection (lower row) sides during the hydrogen visualization test in 0.1 M NaCl (Figure 5). The white dotted curves indicate the electrode area on the hydrogen entry side.

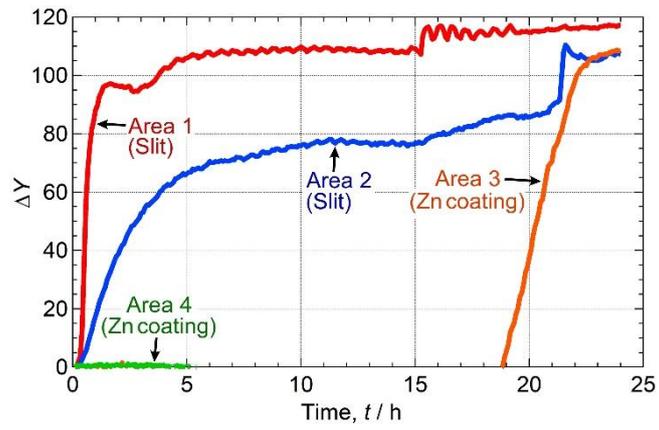
**Figure 8.** The time variations of the average  $\Delta Y$  value in Areas 1–4, as indicated by the red squares in Figure 7.

To further analyze the hydrogen entry behavior in detail, image analyses were conducted. Figure 8 presents the time variation of the average  $\Delta Y$  values in Areas 1–4, as indicated by the red squares in Figure 7. Area 4 corresponds to the region where the color of the Zn coating rarely changed, and no hydrogen entry was detected. Conversely, the color change of the Zn coating was observed in Area 3, and the  $\Delta Y$  value rapidly increased after 19 h. These observations indicate that hydrogen entry does not occur while the Zn coating is intact, but begins only after the steel substrate becomes exposed to the solution. Areas 1 and 2 correspond to the slit area. In Area 1, the  $\Delta Y$  value drastically increased at the beginning of the test, whereas in Area 2, the increase was more gradual. However, after 21 h, a sharp rise in  $\Delta Y$  value was observed in Area 2—from 90 to 110. Eventually, the  $\Delta Y$  values in both Areas 1 and 2 became almost the same, suggesting that hydrogen entry did not proceed uniformly on the steel substrate. This supports the presence of a hydrogen flux distribution within the steel substrate.

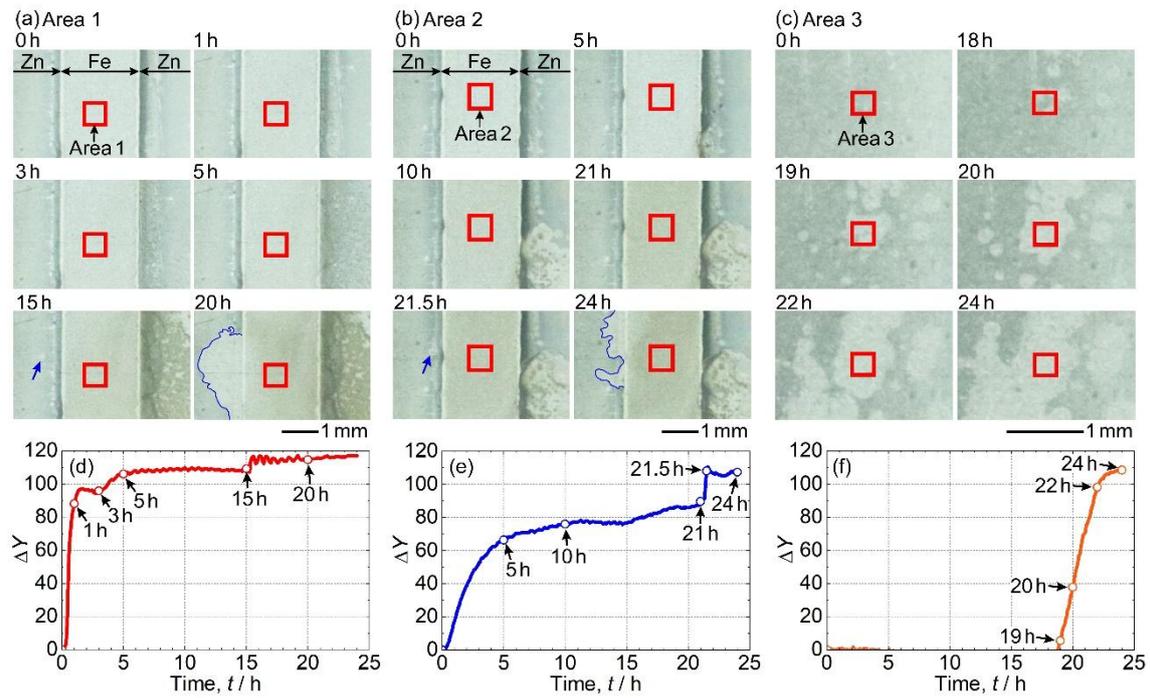
**Figure 9.** Optical images of (a) Area 1, (b) Area 2, and (c) Area 3 and their surrounding

regions, as shown in Figure 7. The average  $\Delta Y$  values in Areas 1–3 and the

time points of optical images acquisition are indicated by the solid curves and

white dots in (d)–(f), respectively.

As was shown in Figures 9b and 9e, the  $\Delta Y$  value in Area 2 reached approximately 65 at 5 h, even though no color change was observed in the adjacent Zn coating. The  $\Delta Y$  value continued to increase with time and stabilized after 10 h. Compared to Area 1, the  $\Delta Y$  value in Area 2 remained relatively low, likely due to the greater distance between Area 2 and the dissolving Zn coating, which was shorter in the case of Area 1. From 10 to 21 h, little to no color change was observed in the Zn coating adjacent to Area 2, indicating that HER activity remained limited during this period. However, at 21.5 h, Zn coating dissolution commenced on the left side of Area 2, as indicated by the blue arrow, and this was followed by the increase in the  $\Delta Y$  value. These results confirm that hydrogen entry into the steel substrate is accelerated by the dissolution of adjacent Zn coating. The dissolution process of Zn continued, and after 24 h, the underlying steel substrate was exposed in the region marked by the blue curve. Figures 9c and 9f present the optical images and time variation of the  $\Delta Y$  value in Area 3. In this region, neither color change nor evidence of hydrogen entry was confirmed until 18 h. After this point, the color of the Zn coating started to change, and subsequently, the  $\Delta Y$  value drastically increased after

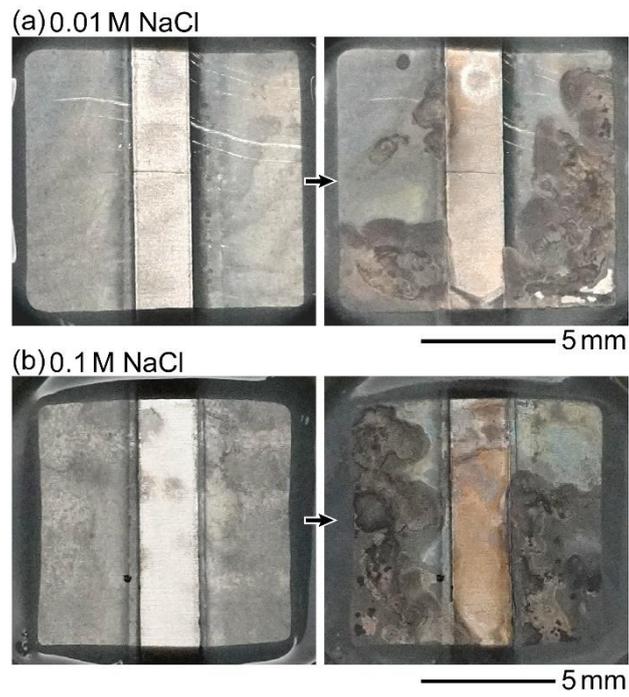
**Figure 10.** Optical images of the hydrogen entry side before (left) and after (right) the corrosion test in (a) 0.01 and (b) 0.1 M NaCl, corresponding to the Zn-coated steel shown in Figure 4b.

Although  $\text{Cl}^-$  concentration is known to influence hydrogen entry into steels [25, 48, 49], its specific role in Zn-coated steels remains unclear. In this section, hydrogen entry behavior in Zn-coated steels was investigated using a NaCl solution with lower  $\text{Cl}^-$  concentration than that used in Section 3.2, in order to investigate the effect of  $\text{Cl}^-$  concentration on hydrogen uptake. Figure 10a shows the optical images of the Zn-coated steel before (left) and after (right) the corrosion test in 0.01 M NaCl for 24 h. The color in the Zn coating indicates corrosion. For comparison, Figure 10b presents optical images of the Zn-coated steel before and after a similar corrosion test in 0.1 M NaCl for 24 h, as

shown previously in Figure 4b. No significant difference in surface appearance was observed between specimens immersed in 0.01 and 0.1 M NaCl. The color-changed areas of the Zn coating after testing were *ca.* 39 mm<sup>2</sup> and *ca.* 32 mm<sup>2</sup> for the 0.01 and 0.1 M NaCl solutions, respectively. These results suggest that decreasing Cl<sup>-</sup> concentration from 0.1 to 0.01 M had minimal impact on the macroscopic dissolution behavior of Zn coating.

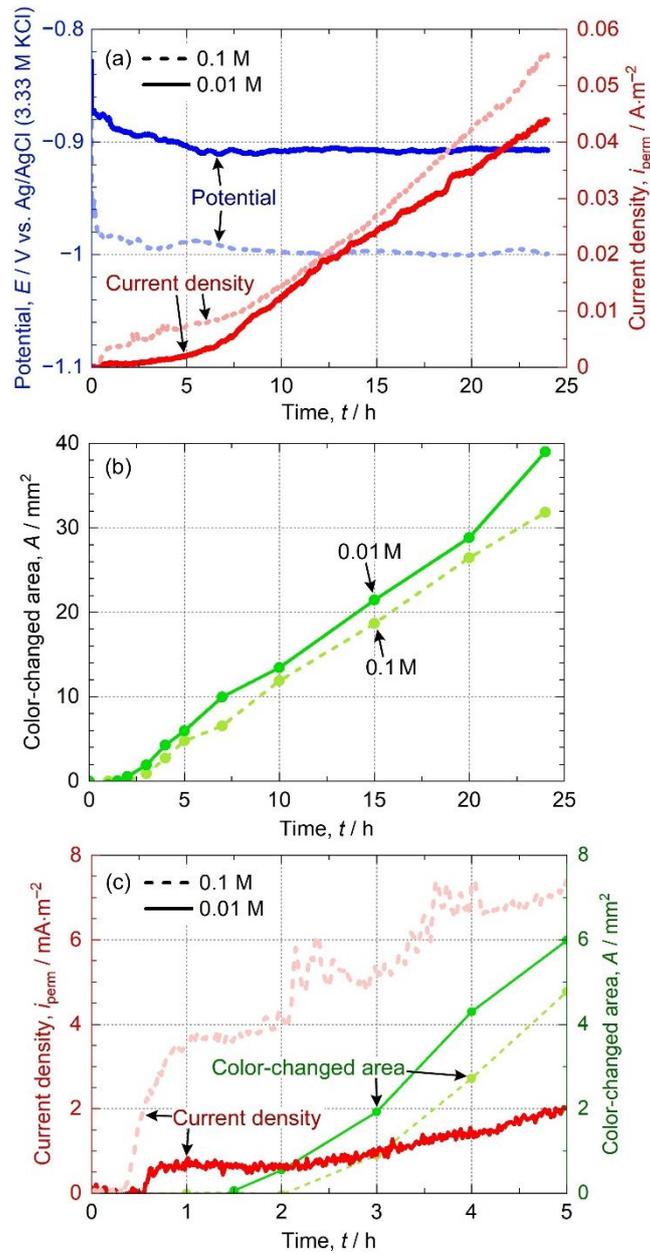
**Figure 11.** (a) Time variations of OCP (blue) and  $i_{\text{perm}}$  (red) of the Zn-coated steel in 0.01 M NaCl. The results for 0.1 M NaCl from Figure 4c are shown as dotted curves for reference. (b) Time variations of the color-changed area of the Zn coating (green) during the corrosion test shown in (a). (c) Enlarged view of time variations of  $i_{\text{perm}}$  and color-changed area presented in (a) and (b).

Figure 11a shows the time variation of the OCP and  $i_{\text{perm}}$  of the Zn-coated steel during the corrosion test in 0.01 M NaCl. For reference, the corresponding results of the Zn-coated steel in 0.1 M NaCl (Figure 4c) are indicated by the dotted curves. The OCP in 0.01 M NaCl was *ca.* 0.1 V higher than that in 0.1 M NaCl. Regardless of Cl<sup>-</sup> concentration,  $i_{\text{perm}}$  increased in both solutions; however, the magnitude was higher in 0.1 M NaCl than in 0.01 M NaCl. Figure 11b presents the time variation in the color-changed area of the Zn coating. The growth rate of this area was found to be independent of Cl<sup>-</sup> concentration, suggesting that the dissolution rate of the Zn coating was nearly identical in both solutions. After 10 h, the growth rate of this area was approximately 1.4 mm<sup>2</sup> h<sup>-1</sup> (see Supplementary Figure 3 for detail). Figure 11c presents an enlarged view of the time variations of  $i_{\text{perm}}$  and the color-changed area, as shown in Figures 11a and 11b. In 0.01 M NaCl,  $i_{\text{perm}}$  was first detected after 0.6 h (21.6 ks), approximately 720 s later than in 0.1 M NaCl. In both 0.01 and 0.1 M NaCl,  $i_{\text{perm}}$  reached a stable value before

any visible color change was observed in the Zn coating. When  $i_{\text{perm}}$  stabilized at 2 h, the  $i_{\text{perm}}$  in 0.1 M NaCl was  $3.7 \text{ mA m}^{-2}$ , while it was  $0.7 \text{ mA m}^{-2}$  in 0.01 M NaCl. This suggests that hydrogen entry was suppressed in 0.01 M NaCl compared with that in 0.1 M NaCl, although there is no significant difference in the overall corrosion behavior of the Zn coating.

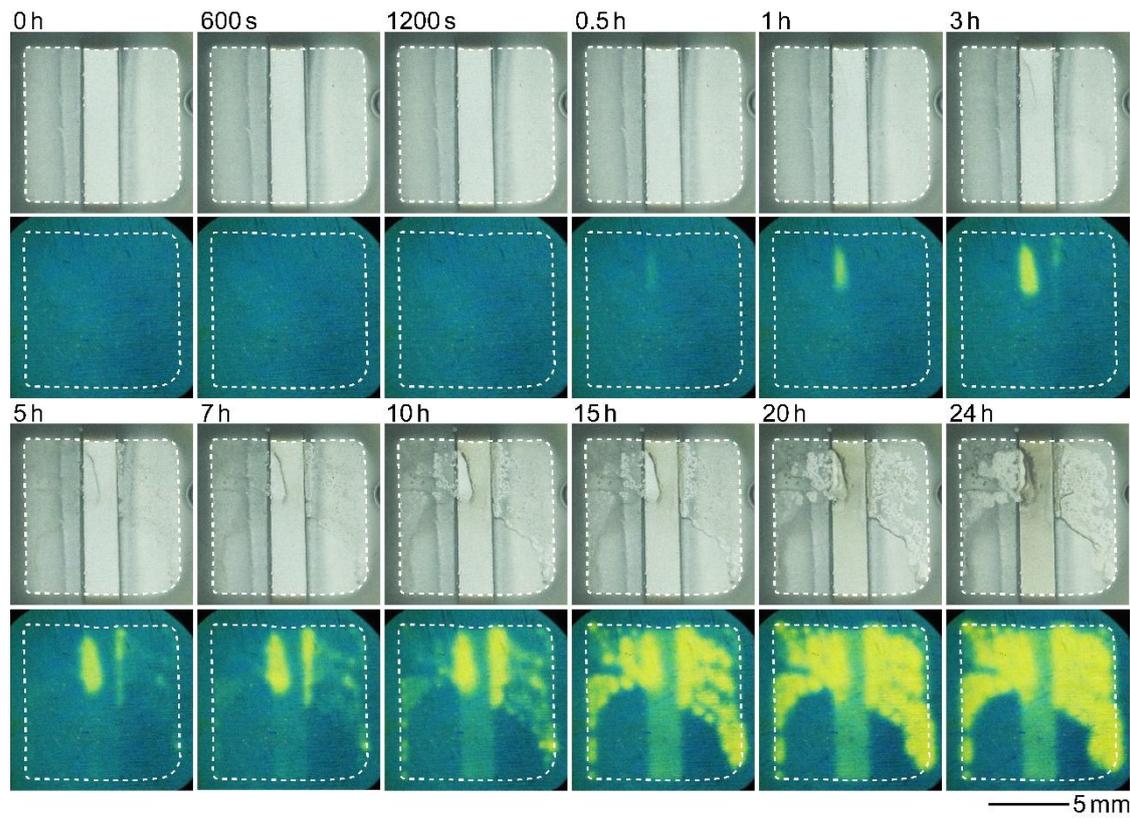
**Figure 12.** Optical images of the hydrogen entry (upper row) and detection (lower row) sides during the hydrogen visualization test in 0.01 M NaCl.

To elucidate the effect of  $\text{Cl}^-$  concentration on the hydrogen entry site and hydrogen flux distribution, a hydrogen visualization test was conducted in 0.01 M NaCl. Figure 12 presents optical images of the hydrogen entry and detection sides during the test. In 0.1 M NaCl, hydrogen entry was detected at 600 s, whereas in 0.01 M NaCl, it was first observed at approximately 0.5 h. The initial hydrogen entry site was the steel substrate located near the steel/Zn boundary of the slit, consistent with the results obtained in 0.1 M NaCl. Even after 5 h, there was a clear positional dependence of the hydrogen flux within the slit: regions of the steel substrate adjacent to the dissolving Zn coating exhibited higher hydrogen flux, which decreased with increasing distance from the dissolving Zn coating. The hydrogen entry site expanded with time, with additional hydrogen entry also detected in newly exposed areas of steel substrate due to the continued dissolution of the Zn coating. The optical images shown in Figure 12 were converted to a video file (see Supplementary Video 2)

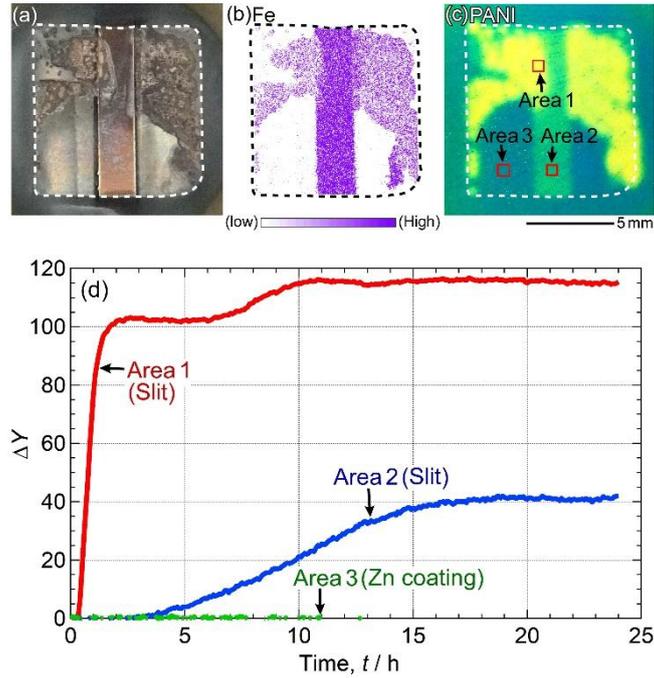
**Figure 13.** (a) Optical image and (b) elemental map of Fe on the hydrogen entry side, and (c) optical image of hydrogen detection side after the hydrogen visualization test in 0.01 M NaCl. (d) The time variations of the average  $\Delta Y$  values in Areas 1–3, as indicated by the red squares in (c).

Figures 13a and 13b show the optical image of the corrosion side and the corresponding Fe element map, respectively, obtained after the hydrogen visualization test shown in Figure 12. Figure 13c depicts the optical image of the hydrogen detection side. The hydrogen entry site roughly corresponded to the area where the steel substrate was exposed, indicating that the overall size of the hydrogen entry site was independent of the  $\text{Cl}^-$  concentration. However, the hydrogen flux distribution was non-uniform in 0.01 M NaCl compared to that observed in 0.1 M NaCl.

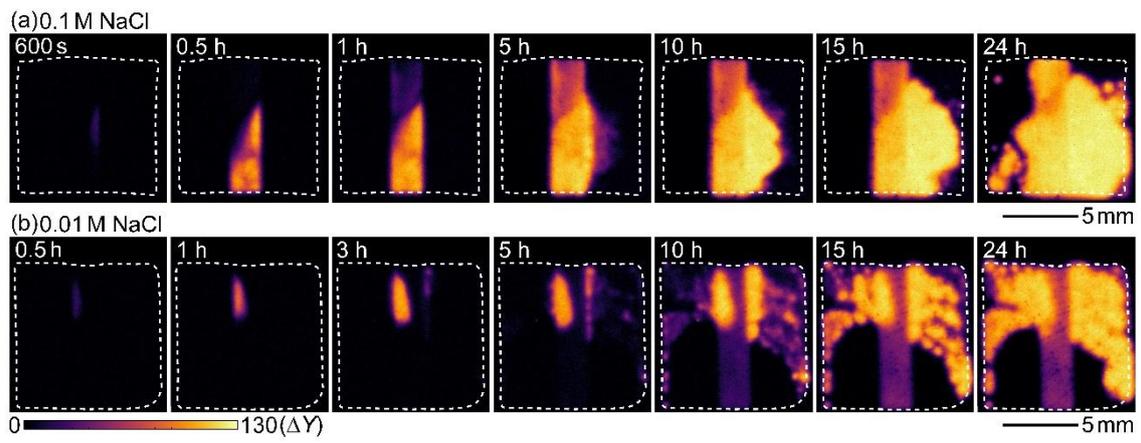
**Figure 14.** Contour maps of the  $\Delta Y$  values of the hydrogen detection side shown in (a)

Figure 7 and (b) Figure 12.

distribution between 0.1 and 0.01 M NaCl. Then, to quantitatively assess these differences, contour maps of the  $\Delta Y$  values on the hydrogen detection sides were generated. Figures 14a and 14b present the  $\Delta Y$  contour maps obtained from the hydrogen visualization tests with 0.1 (Figure 7) and 0.01 M NaCl (Figure 12), respectively. In 0.1 M NaCl, hydrogen entry was detected in approximately half of the slit by 0.5 h, following an initial increase in the  $\Delta Y$  value at 600 s. In contrast, in 0.01 M NaCl, hydrogen entry was observed only near the steel/Zn boundary at 1 h. The final sizes of the hydrogen entry sites in 0.1 and 0.01 M NaCl were 87 and 77 mm<sup>2</sup>, respectively, showing no significant dependence on Cl<sup>-</sup> concentration. However, a clear difference in the distribution of the  $\Delta Y$  values (reflecting hydrogen flux) was observed between the two NaCl concentrations. In particular, the hydrogen flux distribution within the slit marked variation: in 0.1 M NaCl, the  $\Delta Y$  values were predominantly high, with a maximum value of 129. In contrast, in 0.01 M NaCl, significant hydrogen entry occurred only locally—within *ca.* 1-mm area of the dissolving Zn coating—with a maximum value of 127. In other regions, the  $\Delta Y$  values ranged from *ca.* 30 to 50. These results indicate that the maximum hydrogen flux was not largely dependent by Cl<sup>-</sup> concentration. However, the hydrogen flux was non-uniform in 0.01 M NaCl compared with that in 0.1 M NaCl. Given that the size of the hydrogen entry site was independent of Cl<sup>-</sup> concentration, the observed difference in  $i_{\text{perm}}$  between 0.1

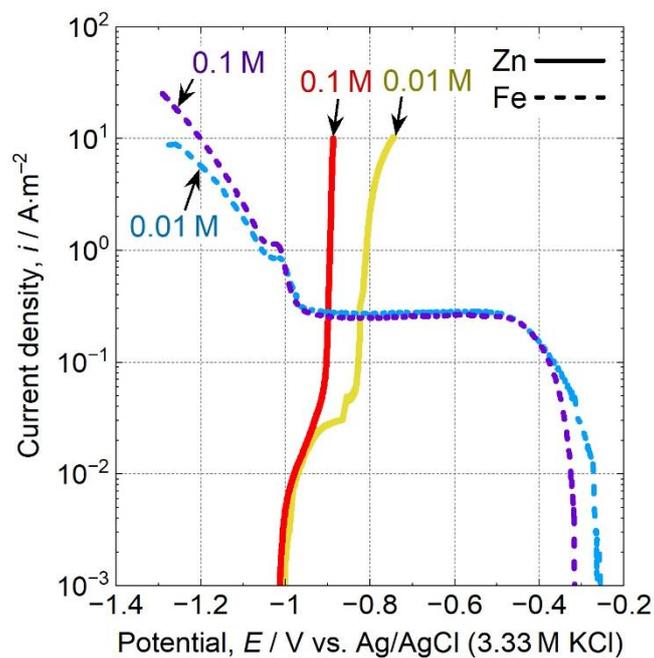
**Figure 15.** Anodic polarization curves of Zn plate and cathodic polarization curves of bare steel in 0.1 and 0.01 M NaCl.

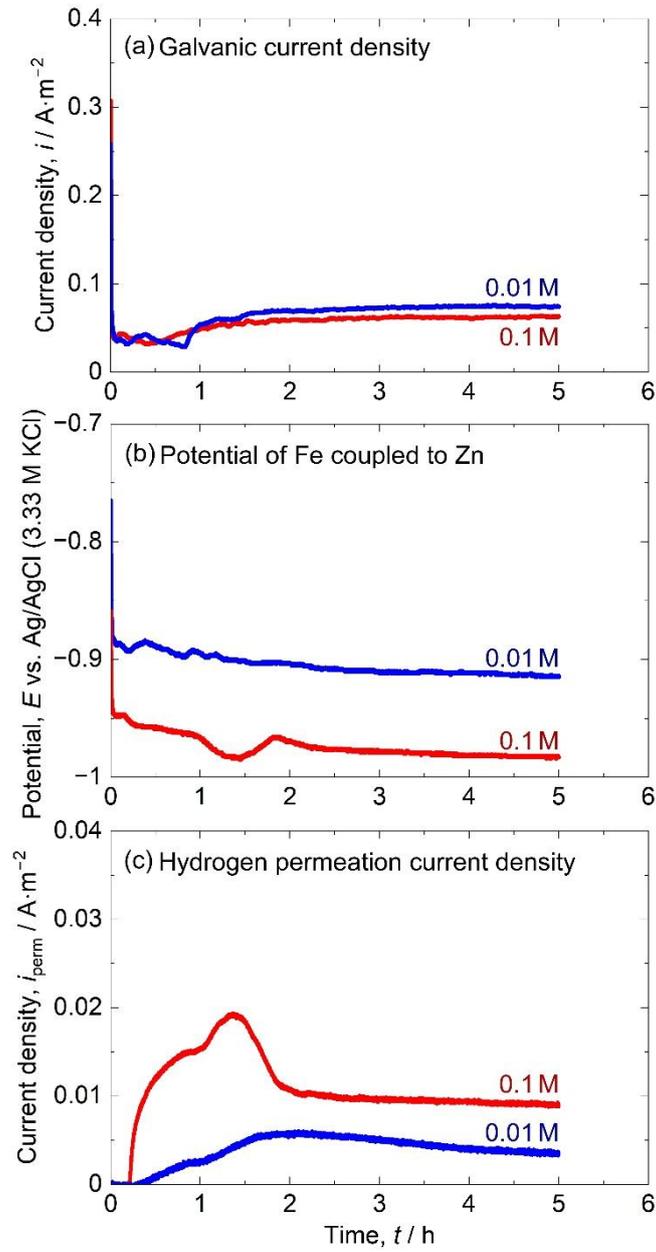
**Figure 16.** Time variations of (a) galvanic current density, (b) OCP, and (c)  $i_{\text{perm}}$  of the bare steel coupled to Zn plate in 0.1 and 0.01 M NaCl.

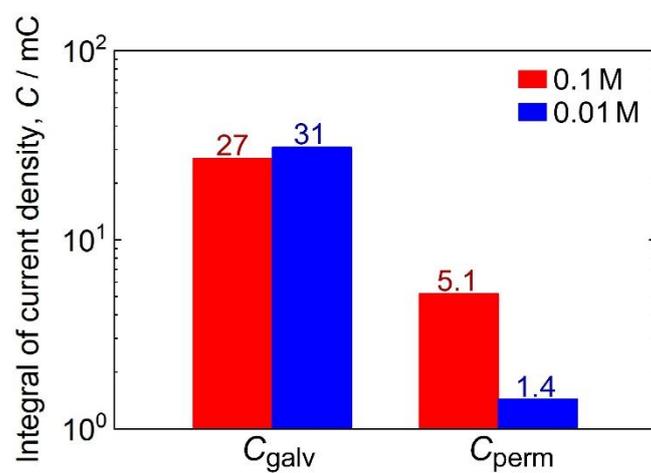
**Figure 17.** The integral values of galvanic current density ( $C_{galv}$ ) and hydrogen permeation current density ( $C_{perm}$ ), corresponding to the galvanic and hydrogen permeation current densities shown in Figures 16a and 16c.

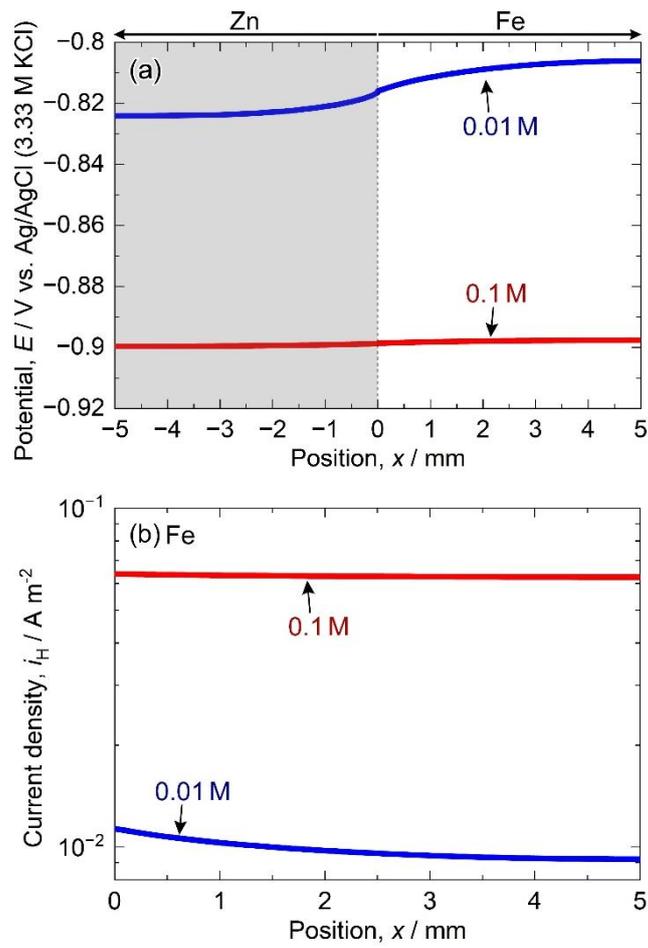
**Figure 18.** Distributions of (a) potential and (b) current density of HER on Zn-coated steels in 0.1 and 0.01 M NaCl.

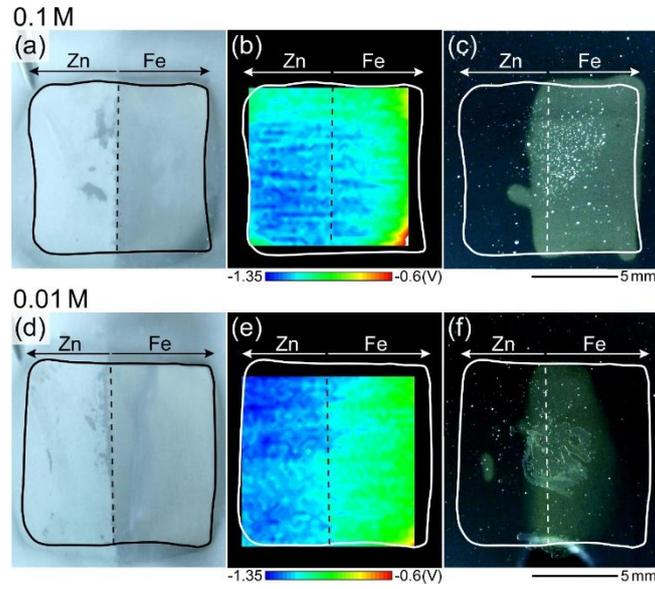
**Figure 19.** (a) Optical image and (b) potential distribution of the hydrogen entry side of the Zn-coated steel immersed in 0.1 M NaCl, and (c) corresponding hydrogen detection side after 7.2 h of immersion. (d) Optical image and (e) potential distribution of the hydrogen entry side of the Zn-coated steel immersed in 0.01 M NaCl, and (f) corresponding hydrogen detection side after 7.2 h of immersion.

The potential gradients in 0.01 M NaCl simulated in this study were lower than those reported in previous studies [34, 36, 51, 52], likely due to exclusion of changes in solution chemistry and electrode surface conditions. To experimentally validate the effect of  $\text{Cl}^-$  concentration on the potential distribution of Zn-coated steel, SKP measurements were conducted in both NaCl solutions. Figures 19a and 19d show optical images of the hydrogen entry side after 7.2 h of immersion in 0.1 and 0.01 M NaCl, respectively. The solid and dotted curves indicate the electrode area and the steel/Zn boundary, respectively. Figures 19b and 19e show the potential distributions of Zn-coated steel after 7.2 h of immersion in 0.1 and 0.01 M NaCl, respectively. In 0.1 M NaCl, the potential across the

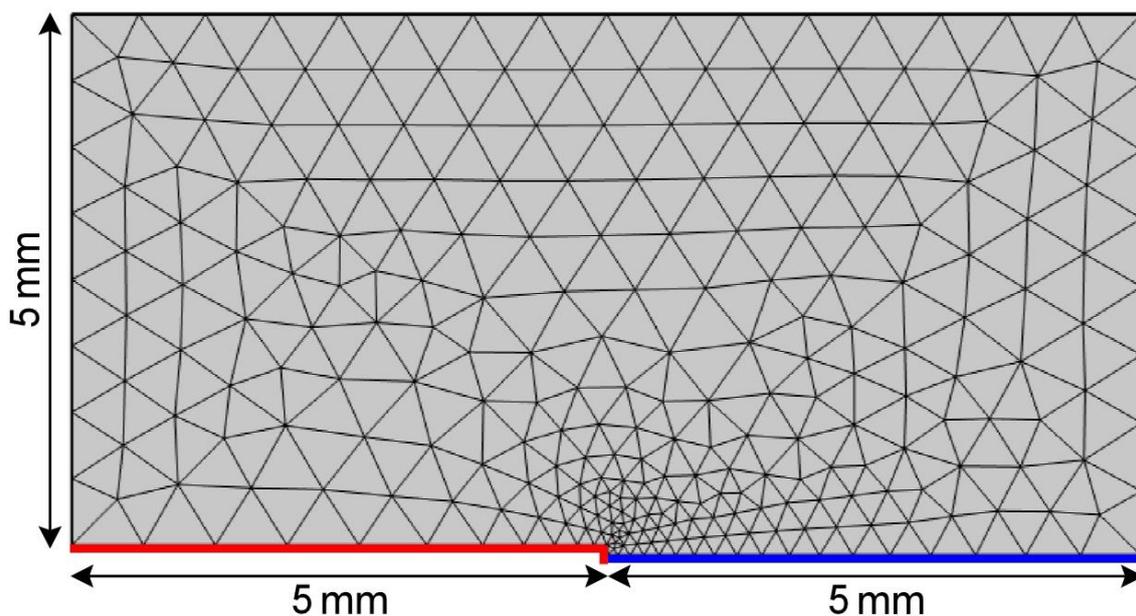
Supplementary Figure 1 shows the geometric structure used in the finite element method (FEM) simulation. COMSOL Multiphysics version 6.2 was utilized to implement a secondary current distribution model to calculate the potential distribution on Zn-coated steel in 0.1 or 0.01 M NaCl. The gray area indicates the NaCl solutions, with an electric conductivity of  $1.0 \text{ S m}^{-1}$  for 0.1 M or  $0.11 \text{ S m}^{-1}$  for 0.01 M. The red and blue lines indicate the Zn coating and steel substrate, respectively.

**Supplementary Figure 1.** Geometric structure and mesh used in the finite element model.

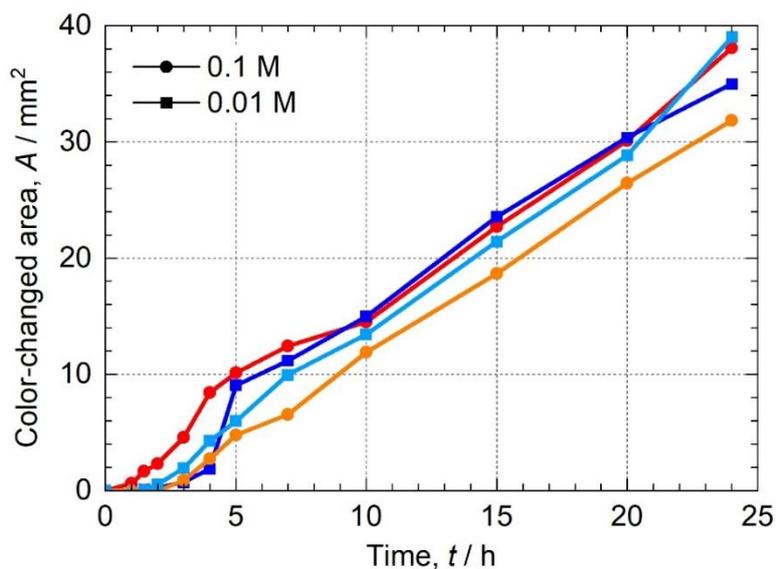
Supplementary Figure 2 shows the time variations of the color-changed area of the Zn coating during the tests presented in Figures 4b, 7, 11, and 12. The results for 0.1 and 0.01 M are indicated by circles and rectangles, respectively. No significant difference in the growth of the color-changed area was confirmed, implying that the dissolution behavior of the Zn coating is largely independent of  $\text{Cl}^{-}$  concentration. After 10 h, the growth rate of the color-changed area was approximately  $1.4 \text{ mm}^2 \text{ h}^{-1}$ .

**Supplementary Figure 2.** Time variations in the color-changed area of the Zn coating during the tests shown in Figures 4b, 7, 11, and 12.

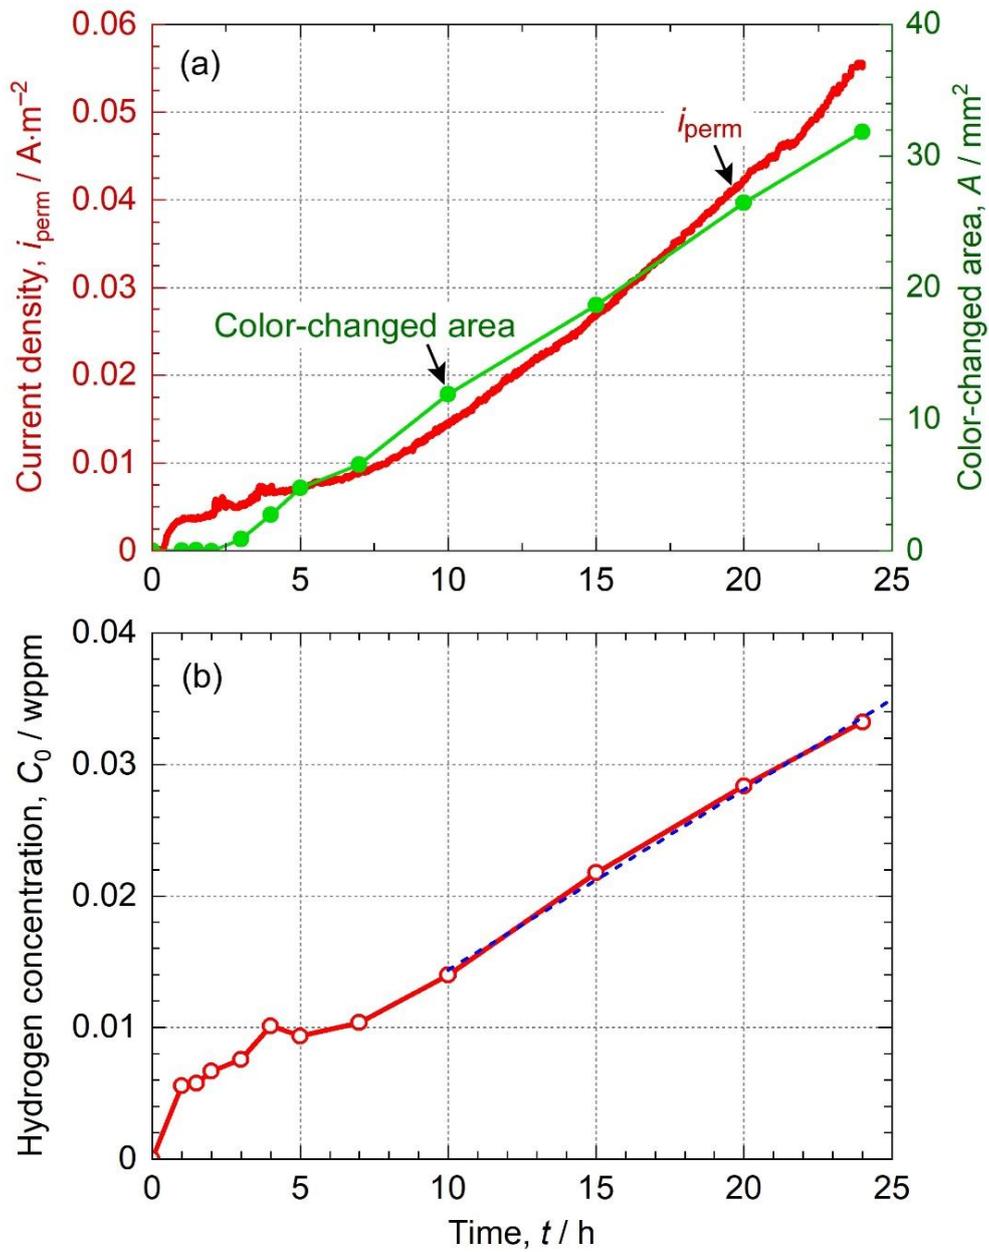
Supplementary Figure 3a presents the time variations of  $i_{\text{perm}}$  and the color-changed area of the Zn coating shown in Figure 4c. Based on these measurements and Equation (7) from the main manuscript, the time variation of  $C_0$  on the steel substrate was calculated. The color-changed area was used to estimate the area of the steel substrate exposed to the solution. Supplementary Figure 3b shows the resulting time variation of  $C_0$ . The  $C_0$  value was found to increase over time. Then, an approximate linear fit (dotted blue line in Supplementary Figure 3b) was calculated using the least squares method, based on  $C_0$  values after 10 h. The calculated rate of increase in  $C_0$  was *ca.* 1.4 wppb h<sup>-1</sup>. These results indicate that the increase in  $i_{\text{perm}}$  is influenced by not only the expansion of the hydrogen entry site but also changes in the solution chemistry and surface conditions of the steel substrate.

**Supplementary Figure 3.** (a) Time variations of  $i_{\text{perm}}$  and the color-changed area of the Zn coating, as shown in Figure 4c. (b) Time variation of  $C_0$ , calculated based on the data in (a).

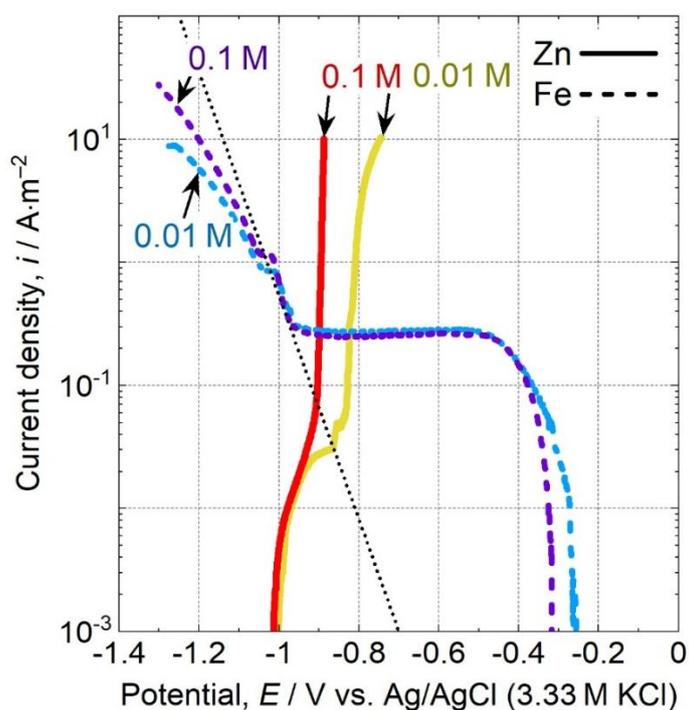
To estimate the distribution of the current density associated with the HER on the steel substrate, the potential dependence of HER current density was derived from the polarization curves shown in Figure 15. Supplementary Figure 4 displays these polarization curves. Assuming that the increase in current density in the potential range below  $-1$  V is caused by HER, the polarization curve below  $-1$  V was extrapolated (black dotted line). The Tafel slope of the black dotted line was  $110 \text{ mV dec}^{-1}$ . Using the extrapolation line in Supplementary Figure 4 and the potential distribution shown in Figure 18a, the distribution of HER current density shown in Figure 18b was calculated.

**Supplementary Figure 4.** Anodic polarization curves of the Zn plate and cathodic polarization curves of bare steel in 0.1 and 0.01 M NaCl, corresponding to the data shown in Figure 15. The increase in the current density in the potential range below  $-1$  V was extrapolated using the dotted black line.
