COLISEUM PROJECT: CORRELATING CLIMATE CHANGE DATA WITH THE BEHAVIOR OF HERITAGE MATERIALS

1.1. Notre-Dame of Strasbourg Cathedral site and materials

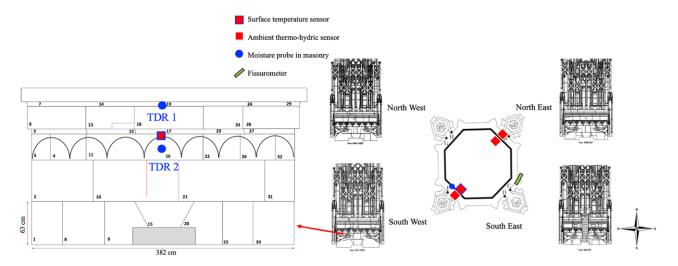
Figure 2: Location of sensors on the cathedral spire installed in April 2024

This methodology consists in non-destructive and simultaneous monitoring of both climate and the state of alteration of studied site. The instrumentation and the first on-site campaign presented were carried out in April 2024. As represented on figure 2, two contrasting zones of the cathedral spire were selected. The Northeast face less altered and less exposed to direct sunlight and the South-west face more altered and subject to strong thermal variations. Blocks of control batches were also placed on the spire (and on all the study sites) for natural ageing over 3 years. The batches are 5x5x5cm cubes of granite (Bibracte), Alsatian sandstones (Vosges sandstone, Bitburg sandstone, Staub sandstone), Barutel limestones (Sèle quarry, Nîmes), Estaillade limestones (Provence quarries, Oppède). For continuous climate monitoring, sensors have been installed for humidity (%) and ambient temperature (°C), surface temperature (°C) for dew point monitoring and relative humidity in the masonry (water circulation monitoring). To interpret differences in weathering, sensors are positioned in each zone, and in different orientations. The location of the sensors is shown in figure 2 and specified in table 1.

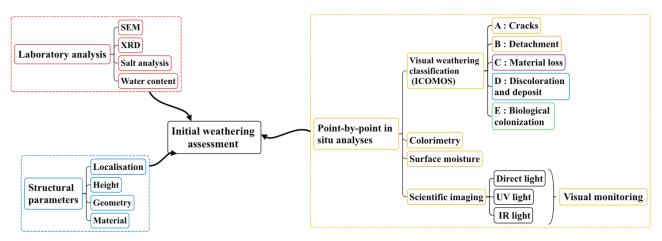
Figure 3: Parameters and analyses included in the initial damage assessment

To correlate climatic data with the evolution of weathering, an initial damage assessment is defined to start. This initial damage assessment is based on four types of point-by-point diagnosis, supplemented by laboratory and structural analyses, pictured in figure 3. Structural parameters include the consideration of geometry, location and type of material. In situ, surface analysis campaigns involve the use of portable, non-destructive analysis techniques such as colorimetry, relative surface humidity (capacitive moisture meter) and imaging campaigns. Imagery is used to visually monitor each area. An alteration index between 0 and 5 is assigned according to ICOMOS categories of stone deterioration patterns. This campaign is supplemented by laboratory analysis of collected samples: analysis of soluble salts with ion chromatography, gravimetric measurement of water content in masonry and analysis of efflorescence by X-ray diffraction (XRD). Hygroscopic water content, which corresponds to the maximal quantity of water adsorbed by the sandstone and gives an indication on the presence of soluble salts. Finally, this initial campaign is repeated every 3 to 6 months. Collected data is gathered in a grid of analysis points (one per sandstone block). Subdividing each face into sub-zones enables the compilation of results in an alteration matrix that will feed the predictive models.

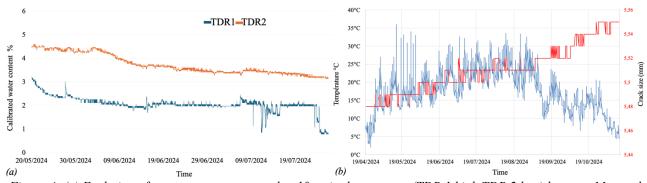
Figure 4: (a) Evolution of water content measured at 10cm in the masonry (TDR 1 high TDR 2 low) between May and July 2024; (b) Changes in crack size and ambient relative humidity between April and October 2024

Tracking a crack in the gallery at the base of the spire reveals its progressive enlargement (graph (a) figure 4). The evolution of the crack will be correlated with specific climatic events through time. Concerning masonry, according to graph (b), the top probe TDR1 measures a higher water content than the bottom probe TDR2. Given the structure of the studied faces overhung by a cornice (with a lead and plaster cap), the circulation of water through the top is expected. Regarding waterflow in masonry, whatever the face studied, sandstone moisture seems to originate from water flowing from above (base of the spire). This water may be loaded with solubilized salts, which recrystallize at depth and on the surface during the soaking/drying cycles observed. Water content in masonry decreases over the summer, particularly on the lower probe, which is more exposed to the sun. Studying the presence of soluble salts will help to understand the influence of water circulation on weathering.

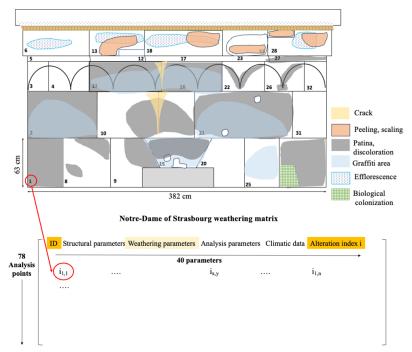
Figure 5: Presentation of the general structure of the weathering matrix: 1 block > 1 ID > 1 line and weathering mapping of the Southwest face

An alteration map of the Southwest face and the general structure of associated weathering matrix is shown in figure 5. Each row of the matrix corresponds to a sub-zone, and each column to an associated weathering or climatic parameter (more than 40 parameters). Thus, the calculated index i reflects the state at which climate monitoring began and is calculated as followed. The first step is to delimit and label precisely the sub-zones to be mapped. For the Notre-Dame de Strasbourg spire, they are the 70 sandstone blocks and the 8 batches blocks (78 lines). Labelling is important for linking the modalities together in the algorithm (weathering, pictures, sensors and weathering parameters). The second step is to fill in the invariable "structural" information for each block, such as sandstone type, height or block configuration. This results in a structural index *istructure*. Thirdly, for each subzone alterations are recorded and assigned a sub-index (between 0 and 5) according to the degree of affection, represented table 4. Rating from 0 to 5 depends on the percentage of coverage of the area for each sub-family of alteration. Additionally, measured parameters from in situ analyses (colorimetry, surface humidity) and laboratory analyses are added. In the end, a continuous variable *ialteration* is obtained and, at last the general weathering index *i* is calculated by averaging all these sub-indices. Over time, the matrix will be completed with climate monitoring parameters. Each block is associated with one or more sensors.
