Results of an RF Pulsed Heating Experiment at SLAC*

D. P. Pritzkau and R. H. Siemann, Stanford Linear Accelerator Center, Stanford, CA, 94309, USA

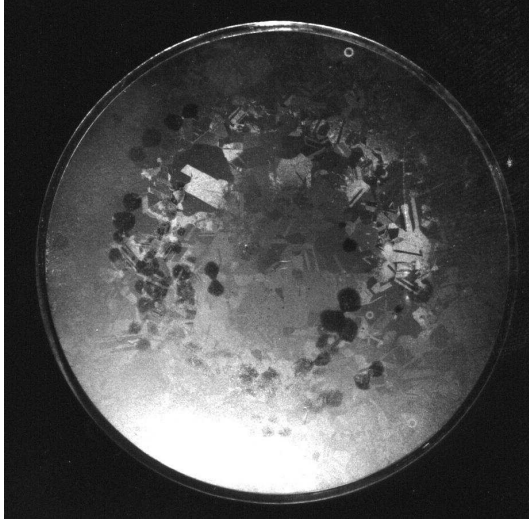
In Figure 1, one can see a visible change in the crystal grains in the region approximately 10.4 mm to 11.0 mm from the center with an average width of approximately 4 mm to 5 mm. From GdifeL [8] simulations, the fields in the region closer to the coupling iris is 5% higher than the fields diametrically opposite of this region. This simulation would then explain why there is more damage in the region closer to the aperture, since the region farther away has a temperature rise approximately 10% lower.

Figure 1: One of the copper endcaps. The other endcaps are similar in appearance.

density of the copper globules increases closer to the plane of the coupling irises. One may also see dark circles along the area of maximum magnetic field. Since they seem to occur in pairs and the magnetic field in this area is radial, we believe these patches are due to multipacting. However, it is not yet understood why this occurs since the electric field in this region is zero.

Each endcap was scanned along a random diameter. The scans show that cracks are only evident in the region of visible grains in Figure 1 where maximum damage is expected. Higher magnification images of the regions of cracks were

An internal cross-section of the endcap shown in Figure 1 was completed. Not as many cracks were evident in the cross-section, but they did occur in the region of maximum temperature rise. One interesting crack is shown in Figure 5. It begins at the surface and propagates down to an internal grain boundary. Afterwards, the crack propagates along the grain boundary.

We have demonstrated that RF pulsed heating with a temperature rise of 120 K poses a danger to OFE copper structures. The evidence is the surface modification and damage shown in Figures 1, 2, 4 and 5. We have measured degradation of the cavity Q_0 also. Because of copper sputtered from breakdown at the coupling iris, it is not conclusive that this degradation was caused by the surface damage.

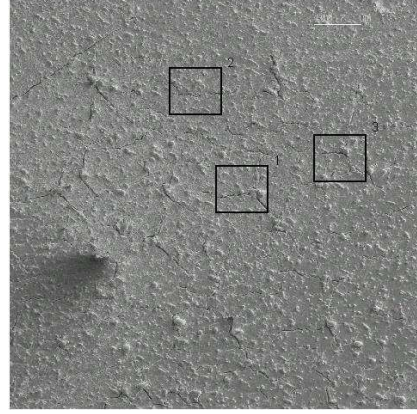
The endcaps were examined with a scanning electron microscope using secondary emission and a 5 keV electron beam. Figure 2 shows a region where maximum damage is expected. Note that this endcap pictured is different from the one shown in Figure 1; however, all four endcaps are similar in appearance. The little bumps along the surface are the copper globules sputtered from breakdown at the coupling iris. More importantly, one can easily see the numerous cracks that have occurred on the surface. For comparison, a region at the center where the temperature rise is close to zero is shown in Figure 3. This picture was taken at the same magnification. There are no cracks in this region. The copper globules are also noticeable here. Because of the sputtering, we cannot isolate the unloaded Q degradation shown in Table 1 due to sputtering from that due to the presence of the cracks.

Figure 2: Region (0.9 mm \times 0.9 mm) where maximum damage is expected. The scale in the upper right-hand corner is 100.7 μm . Figure 4 has higher magnification images of the indicated regions.

taken. For the endcap shown in Figure 2, the average location of all higher-magnification images of cracks is approximately 10.4 mm from the center with a standard deviation of 1.3 mm. Close-up shots of a few of these cracks are shown in Figure 4.

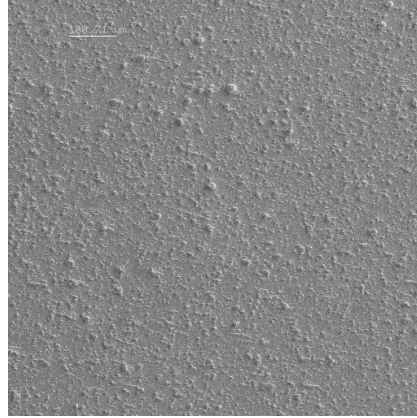
Figure 3: Center of endcap. The scale in the upper left-hand corner is 100.7 μm .

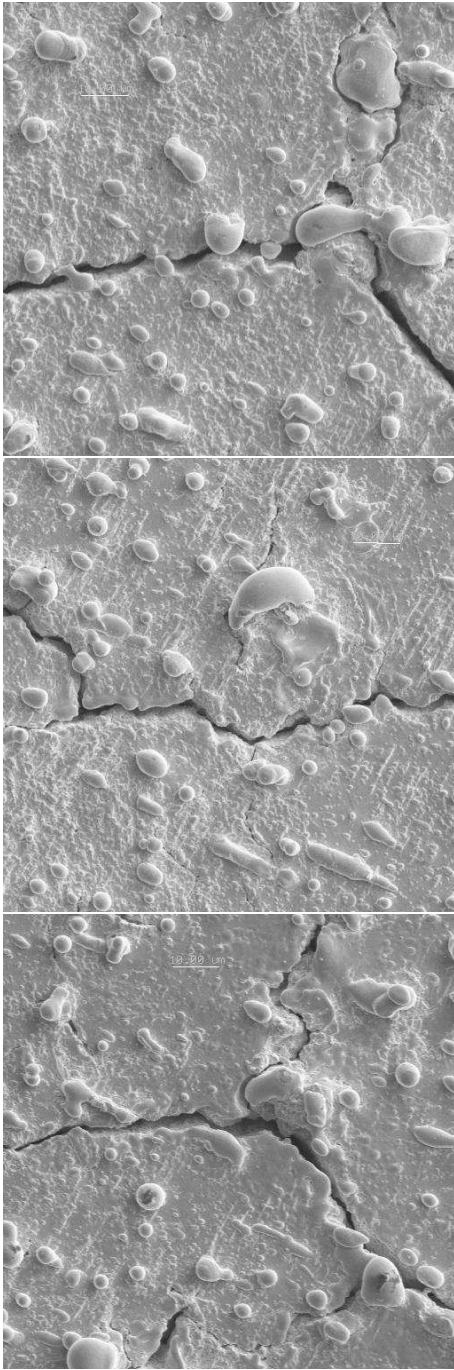
Figure 4: Regions 1–3 from Figure 2. The scale shown in each image is $10.0\ \mu\text{m}$.

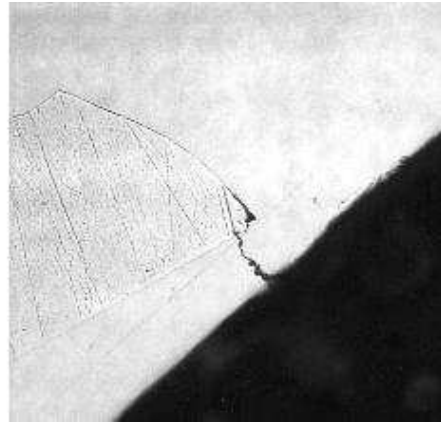
Figure 5: A cross-section of the endcap shown in Figure 1 showing an internal crack in the region of maximum temperature rise. The crack extends $24\ \mu\text{m}$ into the surface before touching the grain boundary.
