# Interpreted Investigation Report: Loss of Vikram Lander During Lunar Landing Phase

**Abstract:** This article examines India's first science lander mission on 22 July 2019, attempting a historic landing on the Lunar South Pole Region. Communication was lost at 2.1 km above the lunar surface during the rough braking phase. The cause of the Chandrayaan 2 lander "Vikram" failure remains undisclosed. Possible factors such as vibrations, thruster issues, and power depletion are considered. Recommendations include backup power sources and direct communication systems for interplanetary missions. Despite the setback, ISRO proposed "Chandrayaan 3" to explore the lunar polar region. Chandrayaan 2's legacy influences future missions, shaping India's aspirations for pioneering space endeavors. Gratitude is expressed to ISRO for insights gained during live coverage.

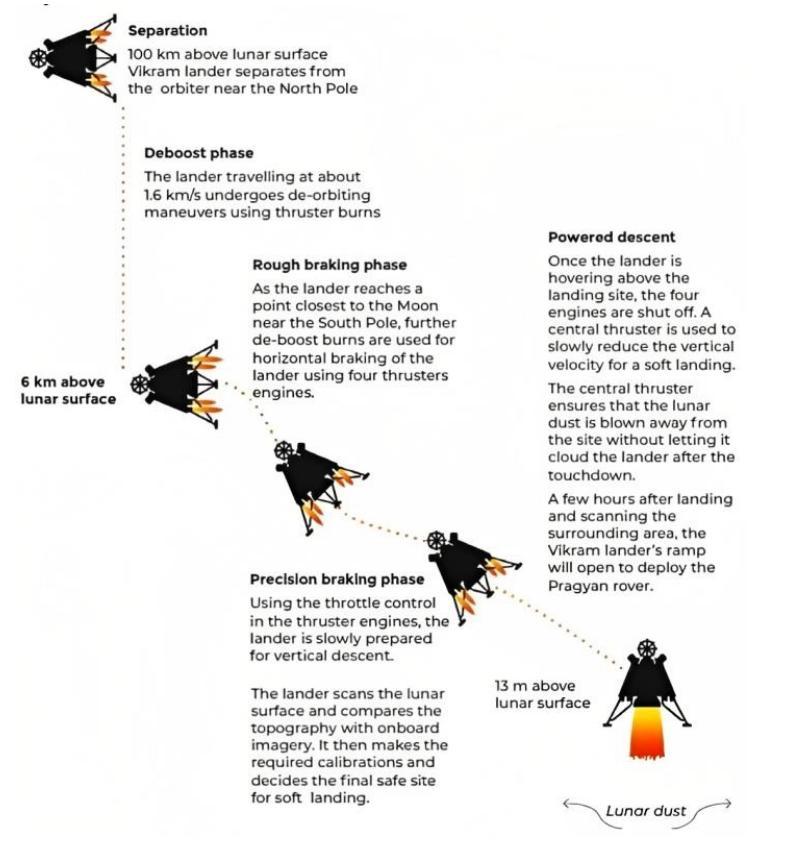
upon reaching this altitude, at 20:23 UTC (approximately 15 minutes into the landing phase), communication with the lander was unexpectedly lost. This communication failure ultimately resulted in the failure of the lunar landing attempt [2-3].

Figure 1 Vikram Lander's Landing Sequence [Courtesy: ISRO]

The detailed sequence of the Vikram lander's landing process is depicted in Figure 1. Subsequent to the landing attempt, efforts were undertaken to locate the impact site of the lander. It was Shanmuga Subramanian who first reported notable changes in lunar surface activity, ultimately aiding in the identification of the lander and its impact site by NASA. The crash site of the lander was determined to be at coordinates 70.8810°S, 22.7840°E, with an elevation of 834 meters (Source: NASA), as illustrated in Figure 3 [1].
