# Plasma treated metals after H- irradiation and its effect on vacuum breakdown behaviour

Vacuum breakdown in accelerator structures is a critical challenge that occurs under high electric fields. In environments subjected to hydrogen ion irradiation or high beam losses, such as in Radio-Frequency Quadrupoles (RFQ), residual hydrocarbons from the vacuum may result in carbon contamination of the metal surfaces from charged particle induced cracking. Under these conditions, it has been assessed that surface carbon contamination leads to a decrement of the surface electric field holding properties. This study extends the latest research by exploring the efficacy of Oxygen Plasma Cleaning (OPC) on metal electrodes irradiated by low energy hydrogen ion beam with the purpose of reducing surface carbon contamination. OPC treatment has been employed on different metals, namely copper beryllium (CuBe2), oxygen-free copper (Cu-OFE), and stainless steel (SS316LN). Treated electrodes have been tested for electric field performance in a DC pulsed system and results compared with non-irradiated electrodes and irradiated ones without OPC treatment. The study indicates a significant reduction in

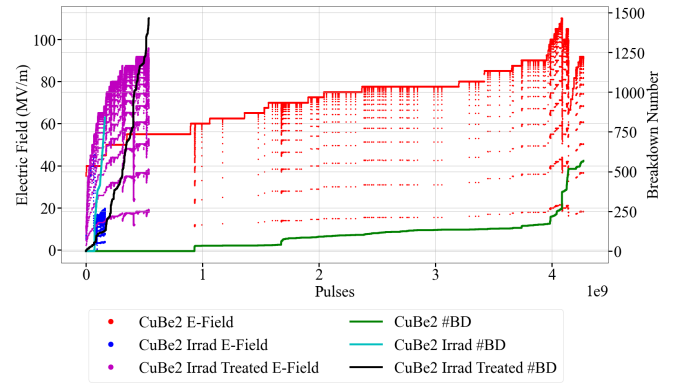
FIG. 4. Overlap of the different conditioning plots of LES tests on CuBe2 electrodes (non-irradiated, irradiated and irradiated and plasma treated).

Figure 4 represents the results from the different LES testing, made in CuBe2 electrodes. The explanation regarding the different conditioning curves can be found in subsection IIIB1. The plot shows the conditioning of CuBe2 irradiated (pre-plasma treatment) and non-irradiated electrodes from publication [12], plotted simultaneously, with the new result of the conditioning test made with the plasma treated CuBe2 in magenta. Again, it should be emphasized that this is the same pair of electrodes that was previously exposed to high voltage pulsing test after irradiation (dark blue curve). The results from the new conditioning show a dramatic difference in terms of higher electric field achieved, by being able to reach a maximum of 95 MV/m and a stable field of 92 MV/m, almost 6x more than the irradiated electrodes without plasma treatment (approximately 17 MV/m). This result stays however slightly below the electric field reached by the non-irradiated electrodes (red curve), where the maximum field was 110 MV/m.

The small difference is possibly attributed to the carbon content that was not removed in some of the regions on the cathode surface. Additionally, the roughness of the surface in both cathode and anode, due to the breakdowns from the previous test, may have contributed to a more hard process of conditioning, which could also explain the higher number of breakdown events for the irradiated and treated electrodes when compared with the total number of breakdowns from the non-irradiated electrodes test.

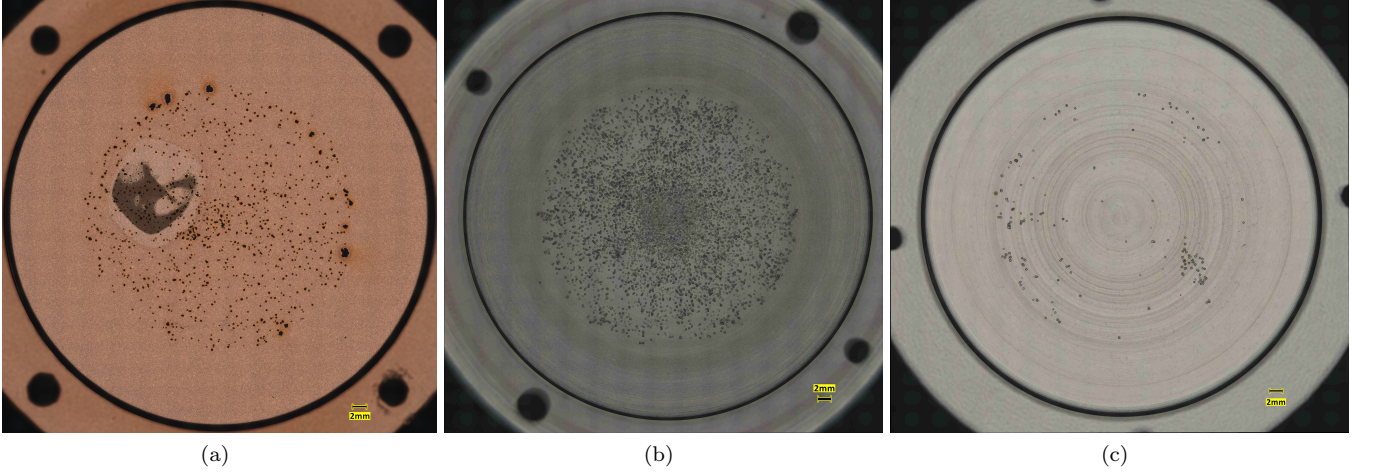
FIG. 10. Optical image of three different cathodes after LES testing: (a) irradiated and plasma treated Cu-OFE cathode surface, (b) non-irradiated SS316LN cathode surface, and (c) irradiated and plasma treated SS316LN cathode surface.

The irradiation didn't provoke sudden and agglomeration of vacuum arcs in specific locations or any decrease in performance when compared with the non-irradiated pair (results as well as surface imaging are very similar to the ones reported in [11]). The final state of breakdown dispersion is shown in Figure 10 (a): the distribution of breakdowns is quite uniform all over the surface, showing no extraordinary events on the blistered irradiated region. Some small clusters have been observed on the edges of the tested surface, however apart from the concentration of multiple breakdowns, no additional features have been found.

Figure 10 includes optical micrographs of the status after high voltage testing for both cases: (b) non-irradiated and (c) irradiated, where the notorious difference in breakdown on the surface are visible. Irradiation on SS316LN material, have produced no blistering seen in the surface. Dark coloration has been observed after irradiation, and associated with the carbon content. After plasma treatment, the irradiated spot was no longer visible on the surface, leaving no traces of irradiation. Additionally, after high voltage testing, SEM imaging showed no defects on the entire surface apart from the breakdowns. The latest, have reached large round crater diameters in the order of  $500\text{ }\mu\text{m}$ , due to the large fields experienced during the testing.

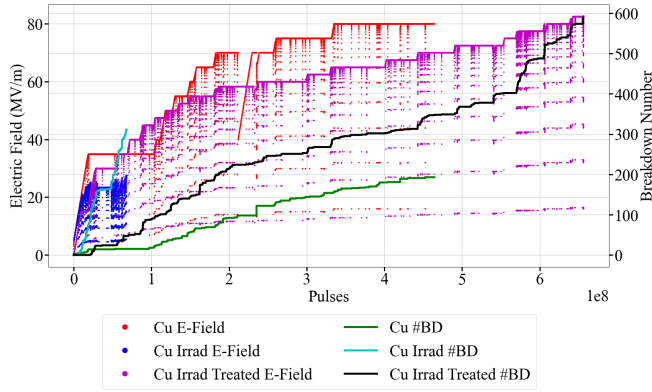
FIG. 11. Overlap of the different testing conditioning made in three different Cu-OFE electrodes (non-irradiated, irradiated and irradiated and plasma treated).

Figure 11 shows simultaneously the LES testing results for three different Cu-OFE electrodes. The conditioning of Cu-OFE irradiated and treated electrodes is shown in the red curve in Figure 11. Both Cu non-irradiated and irradiated plasma treated have reached the mark of 80 MV/m.

When tested with high pulsing voltages in the LES, irradiated electrodes (without any plasma treatment) have only stably reached 23 MV/m - dark blue curve in Figure 11. For the latter, surface analysis have shown breakdown to be positioned in the irradiated region, following

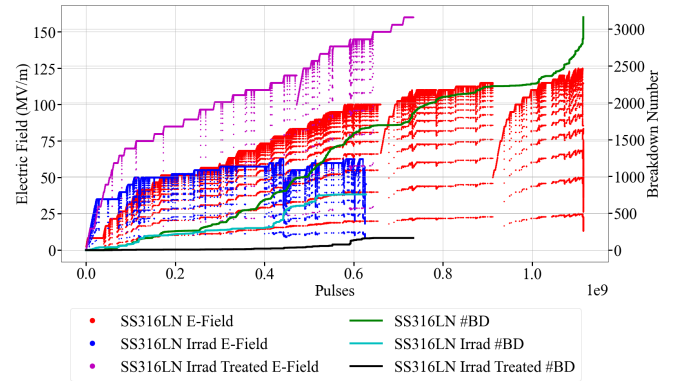
FIG. 12. Overlap of the different testing conditioning made in three different SS316LN electrodes (non-irradiated, irradiated and irradiated and plasma treated).

SS316LN non-irradiated electrodes were among the studied materials in [12], being the material that presented the best results in terms of conditioning performance. The irradiated pair, however, has shown to be able to achieve only 60 MV/m (dark blue curve). For the case of the SS316LN electrodes irradiated and plasma treated, the conditioning results, have not only reached the maximum electric field mark of the non-irradiated electrodes (120 MV/m - red curve), but have surpassed it, by reaching a maximum and constant field of 160 MV/m (magenta curve). The irradiated and treated electrodes have registered until the end of testing less than 200 breakdowns (black curve). It is the first time in breakdown testing that, for this level of electric fields, such a small number of total breakdowns is registered. For comparison, the non-irradiated electrodes have registered more than 3000 breakdown events.

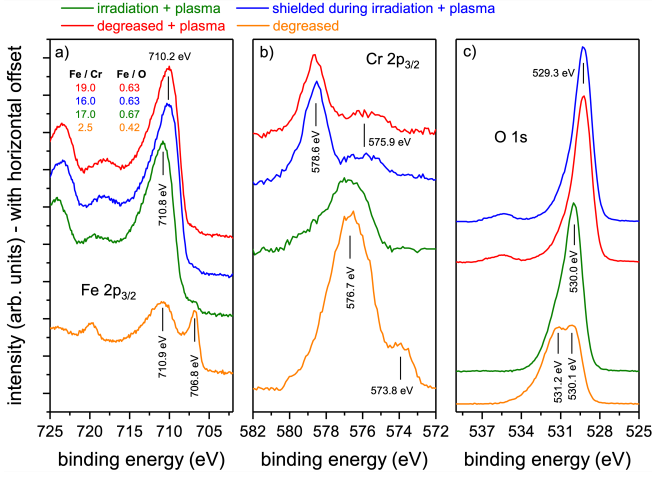
FIG. 14. X-ray photoelectron spectra of SS316LN after different surface preparation procedures as indicated in the legend – (a) Fe  $2p_{3/2}$ , (b) Cr  $2p_{3/2}$ , and (c) O  $1s$  state, respectively. The inset in a) shows the elemental ratios of Fe/Cr and Fe/O.

Figure 14 includes the main core level spectra of the most relevant elements on the surfaces: iron ( $\text{Fe } 2p_{3/2}$ ), chromium ( $\text{Cr } 2p_{3/2}$ ) and oxygen ( $\text{O } 1s$ ) from the XPS characterization of the three samples. The green and blue spectra represent different measurements on the irradiated sample after plasma cleaning, in the irradiated and non-irradiated region, respectively. The red data represents the degreased and oxygen plasma treated sample *ii*), and the orange spectra are representative for the sample that was only degreased (without irradiation nor additional treatments). We have calculated the elemental composition assuming a homogeneous distribution of all elements by fitting all spectra using CasaXPS version 2.3.24 [41] with the algorithms implemented therein considering the electron analyzer transmission function. For all spectra, a Shirley-type background correction was performed, and the elemental sensitivity factors that are based on the cross-sections reported by Scofield [42] and taking into account an inelastic mean free path (IMFP) of the emitted electrons, which depends on their kinetic energy: IMFP proportional to  $E_{kin}^{0.7414}$  [43], are considered.

When analyzing the spectral signatures of the samples, it is clearly visible that the surface is stronger oxidized after the plasma treatment. The  $\text{Fe } 2p_{3/2}$  state at 706.8 eV, which is clearly present on the degreased surface and is linked to metallic  $\text{Fe}^0$  species at the surface [44], is almost absent for all other samples. Instead, the main contribution is from iron oxide (with an intensity maximum at 710.2-710.9 eV). The spectral shape

resembles the spectrum of  $\text{Fe}_2\text{O}_3$  in Ref. [45]. One has to mention that the binding energy values of the core levels for the irradiated samples after plasma cleaning are 0.6–0.7 eV higher than those of both surfaces that were only plasma-treated without prior irradiation. This indicates a difference in work function at the surface, which leads to a global shift of the BE of the core levels. Indeed, when measuring the work function of a degreased sample prior and after plasma oxidation, we found an increment of 0.7 eV. This has to be kept in mind when comparing relative differences in the core level binding energies for the samples. The degreased samples exhibit the presence of hydroxide and hydrocarbon surface adsorbates with a state in the O  $1s$  spectrum at 531.2 eV in addition to the metal-oxide peak at 530.1 eV. The Cr  $2p_{3/2}$  state of the degreased samples exhibits a minor metallic component ( $\text{Cr}^0$ ) around 574 eV [46], while the main chromium content is in the form of  $\text{Cr}_2\text{O}_3$  ( $\text{Cr}^{+3}$ ) with a representative peak at 576.7 eV [44, 47]. For the irradiated sample, the carbon layer and other adsorbates were efficiently removed by the plasma treatment and the surface is composed of  $\text{Fe}_2\text{O}_3$  and  $\text{Cr}_2\text{O}_3$ . However, the plasma process even further oxidized the non-irradiated steel surface. While the Fe  $2p$  spectra are comparable, the dominating state at 578.6 eV in the Cr  $2p_{3/2}$  spectrum, additional to the shifted  $\text{Cr}^{+3}$  feature of low intensity at 575.9 eV, indicates the formation of  $\text{CrO}_3$  ( $\text{Cr}^{+6}$ ) at the surface [48, 49].
