Performance evaluation of electron multiplier tubes as a high-intensity muon beam monitor

May 2024

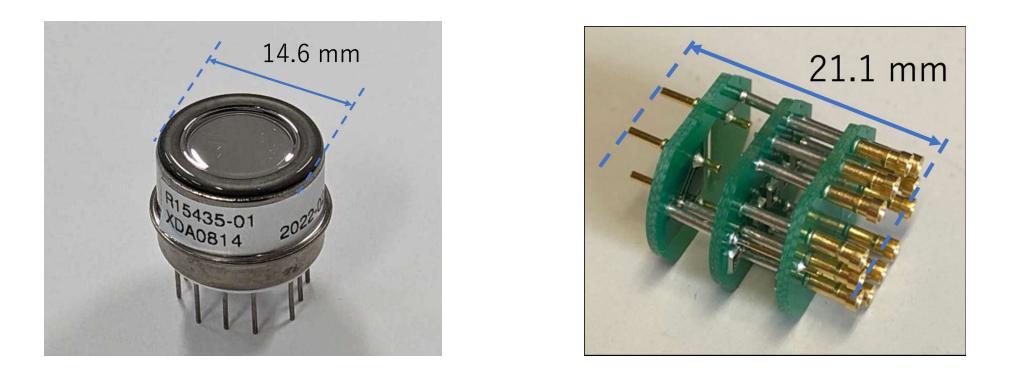
Fig. 1 Photograph of an EMT (left) and a bleeder circuit (right).

Photomultipliers (PMTs) have a superior radiation tolerance and signal response speed compared to semiconductor detectors. So, they may be more suitable for use in MUMON where radiation level is high and the beam needs to be measured bunch-by-bunch (~50 ns width and ~500 ns interval). PMTs were then tested as a candidate sensor, but their radiation tolerance were not satisfactory for the use in MUMON. As the cause seemed to be the cathode, cathode was replaced by aluminium to improve the radiation tolerance. This replacement is not a problem for the use in MUMON as it measures charged particles. Hamamatsu[®] PMT (R9880U-110) are modified with their photocathode deposited with aluminum to produce EMTs. EMTs used for the beam test described in this paper are identified as Hamamatsu[®] R15435-01. The original bleeder circuit used for PMTs has an insulating cover made of polybutylene terephthalate (PBT) or polyacetate (POM), but we decided to use it without the cover as shown in Figure 1 to avoid potential deterioration due to radiation.

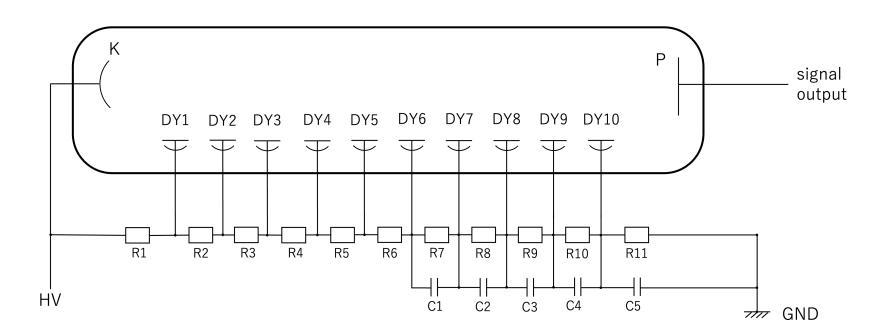
Fig. 2 Structure of the bleeder circuit. "K", "P", "HV", "DY", "R", "C" and "GND" represent the cathode, anode, high voltage, dynode, resistance, capacitor and ground, respectively.

The EMT signal is produced by secondary electrons which are avalanche-amplified in dynodes initiated by charged particles passing through the cathode or dynode. The shape of the EMT dynode is a metal channel type with 10 stages. The bleeder circuit (Hamamatsu[®] E10679-Y001) connected to the EMT consists of 11 resistors $R_1 - R_{11}$ and 5 capacitors $C_1 - C_5$, as shown in Figure 2. Each resistance and capacitance values are listed in Table 1.

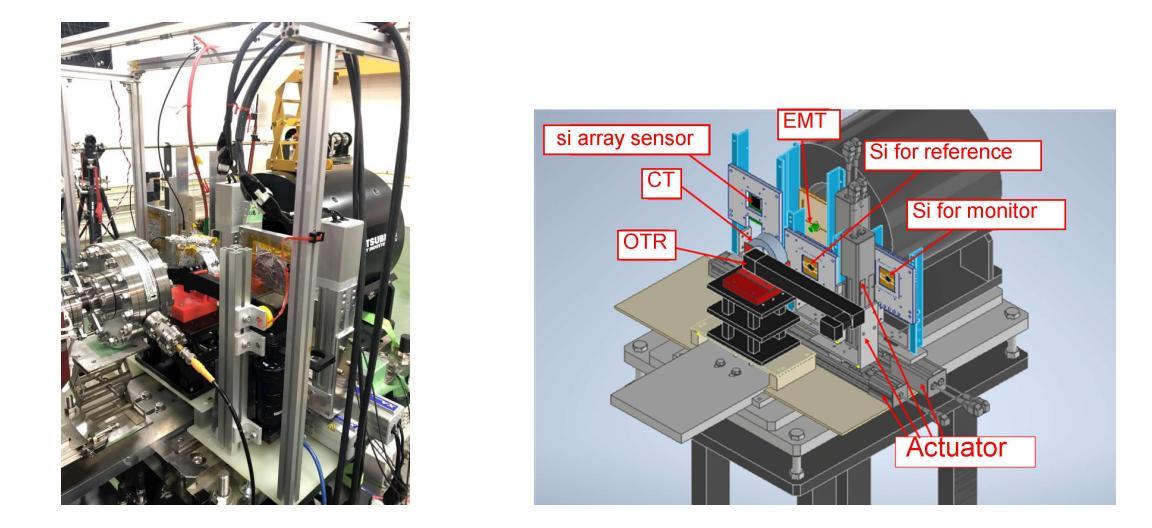
Fig. 3 A photograph (left) and 3D CAD model (right) of the experimental setup from the fourth beam test.

channel silicon pin photodiode array (Si-array) during low-intensity irradiation as shown in Table 3. To avoid beam irradiation, Si sensors and Si-array shown in Figure 3 were moved to position away from the beam line using a movable stage during irradiation with high-intensity beams. The Si located upstream of the movable stage is called ref-Si, and the measured electron beam charge is used as reference to normalize the EMT signal and evaluate the degradation. As shown in Figure 4, OTR, CT, ref-Si, and EMT were installed at positions where the electron beam passed. In addition, a heater and thermometer were installed to measure the temperature dependence of EMTs in the fourth beam test. The CT, EMT, and Si signals were acquired with an 8-channel 250-MHz sampling 14-bit 2-Vpp FADC (CAEN DT5725). The

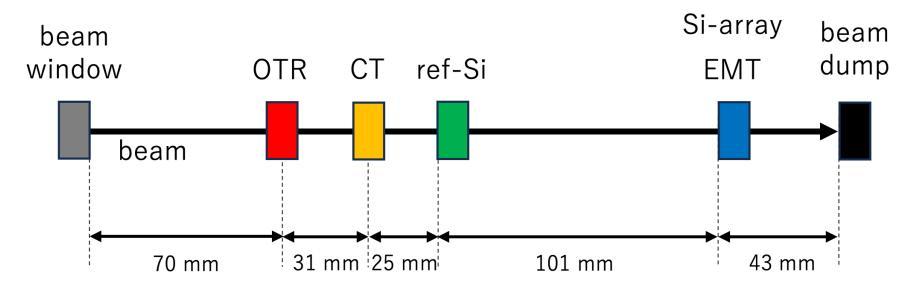
Fig. 4 Schematic diagram of the alignment of each detector along the beam axis.

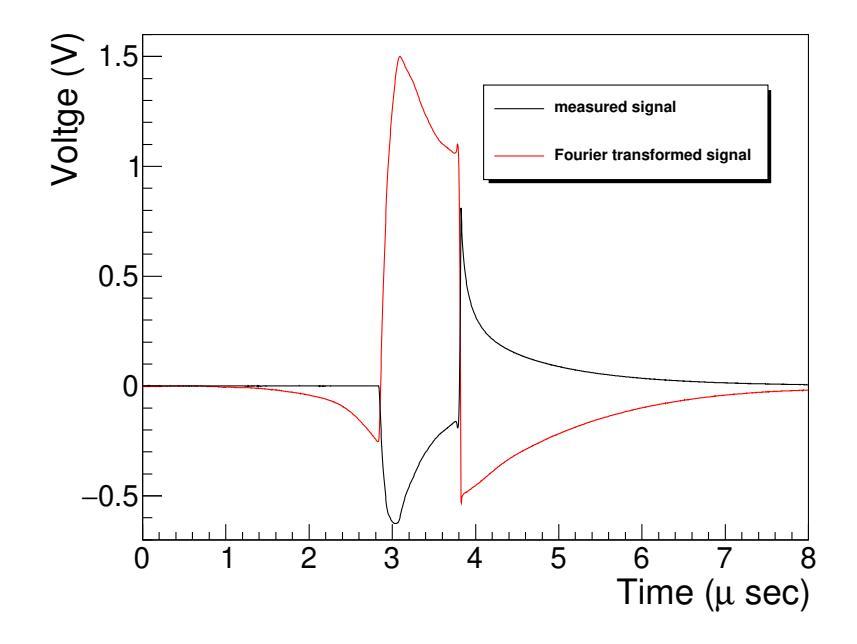
Fig. 5 Measured and Fourier transformed CT waveform at a high-intensity beam. Charge in this pulse is 32.97 nC.

CT can measure the amount of charged particles that have passed by measuring the current that flows to cancel out the magnetic field created by the passing of charged particles. For the CT used in the beam test described here, the inner and outer diameter are 79 mm and 51 mm, respectively, and its width is 25 mm. The material is FINEMET (manufactured by Hitachi Metals, Ltd.) with the magnetic permeability of 18500 H/m, and the number of turns of the coil is 1. The input waveform was derived by Fourier transformation from the CT signal, and the amount of charge passed was determined from the area of that waveform. The waveform measured by CT and the waveform after Fourier transformation are shown in Figure 5. As can be seen, the baseline distortion remained in the waveform after the Fourier transformation, and the reproduction of the input waveform was not perfect. While, since the pulse height and time width are determined by the differentiation of the input waveform, the influence of the distortion of the baseline is considered to be small. So, by using the height H and width W of the reproduced waveform and the impedance of the measuring instrument $R = 50 \ \Omega$, the amount of charge Q was calculated by $Q = H \times W \times \frac{1}{R}$. The systematic uncertainty of this method is described in Section 3.4.

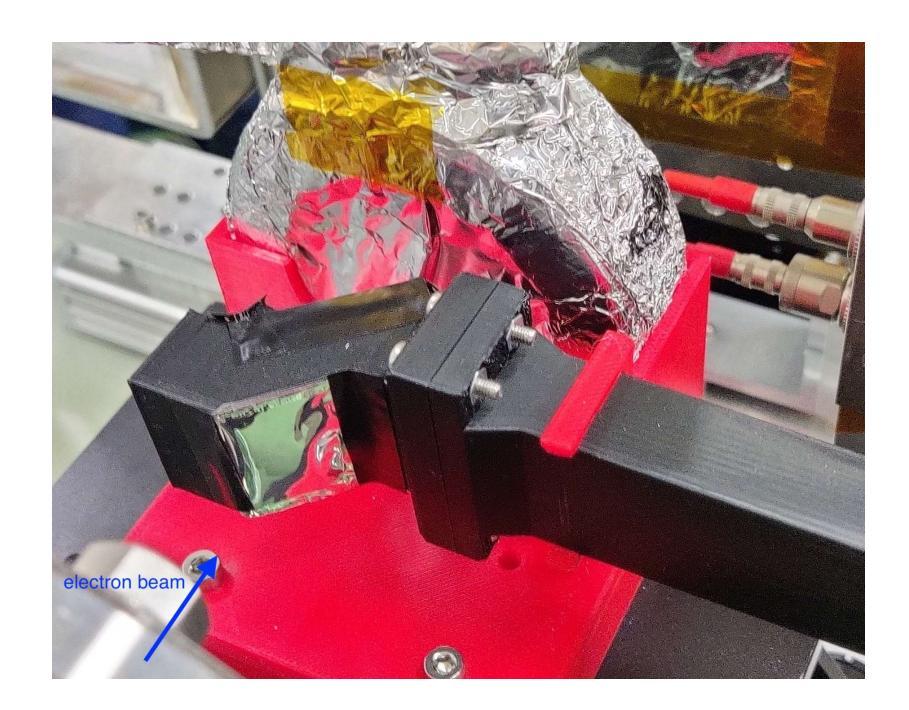
Fig. 6 Photograph of OTR foil. Aluminium foil is attached to a 1 cm square window.

The OTR monitor is a detector that measures the position and shape of the beam by using a camera to take a picture of the transitional radiation generated when relativistic charged particles pass through interfaces with different dielectric constants. When the accelerator changes the beam intensity greatly, a slit was inserted to cut the beam. Therefore, there was a possibility that the beam profile was different between high and low intensities, and it was necessary to measure the beam profile at a high intensity. OTR monitors were introduced from the third beam test. Aluminum foil was settled at 45 degrees to the beam (Figure 6), and images were taken with a CMOS camera (model number CS165MU, lens: FL-BC7528-9M) positioned 30 cm away.

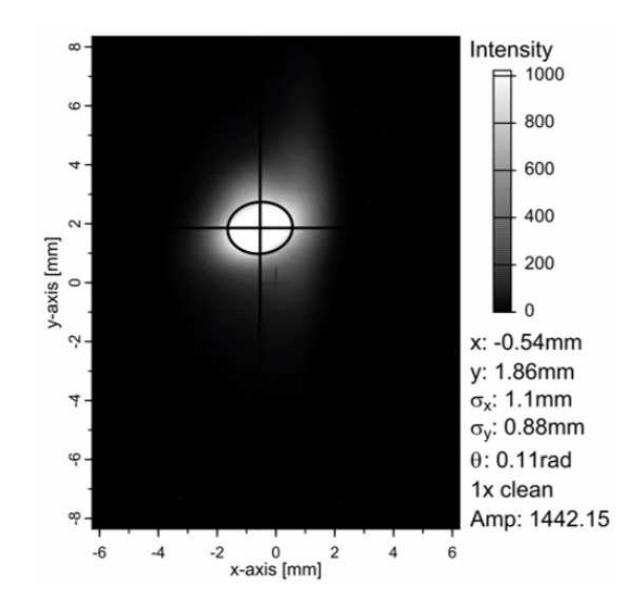
Fig. 7 High-intensity electron beam profile for one bunch taken with OTR.

Figure 7 shows the beam profile during high-intensity beam irradiation taken by OTR. From the measured position and spread of the beam, the fraction at which the charged particles hit the EMT's sensitive area, or irradiation efficiency, is calculated. The irradiation efficiency means the ratio of electrons that hit the EMT out of the electrons in the beam.

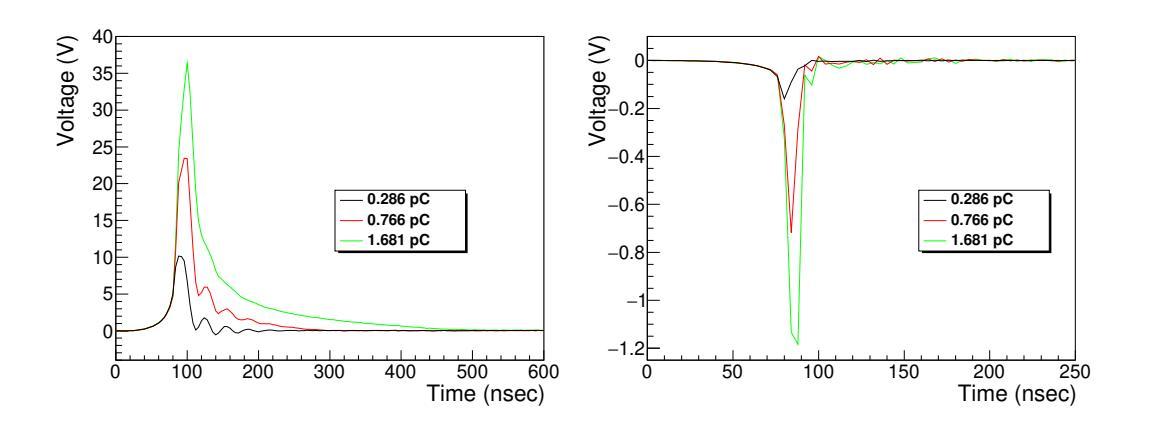
Fig. 8 The measured waveforms with a low-intensity beam from a ref-Si (left) and EMT (right).

The ref-Si was used to measure the low-intensity beam. During the test, an attenuator of 1/79.4 was applied. The applied voltage for Si was 80 V. Low-pass filters were used to ensure stable voltage supply for Si sensors. When measuring the EMT yield with a low-intensity beam, we acquired the ref-Si signal at the same time as the EMT signal, and by taking the ratio, we were able to accurately measure the EMT yield regardless of shot-to-shot variations in the electron beam. The applied voltage of the bleeder circuit of EMT was -450 V for the signal check. Typical ref-Si and EMT waveforms during low-intensity beam irradiation are shown in Figure 8.

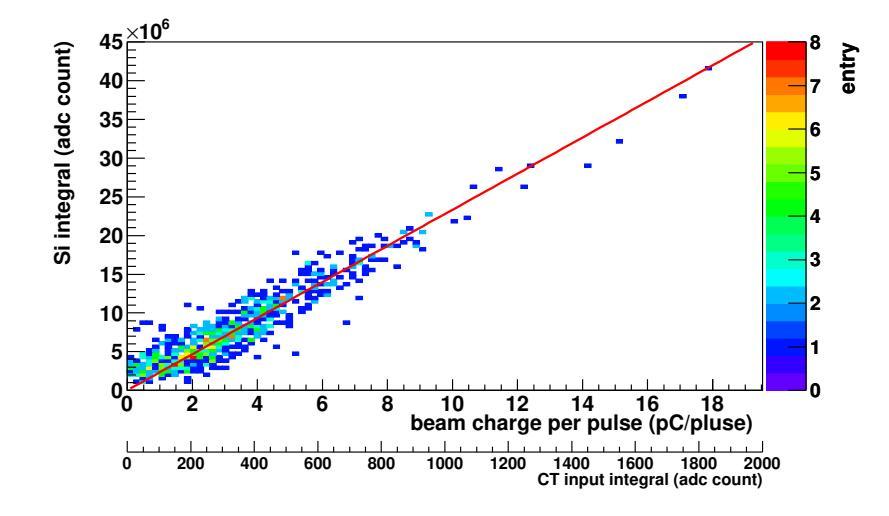
Fig. 9 Relation of integrated signals between ref-Si and CT with a low-intensity beam with a linear fit. The slope is 2.3×10^9 ADC counts/nC/pulse.

The ref-Si was calibrated by simultaneously irradiating the ref-Si and CT with a beam that is several times more intense than the low-intensity beam but still lower than high-intensity beam and taking the ratio of their respective signals as shown in Figure 9. The reason for increasing the beam intensity during the calibration was that the low-intensity beam is too small to detect by CT. According to the calibration result, the integral value of the ref-Si signal can be converted to the amount of charge.

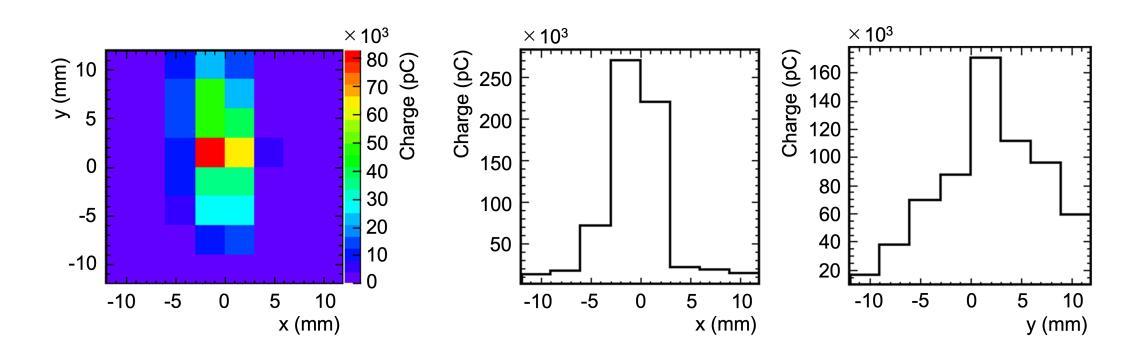
Fig. 10 Typical low-intensity beam profile measured by the Si-array in the fourth beam test. The mean in the x-direction is -0.44 mm and the mean in the y-direction is 1.85 mm. The sigma in the x-direction is 3.51 mm and the sigma in the y-direction is 5.26 mm.

For the Si-array signal, we calculated the amount of charge for each channel and created a two-dimensional profile as shown in Figure 10. By fitting this with a two-dimensional Gaussian, the size and position of the beam were determined. The fluctuation in the position of the low-intensity beam was approximately 1 mm in the horizontal direction and 4 mm in the vertical direction, and a typical beam width is \sim 1–6 mm which was smaller than the EMT cathode area.

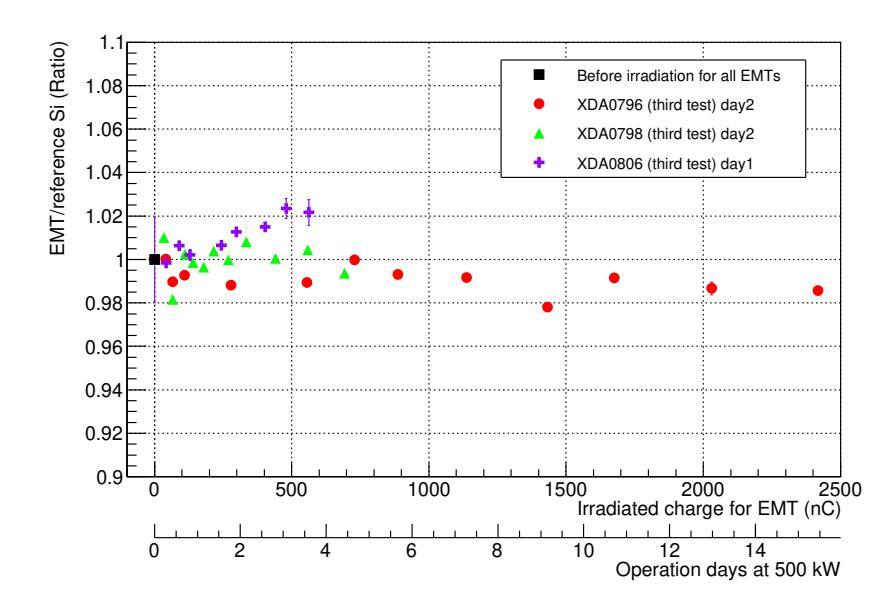
Fig. 12 Measurement result of the variation in EMT signal yield depending on the radiation dose with medium-intensity beam. The ref-Si was not irradiated with a medium-intensity beam. The legend notes the serial number of each EMT identification and the date of the test.

stability measurement results are shown in Figure 12. In this measurement, the variation in signal yield during medium-intensity irradiation was within 2%. One possibility to explain this fluctuation seen in the MUMON site is due to the temperature dependence of EMTs because the temperature of the installed position was not controlled and there was cooling water nearby. The relationship between EMT signals and temperature will be discussed in detail in Section 5.1.

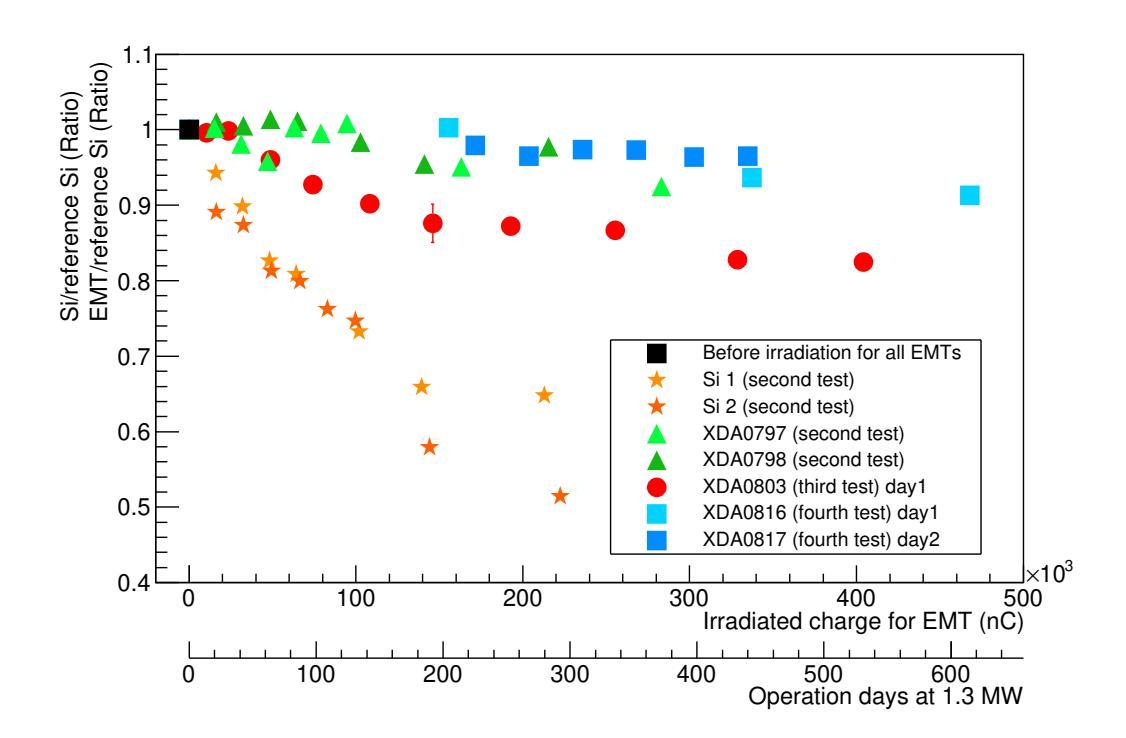
Fig. 13 The results of EMT and Si radiation tolerance measurement. The horizontal axis shows the amount of charge of the electron beam irradiated to the sensor and the value converted into the number of days of T2K operation. The vertical axis is the relative signal amount when the yield before radiation irradiation is set to 1. The ref-Si was not irradiated with a high-intensity beam. Different colors are used to indicate different beam test dates and different tested sensors.

In order to confirm whether the EMT can be used for a long period, we irradiated EMTs with a high-intensity electron beam equivalent to several years of the T2K operation, and measured the relative signal yield of EMTs. In the first beam test, the beam was stopped for a few minutes each time the intensity was switched and settings were changed within the controlled area, which is thought to have caused a large degree of uncertainty in the beam intensity due to changes in the vacuum state of the accelerator. Therefore, in the second irradiation test, we made it possible to control some devices remotely, and from the third and fourth irradiation test, all settings were made remotely. Figure 13 shows the measurement results. For comparison, we also measured the signal yield of Si, the present MUMON sensor, and plotted the result. The radiation tolerance of EMT is overwhelmingly better than that of Si, and even after 600 days of operation at a future intensity of 1.3 MW, the signal decrease is less than 18%.

is unchanged, it was found that the T2K requirement for muon monitor is satisfied if the decrease is within 3%. If Si is operated for 132 days at future beam power, the signal will decrease by 25%, and in addition, the leakage current will increase, making it impossible to apply high voltage. On the other hand, signal decrease of EMT is expected to be less than 10% even after 132 days. Some EMTs hardly degraded after 132 days. If the maximum degradation occurs as a conservative scenario calibration should be carried out every 50 days of operation. While as the degradation is slowing down after certain amount of irradiation, we consider the calibration will be necessary every 132 days in practice, and it can be used for several years without replacement.

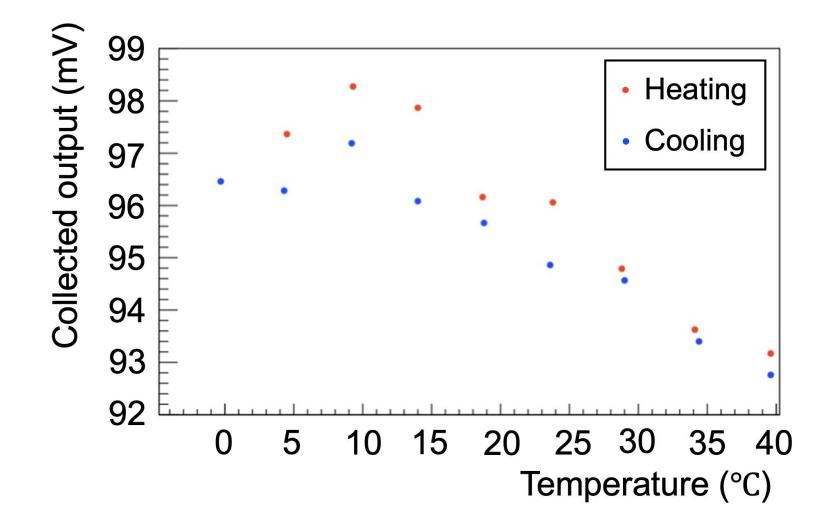
Fig. 14 Measured temperature dependence of the EMT signal yield. Red points are data when the temperature is rising, and the blue points are data when the temperature is falling. EMT signal is corrected by the temperature dependence of the LED emission.

Although the EMT cathode is made of vapor-deposited aluminum, it is sensitive to photon to some extent, so we evaluated using an LED at first. The EMT was placed in a constant temperature bath and the EMT yield was measured at different temperatures. At this time, since the amount of photons emitted by the LED also changes depending on the temperature, we corrected it based on the standard specification "NSPW500GS-K1" of Nichia Chemical Industries, Ltd. as a typical temperature characteristic. At the same time, we also measured Si, which is supposed to have no temperature dependence of the signal to confirm that the temperature characteristics of the LED could be canceled out through correction. Figure 14 shows the measurement results. The the temperature change coefficient of the EMT yield was 0.16-0.18%/°C, which was insufficient to explain the signal fluctuations at around the MUMON site.

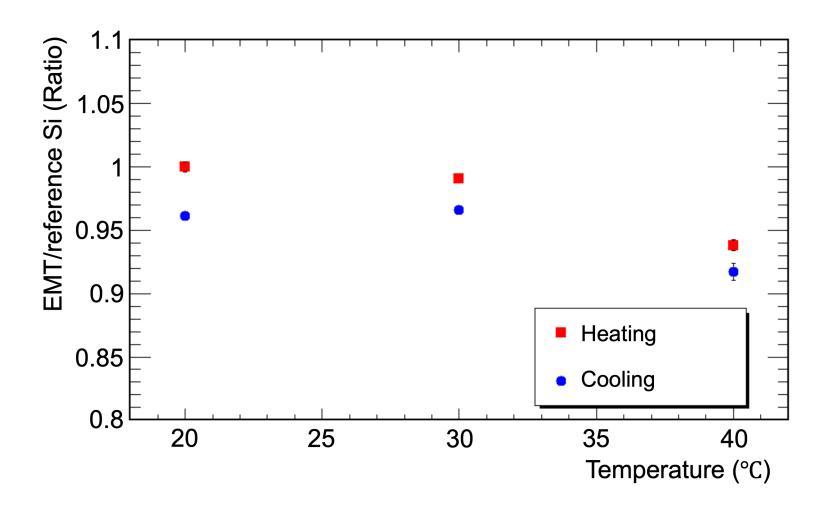
Fig. 15 Temperature dependence of the EMT signal yield measured at fourth ELPH test. The measurement started at 20°C, increased to 40°C (red points), and then decreased to 20°C (blue points). The vertical axis is the ratio to the yield at the first 20°C.

In the fourth irradiation test, we measured the temperature dependence of the EMT signal. The temperature was varied by applying hot air to the EMT using a heater and fan, and a platinum resistance thermometer was used to measure the temperature at the EMT location. Figure 15 shows the measured temperature dependence, and the temperature change coefficient in the range of 30°C or higher was 0.6%/°C. This is larger than that measured using LEDs.

drop. Converting yield instability 2–3% to temperature by using the coefficient of $0.6\%/^{\circ}$ C, the variation of approximately 4°C can explain the instability. The temperature inside the temperature-controlled enclosure, which is the actual environment of MUMON sensor location, is controlled so that the temperature change is less than $\pm 0.7^{\circ}$ C [10]. Therefore, the temperature dependence of EMT is not a problem even if it exists.

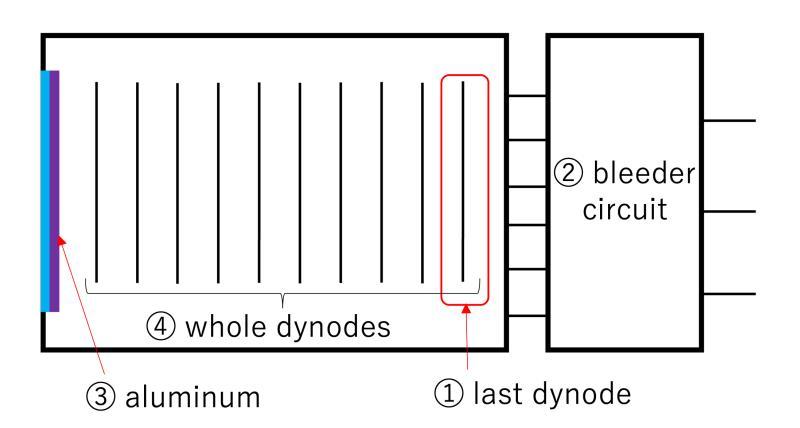
Fig. 16 Schematic diagram of an EMT. Numbers are assigned to each location where the effects of radiation damage are discussed.

The radiation tolerance of EMTs is found to be much better than that of Si, but a signal drop of about 15% in maximum case was observed when it is irradiated with 500×10^3 nC. In this section, we investigate the potential causes of signal degradation by dividing them into the following four areas (Figure 16).

- (1) Deterioration of the last dynode
- (2) Deterioration of the bleeder circuit

- (3) Deterioration of the aluminum cathode
- (4) Deterioration of the dynodes

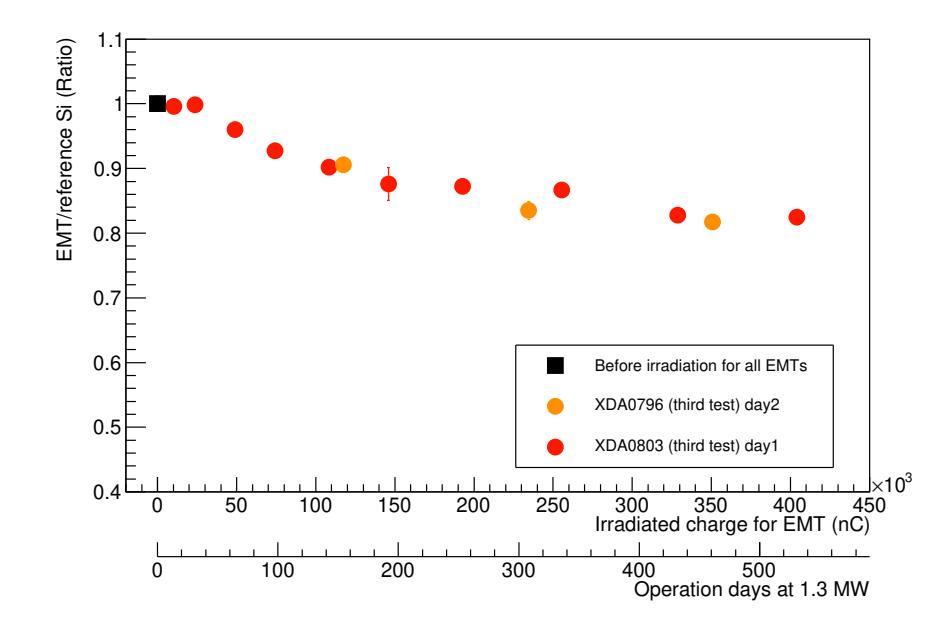
Fig. 17 EMT yield as a function of radiation dose with and without high voltage applied measured in third irradiation test. The axes are same to the Figure 13. The legend notes the serial number of each EMT, identification and date of the test.

First, we focused on deterioration of the last dynode. Measuring a large amount of charge by EMTs means that a large amount of secondary electrons collide with the final stage of the dynode. In order to verify the hypothesis that the signal is reduced due to dynode deterioration, we irradiated with a high-intensity beam and measured the change in yield with and without high voltage application. Figure 17 shows the results measured in the third beam test. Even when high voltage was not applied to EMT during a high-intensity beam, the similar degradation was observed. This result indicates that deterioration in the downstream stage of the dynode was not the main cause of radiation damage.
