Operational Experience, Improvements, and Performance of the CDF Run II Silicon Vertex Detector

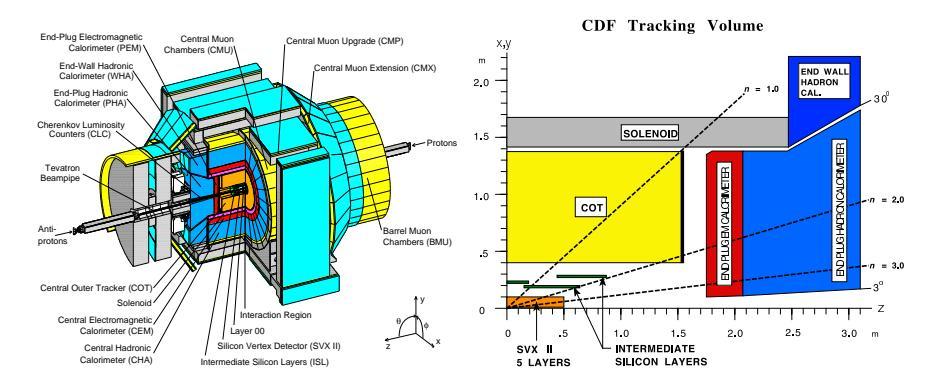
Figure 1: Isometric view of the entire CDF II detector (left), and schematic layout of the CDF II tracking system (right).

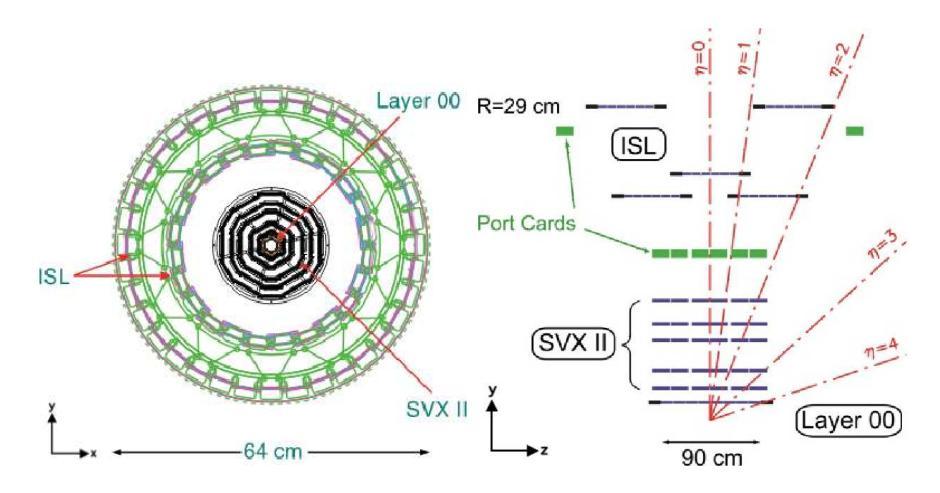
Figure 2: Schematic layout of the CDF silicon detectors showing x-y ($r-\phi$, left) and y-z (r-z, right) views. Note that the z axis is compressed for illustration purposes.

The CDF silicon detector system consisted of three sub-detectors, all with 64 barrel geometry: Layer 00 (L00) [8, 13], the Silicon Vertex detector (SVX-65 II) [14, 15] and the Intermediate Silicon Layers (ISL) [16]. Unless otherwise 66 stated, detector refers to the CDF silicon detector. The design of the system was 67 driven by the goal of providing excellent spatial resolution in the measurement of 68 charged-particle tracks. These measurements were crucial for the reconstruction 69 of the displaced secondary vertices and therefore, identification of events with 70 bottom-quarks. Figures 2 and 3 present the schematic layout of the CDF silicon 71 detector, and Table 1 summarizes some of the basic parameters. The design 72 had eight silicon layers to provide tracking which is robust against failure or 73 degradation of individual components. 74

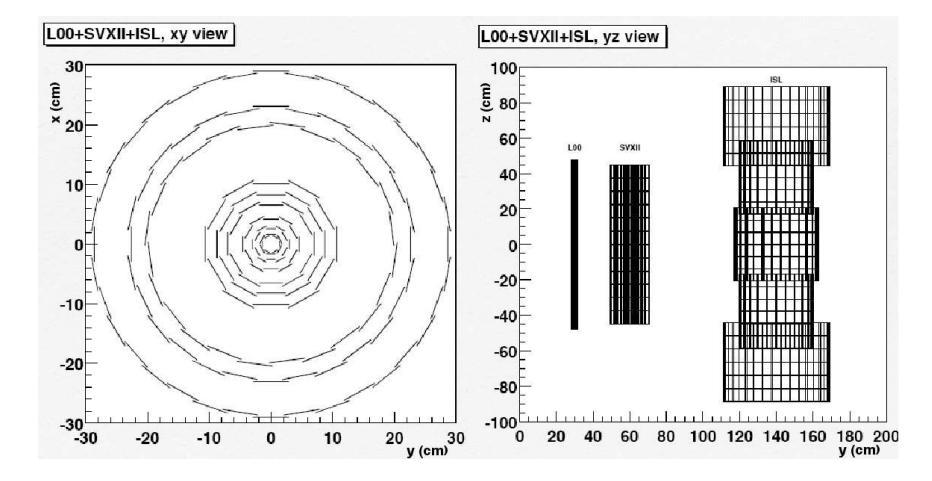
Figure 3: Dimensions, in cm, of the CDF silicon detector system. Shown are x-y and y-z views. In the y-z view, each square corresponds to one sensor and each subdetector has been displaced along the y-axis for illustration purposes.

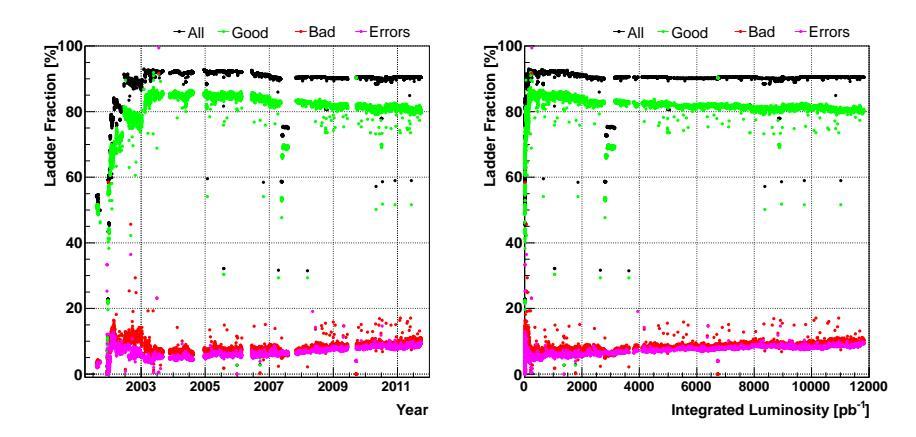
Figure 4: Fraction of ladders which were powered (black), considered good (green) and bad (red) versus time (left) and versus integrated luminosity (right). A ladder is considered good if it has less than 1% digital errors. Also shown is the average digital error rate (pink). The actual fraction of good ladders is larger as it does not included ladders whose digital errors are corrected by the offline reconstruction software.

¹²⁹ ity (right) of the fraction of detector ladders included in data taking since start of commissioning in 2001. Aside from variation during the start-up period,

stable detector operation is observed over the long term data taking period.
The rate of corruption in data transmission out of the detector (referred to as
"digital errors") rises with time. Some of this corruption was recovered with offline processing by using knowledge of the data structure to identify and correct
erroneous bits.

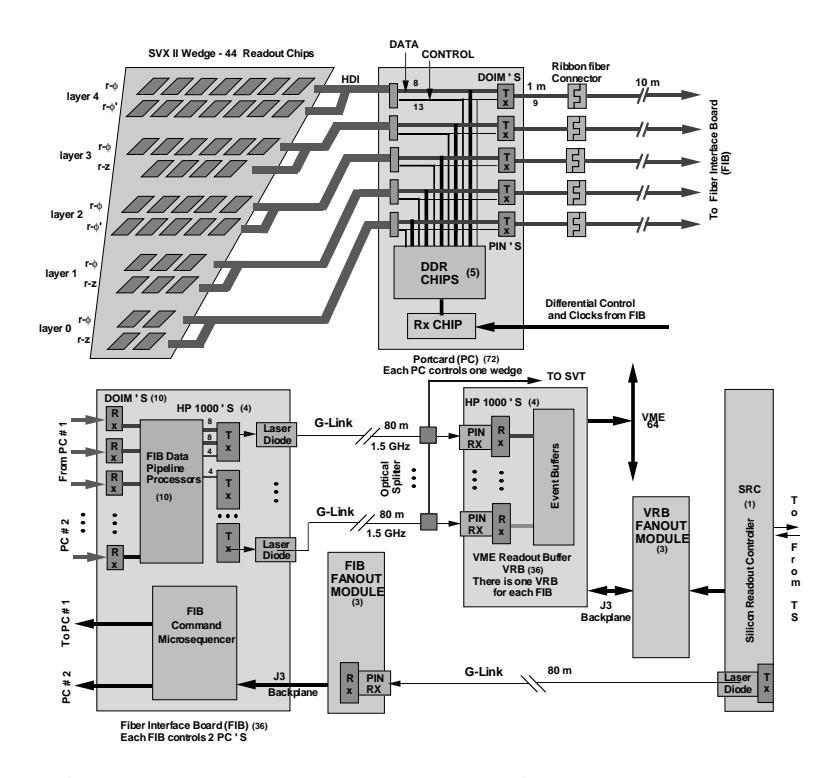
Figure 5: A schematic diagram of the silicon detector DAQ system. The SVX-II wedge and portcard, at the top half of the figure, were known together as the on-detector electronics as they were located directly on the silicon detector. The components, in the lower half of the figure, were known as the off-detector electronics. The FIB and FIB fanout were located in the CDF collision hall. The VRB, VRB fanout and SRC were in the CDF counting room which was located above the CDF collision hall. ISL and L00 DAQ were identical except the SVX-II wedge was substituted with a ISL and L00 wedge, respectively.

system, broadcasted commands to the individual ladders, and controlled data 218 flow through feedback signals from the VME readout buffers. The digitized data 219 from each ladder was transferred in parallel to the allocated readout buffer. The 220 data were buffered until a L2 decision arrived and was either transmitted to L3 221 or discarded. The Silicon DAQ was synchronized to the CDF clock. The elec-222 tronics were divided into an on-detector part, mounted directly on the silicon 223 detector, and an off-detector part, located in VME racks in the CDF collision 224 hall and in the CDF counting room (Fig. 5). 225

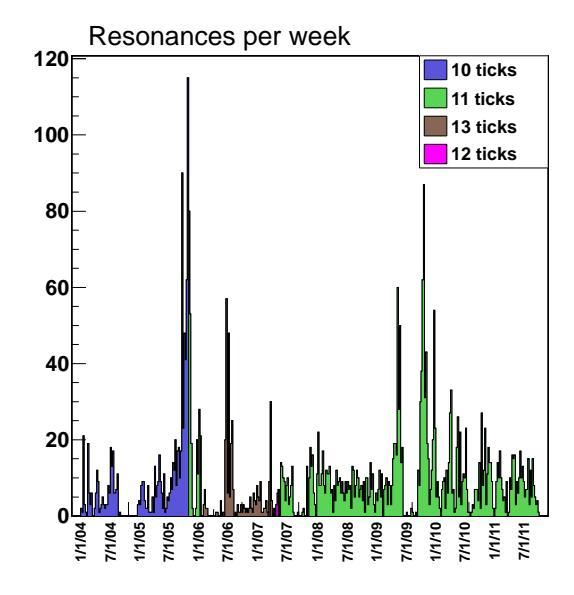
Figure 6: A historical account of the number of resonance per week detected by the Ghostbuster. The maximum number of ticks, which triggered the Ghostbuster resonance detection, varied from 10 to 13 ticks during Run II, and eventually settled at 11. The spikes in the resonance rate are mostly due to faulty trigger hardware. The typical resonance rate was 10 per week (1.4 per day).

Figure 6 shows the the number of resonances per week detected by the Ghostbuster during all of Tevatron Run II. The spikes in the number of resonances per week were mostly caused by faulty trigger hardware or long readout times for ladders. The typical rate, neglecting those originating from faulty trigger hardware, was about 10 resonance errors per week (1.4 per day) consistent with stochastic operation.

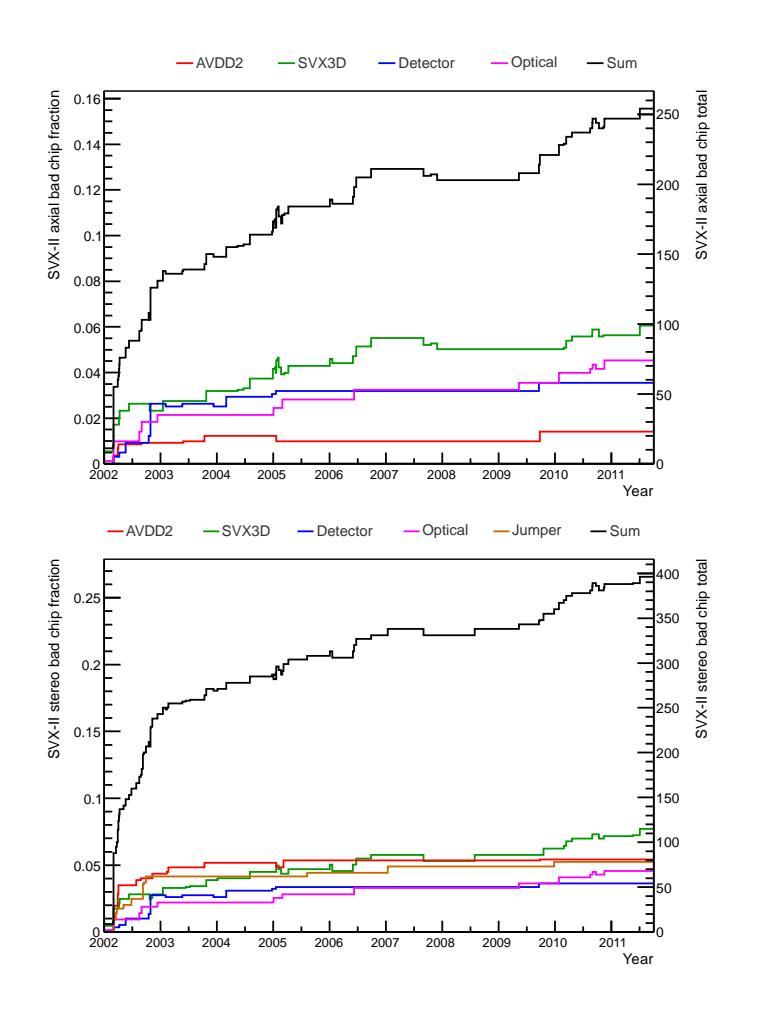
Figure 7: A historical account of the different errors and faults accrued by the SVX-II r- ϕ (top) and r-z (bottom) SVX3D chips during Tevatron Run II. Each error category is defined in Section 3.9. At the end of Tevatron Run II, 84% r- ϕ and 73% r-z SVX chips were still operating without error.

During the commissioning phase, the number of bad chips (ladder) grew as 729 the different problem manifested, then stabilized in 2003 (steady state running). 730 The r-z plots in Fig. 7 shows that there were only 4 additional jumper failures 731 after the inclusion of the Ghostbuster and none of these was an immediate 732 consequence of beam incidents or resonant conditions. After the inclusion of the 733 Ghostbuster, data was taken safely and reliably with peak L1 trigger rates in 734 excess of 25 kHz - essential for CDF physics. The failure rate of chips after 2003 735 is far lower compared to the commissioning period. Most of the different failure 736 categories stabilized. From 2009, the chronic effects of radiation damage and 737 aging were starting to take their toll on the silicon detector. The failures from 738 SVX3D and optical were steadily increasing and half the total radiation dose 739 was delivered between 2009-2011. With the increased radiation, components 740 started failing more often, shrinking the pool of spare components. These plots 741 742 also highlight other problems of the silicon detector that affected the DAQ. Figure 8 shows a large rise and fall in the fraction of bad ISL chips during 743 2003 due to blocked cooling line and its eventual clearance; this is discussed in 744 further detail in section 5. 745

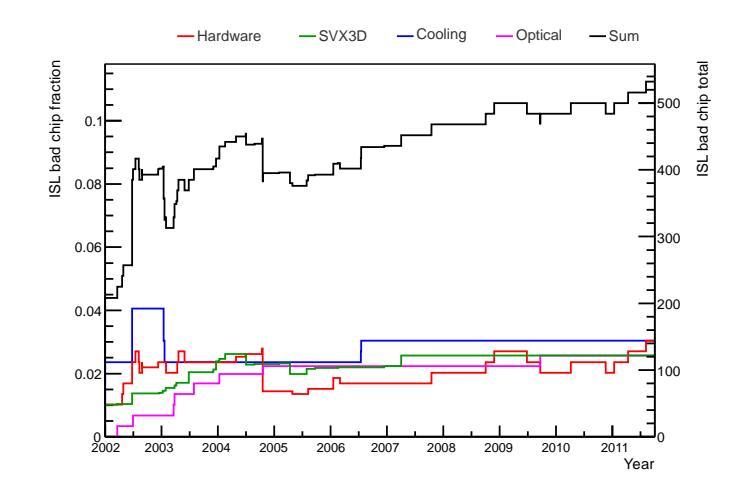
Figure 8: A historical account of the different errors and faults accrued by the ISL SVX3D chips during Tevatron Run II. Each error category is defined in Section 3.9. At the end of Tevatron Run II, 89% of ISL SVX3D chips were still operating without error.

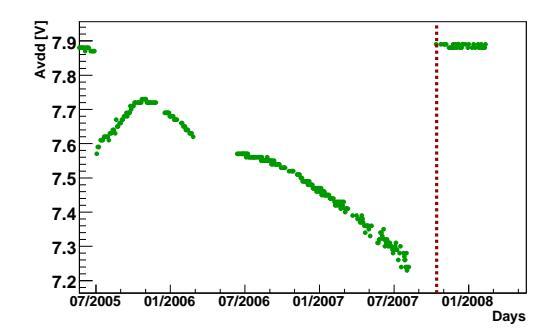
Figure 9: An analog low voltage line powering a series of SVX3D chips of an SVX-II ladder is seen dropping gradually over time. The vertical dashed line marks the replacement of the faulty power supply.

The solution was to replace all of the filter capacitors (32 in total) on the supply. This repair was done on-site at FNAL, and typically only took a few hours. The swaps were usually not urgent (the readout electronics would still work at 0.5 V below nominal), and were done when another problem in the detector required an access to the collision hall. Figure 9 shows the analog low

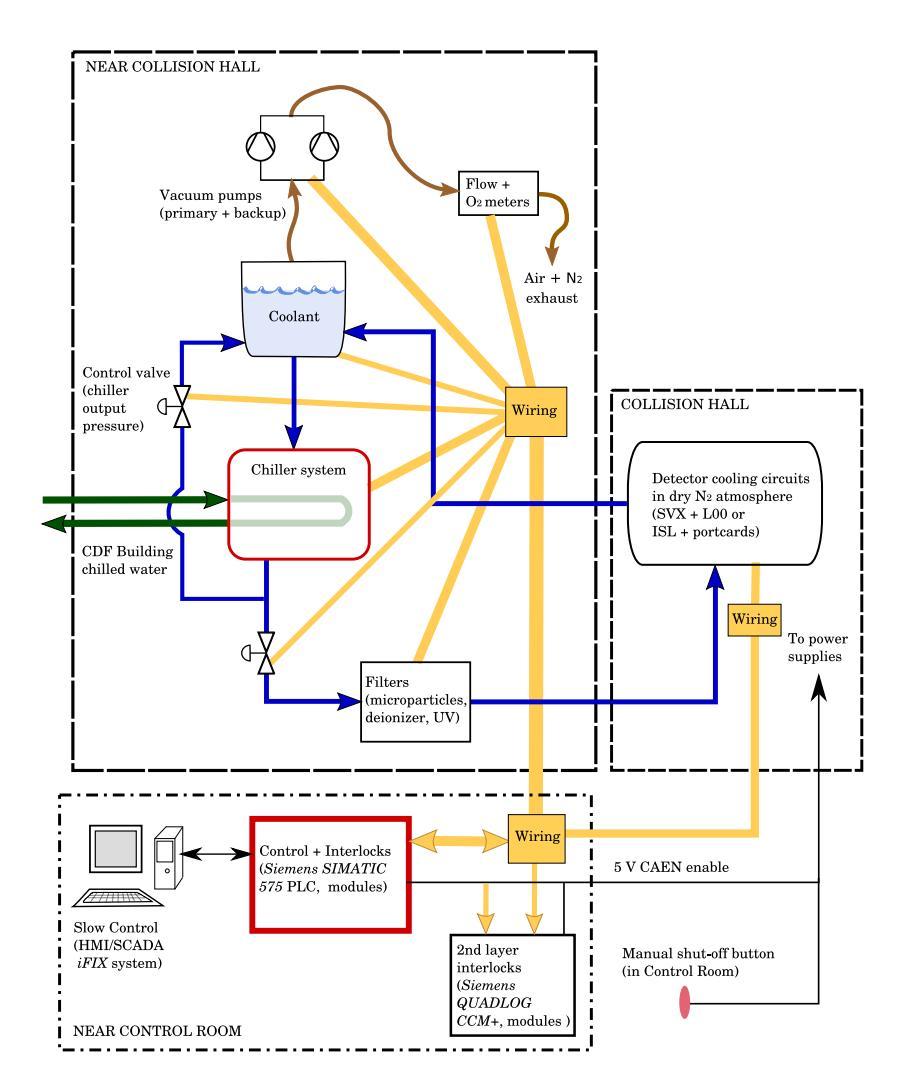
Figure 10: Schematic of the SVX-II/L00 cooling subsystem. The subsystem for ISL can be described in the same manner, though both subsystems share the same PC and control/interlocks crates.

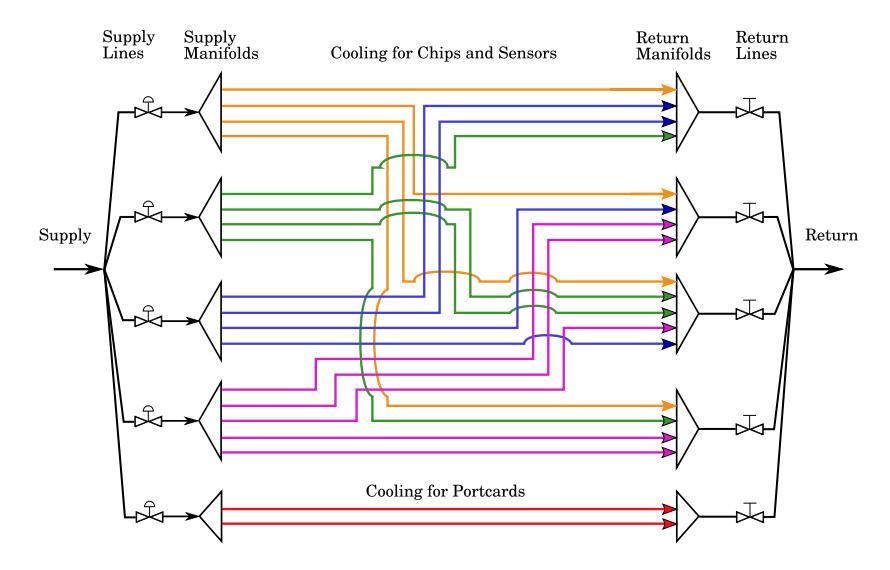
Figure 11: Diagram of the connections of the cooling lines of the east half of ISL showing the supply and return manifolds located in the detector frame. Flow which enters the detector via one of the four supply lines was be shared among several return lines. Electronic supply valves and manual return valves are shown.

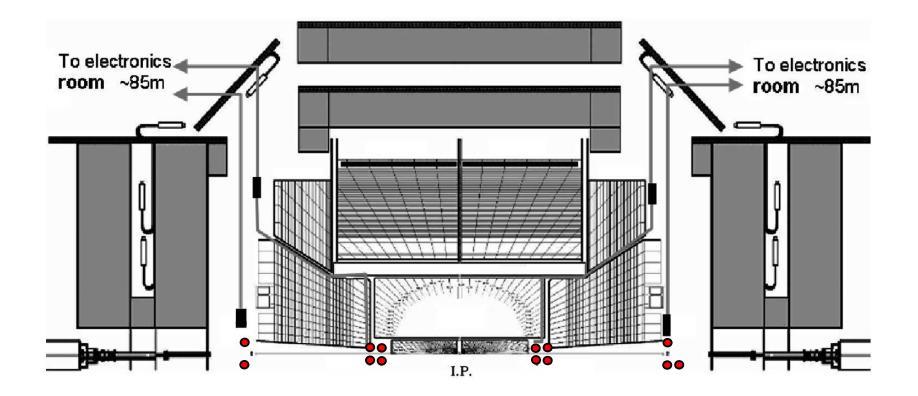
Figure 12: The locations of the diamond-based BCM system in the CDF detector. The picture shows the upper hemisphere of the CDF detector. The proton beam circulated from left-to-right along the horizontal axis, colliding with the anti-proton beam that circulated in the opposite direction. The collision occurred at the interaction point, indicated by "I.P." in the figure. A pair of four red dots, symmetrically placed on either side of the I.P., indicate the sensors inside the tracking volume, and the red dots further away from I.P. along the beamline indicate sensors outside the tracking volume.

The BCM system was configured to abort the Tevatron beams when at least four diamond sensors measured a current of at least 500 nA and the CDF solenoid was fully energized, as the diamond dark current was affected by the external magnetic field. These settings were determined from a six-month study period to optimize the thresholds, and allowed quick response to potential beam incidents, while minimizing the number of false aborts.

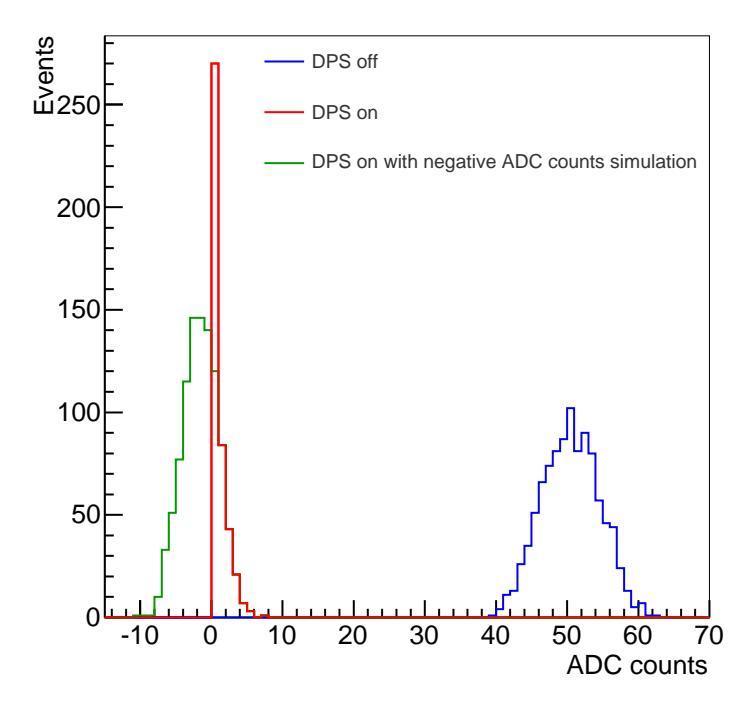
Figure 13: Effect of Dynamic Pedestal Subtraction on pulse height distribution of a single channel in 1000 events. The DPS-off distribution is shown in blue, DPS-on is red, and the green histogram is an extrapolation of what the DPS-on distribution would be if negative ADC counts could be recorded. The peak at 0 ADC counts in the DPS-on distribution is suppressed by choice of scale.

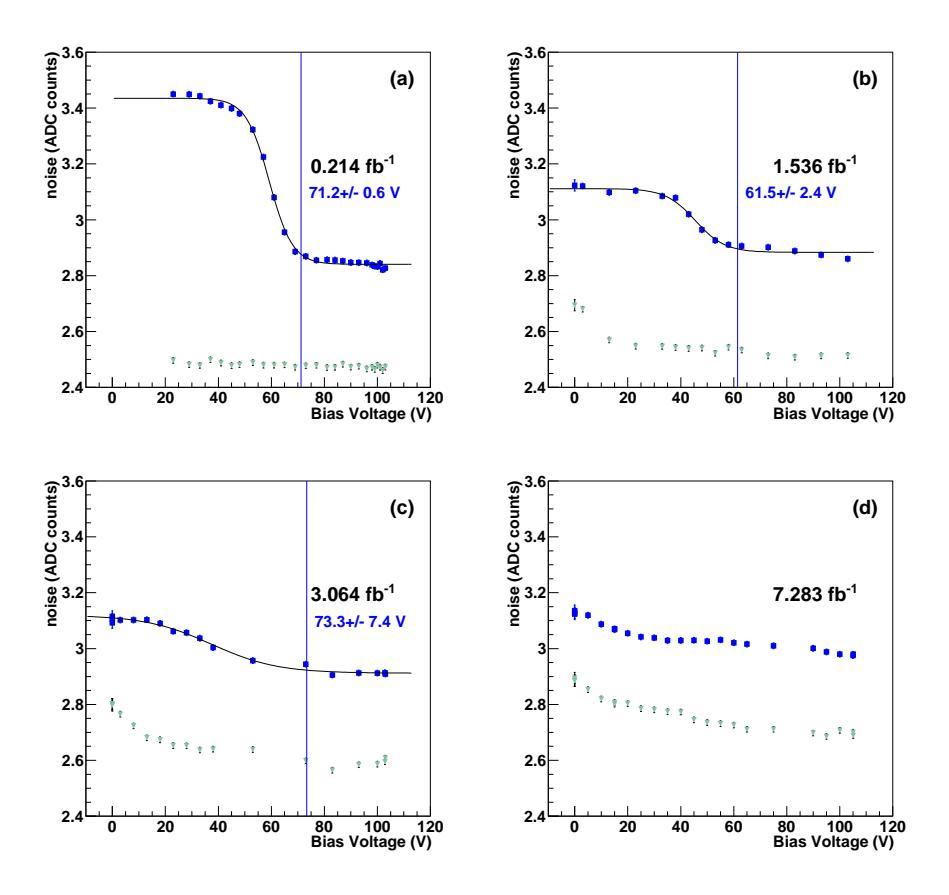
Figure 14: Noise scan measurements for a single ladder from layer 1 of SVX-II at four different integrated luminosities (given in fb^{-1}). The blue squares are the measured noise on the n-side. The pale green triangles are the measured noise on the p-side of the sensor. The extracted depletion voltage is indicated with a vertical line.

Noise scans for a typical ladder taken at different integrated luminosities are
shown in Figure 14. In the early scans, the separation between the two noise
levels for the n-side was large, and the depletion voltage was easily determined,
as seen from Figure 14(a). As the sensor became irradiated, the underdepleted

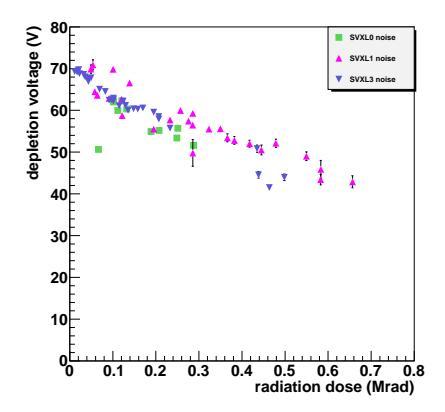
Figure 15: The average depletion voltage determined from noise scans is plotted for the Hamamatsu sensors in SVX-II (see Table 1) as a function of radiation dose.

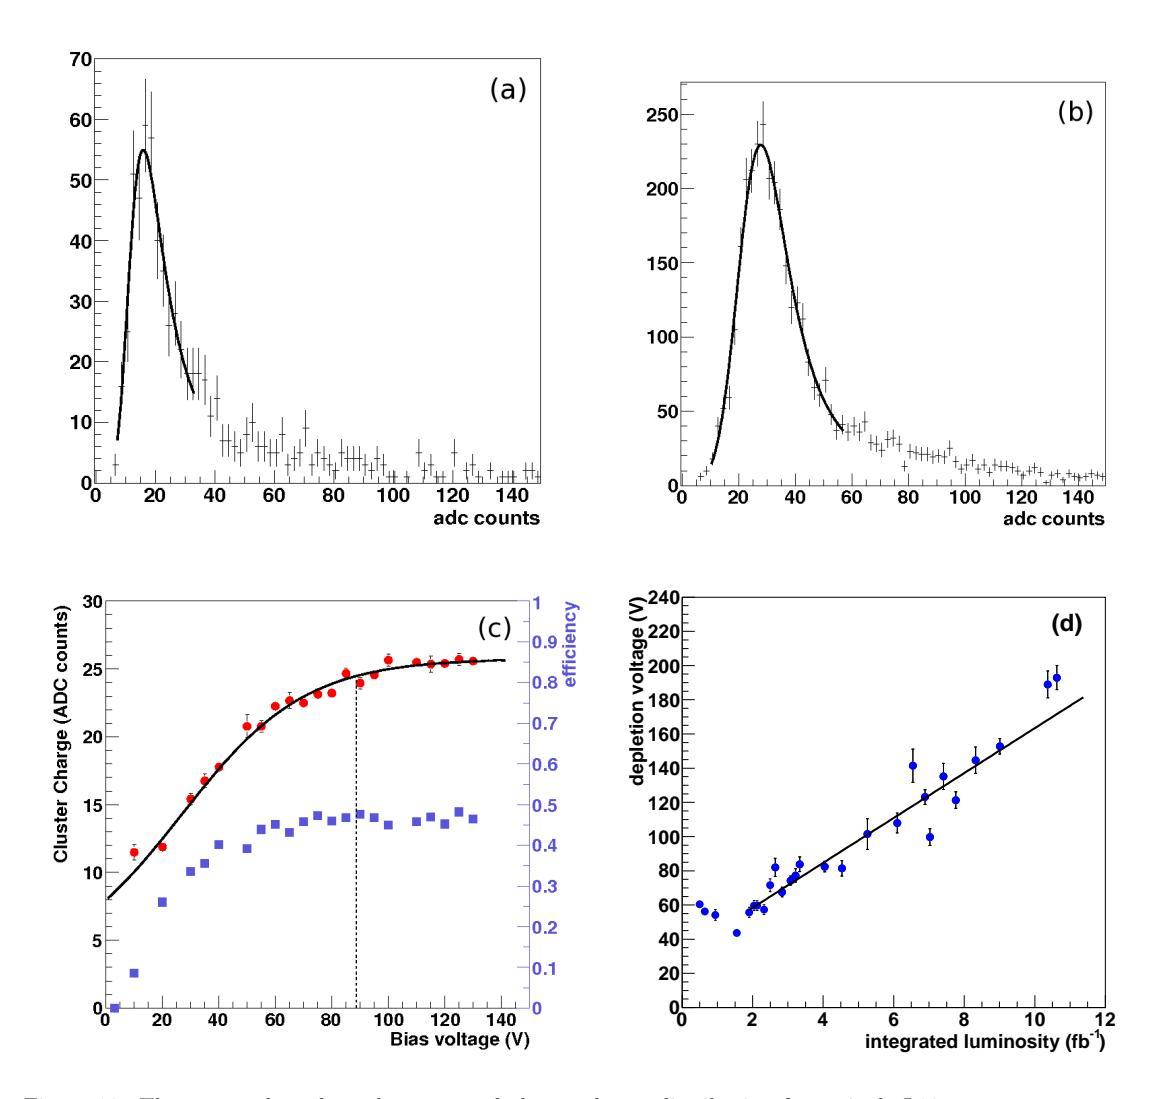
Figure 16: The upper plots show the measured cluster charge distribution for a single L00 ladder at a bias voltage of 30 V (a) and 130 V (b) after 4 fb⁻¹ of integrated luminosity. Plot (c) shows the peak of the cluster charge distribution (red circles) and the efficiency (blue squares) as a function of bias voltage. The dashed line indicates the depletion voltage extracted from the sigmoid fit. Plot (d) shows the measured depletion voltage for this ladder as a function of integrated luminosity, and the linear fit used to extrapolate to higher luminosity values.

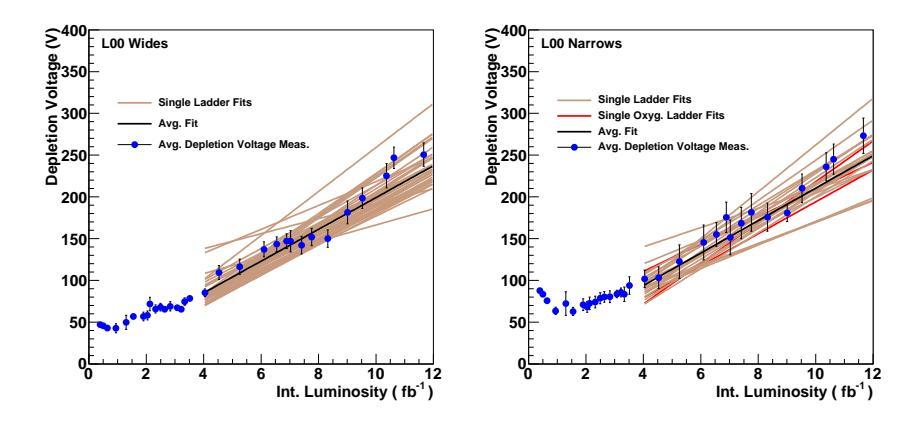
Figure 17: Summary of depletion voltage measurements and fits for L00 wide ladders (left) and narrow ladders (right).

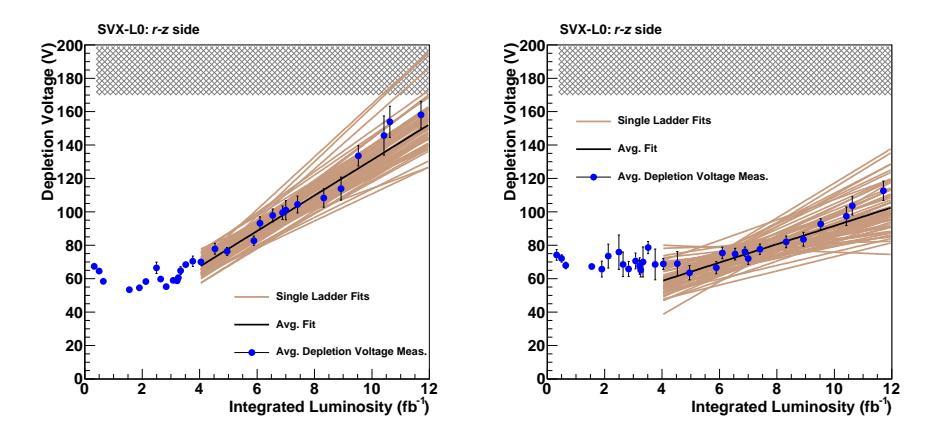
Figure 18: Summary of depletion voltage measurements and fits for the $r-\phi$ side or p-side (left) and the r-z side or n-side (right) of SVX-L0 sensors.

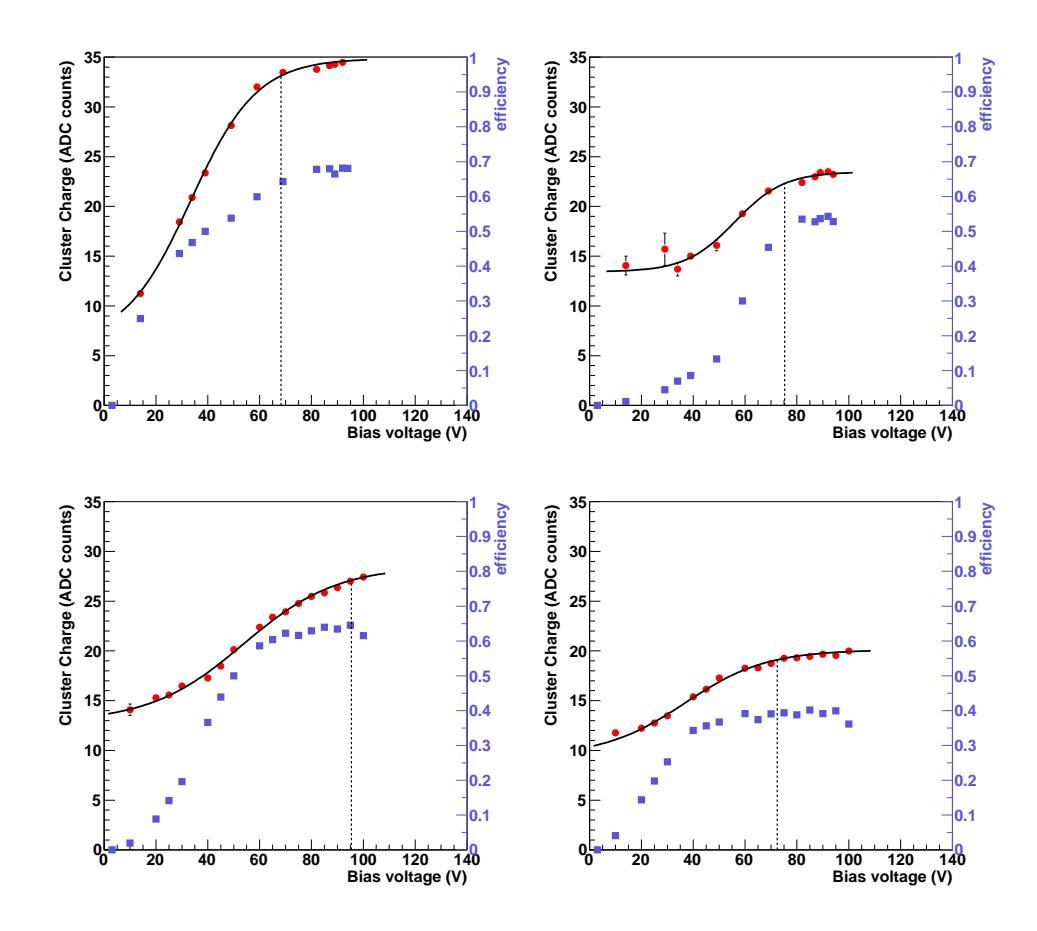
Figure 19: The cluster charge (circles) and efficiency (squares) as a function of bias voltage for the p-side $(r-\phi, \text{ left})$ and n-side (r-z, right) of a typical SVX-L0 sensor. The dashed line indicates the depletion voltage extracted from the measurement. The upper plots contain data taken after 0.3 fb⁻¹ of delivered luminosity, the lower plots data taken after 6.9 fb⁻¹ for a sensor that inverted around 1.5 fb⁻¹.

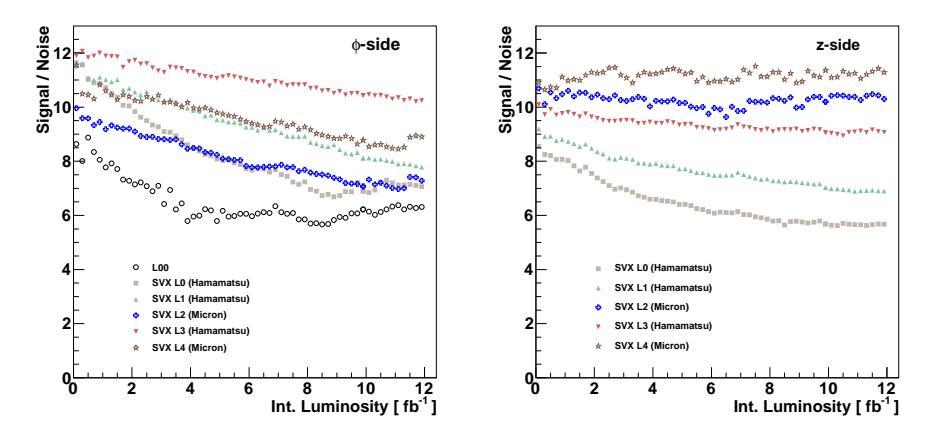
Figure 20: Measured signal-to-noise ratio for L00 (left), the $r-\phi$ side of SVX-II (left) and the r-z side of SVX-II (right).

We observed plateaus in the ratios in the L00 and SVX-L0 S/N ratios be-1606 ginning at 5 fb^{-1} and 8 fb^{-1} , respectively. To verify that the leveling-off was 1607 not an artifact of the averaging, the S/N curves for the individual ladders were 1608 investigated. Figure 21 shows the S/N trends for the overall L00 average and 1609 for three typical ladders whose S/N values are close to (a) the overall L00 av-1610 erage, (b) the plus-one RMS variation with respect to the overall average, and 1611 (c) the minus-one RMS variation with respect to the overall average, where the 1612 RMS was defined as the spread of S/N values for the ladders used in the aver-1613 age. As we observed a plateau-like feature for each ladder, we concluded that it 1614 was not due to an averaging artifact. The source of the plateau remains under 1615 investigation. 1616

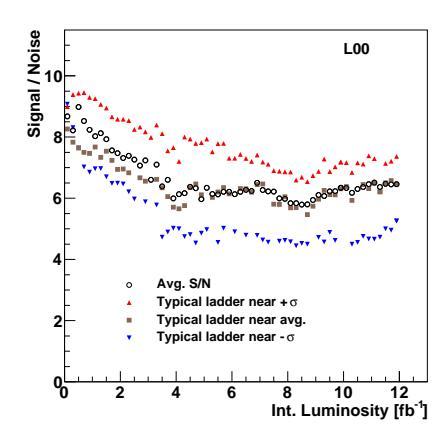
Figure 21: Measured signal-to-noise ratio for the L00 average, and for three ladders that represent typical ladders close to the average, and close to the ± 1 RMS signal-to-noise values with respect to the average. The RMS represents the spread of signal-to-noise values for the various ladders included in the average.

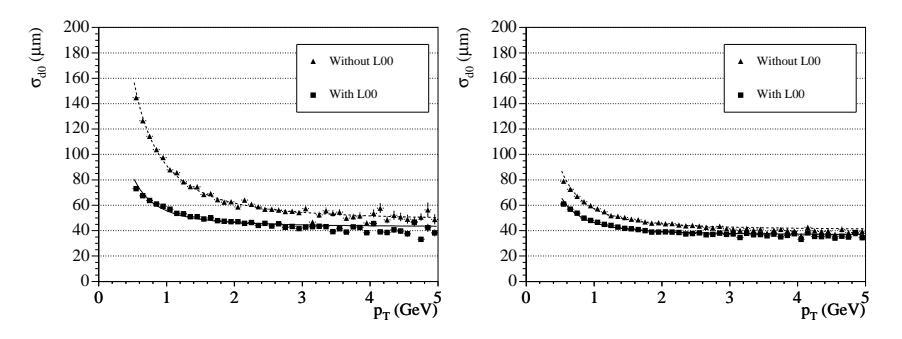
Figure 22: Impact parameter resolutions for tracks as a function of track $p_{\rm T}$. Both plots show the resolutions for tracks before and after the addition of L00 hits. The plot on the left shows the resolutions for tracks that pass through readout hybrids which are mounted on some of the sensors, and the plot on the right shows the performance for tracks that do not pass through hybrids. These plots include the $r_{\rm beam}^2$ term in Equation 2.

The inclusion of L00 enhances the impact parameter resolution at low momen-

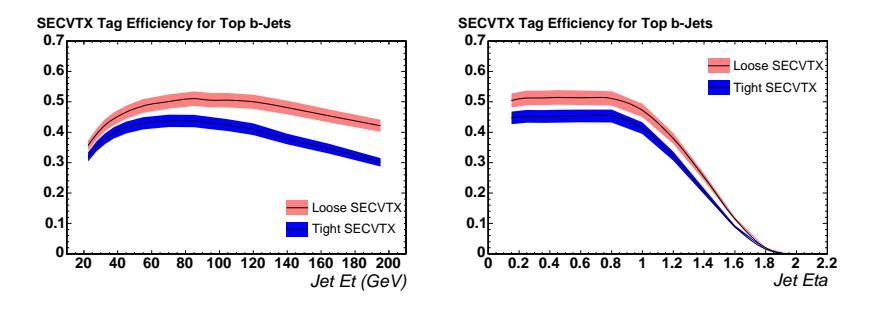
Figure 23: Efficiency of the displaced vertex *b*-tagger, as functions of jet $E_{\rm T}$ and jet pseudorapidity, for two configurations of the *b*-tagger. The efficiency is obtained from tagging jets which have been matched to *b* quarks in Monte Carlo top quark decays, multiplied by data/MC scale factors.

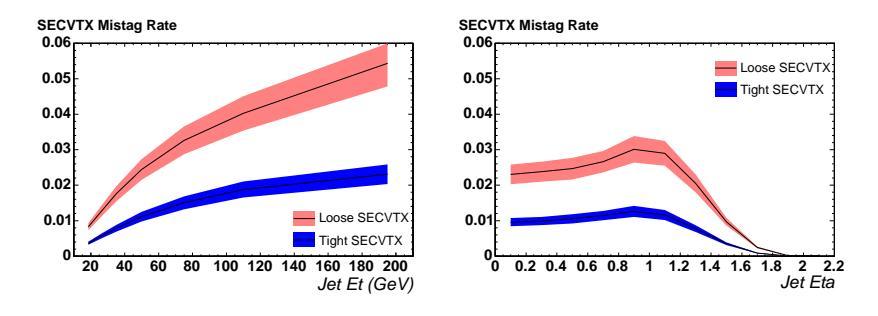
Figure 24: Probability of non-*b*-jets to be *b*-tagged for the displaced vertex *b*-tagger, as functions of jet $E_{\rm T}$ and jet pseudorapidity, for two configurations of the *b*-tagger. The probabilities have been measured from inclusive jet data.

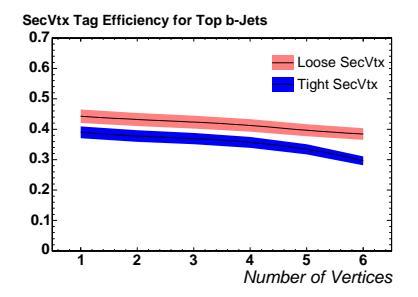
Figure 25: Efficiency of the displaced vertex *b*-tagger, as a function of the number of reconstructed $p\bar{p}$ collision vertices per beam crossing, for two configurations of the *b*-tagger. The efficiency is obtained from tagging jets which have been matched to *b* quarks in Monte Carlo top quark decays, multiplied by data/MC scale factors.

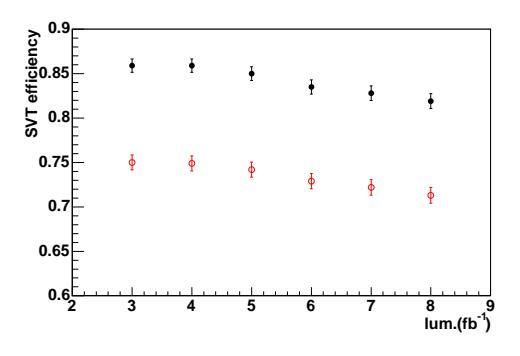
Figure 26: Prediction of the efficiency of SVT as a function of total integrated luminosity. Closed black circles show the efficiency when only four layers of SVX-II are used by the SVT algorithm; empty red circles show the efficiency including all five layers.
