In situ detection of RF breakdown on microfabricated surface ion traps

Joshua M. Wilson, Julia N. Tilles, Raymond A. Haltli, Eric Ou, Matthew G. Blain, Susan M. Clark, and Melissa C. Revelle

Sandia National Laboratories, Albuquerque, NM 87123

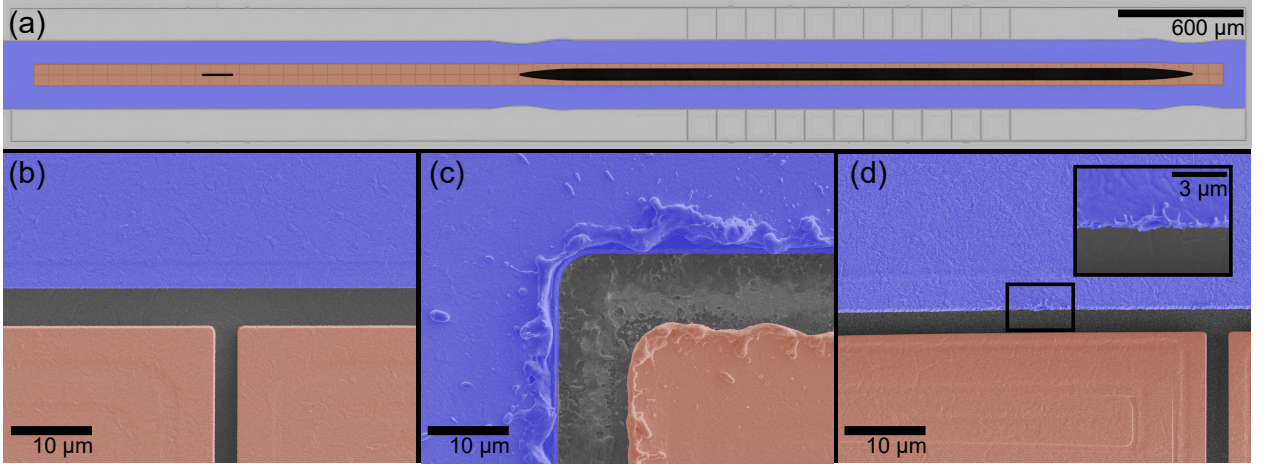
FIG. 1. Microscope images of several ion traps (false color added). In (a) there is an optical image of a Phoenix ion trap. The segmented, DC confinement electrodes (red) are surrounded by the RF electrode (blue). The small black slot on the left is a dedicated loading hole, while the large black slot on the right can be used for loading or optical access to the ions. Images (b-d) are taken with an SEM. As in (a) the RF electrode is colored blue, and the DC confinement electrodes are colored red. The grey area in between is a ground plane beneath the electrodes. The device in (b) shows no breakdown induced surface damage. Image (c) shows a device which has had a sudden ramp in voltage (≈ 500 V) and a breakdown event that led quickly to a permanent RF-ground short. The damage to the device covered a region an order of magnitude bigger than what is shown. The gap exposing the ground plane in (c) was originally the same size as the top gap in (b), but the breakdown event altered and deformed the overhanging electrode edge away from the gap. The device shown in (d) has slightly different geometry than the devices in (a) and (b), but the colors correspond to the same device regions. This device had a single breakdown event at a much lower voltage (≈ 150 V). The damage is barely visible at this scale. The inset to (d) is a magnified look at the region enclosed by the black rectangle.

Most of the surface ion traps utilized at Sandia are connected to routing circuits inside an ultrahigh vacuum chamber with optical access and appropriate electronic vacuum feedthroughs as described in Refs 12 and 20. Figure 1(a) shows the RF and direct-current (DC) electrodes on a Phoenix trap (a linear, multi-layered surface ion trap fabricated at Sandia National Laboratories²⁰). We couple RF power to our devices with a helical resonator, which uses inductive coupling to both filter out all but a specific resonance frequency and increase the voltage applied at the device²⁵. Such a resonator system applies a root mean square voltage (V_{rms}) to the trap that can be estimated as²⁵:

We verified that this technique was registering single breakdown events by characterizing a device before and after a measured discharge. First by visually characterizing a device using an optical microscope at $500\times$ magnification and documenting the surface condition before beginning testing. After installing the device in our chamber we slowly increased the voltage until the D-Dots detected an apparent breakdown event. We then removed the device and performed another visual inspection for any sign of surface damage. With our optical microscope we saw a single new blemish and then further inspected that region with a scanning electron microscope (SEM). The result of this measurement can be seen in Figure 1(d). There is clear visual evidence of breakdown that was not present in the initial inspection of the de-

lower voltages caused qualitatively less damage than those at higher voltages. In fact, Figure 1(c) shows the damage when a device was accidentally ramped to a higher than desired voltage and caused a nearly instant breakdown and device short. The damage to the device was more consistent with the instantaneous breakdown measurements in Ref. 22 than with our other, more localized events at lower voltages (Figure 1(d)). Furthermore, we don't know if the discharge causing trap damage is a "cold" breakdown like coronal discharge (which wouldn't necessarily be detected by a camera), or something "hot" and highly luminous like arcing²¹ (or perhaps some combination of discharge types). A wide range of breakdown types (if they occur) would be indistinguishable with our setup.

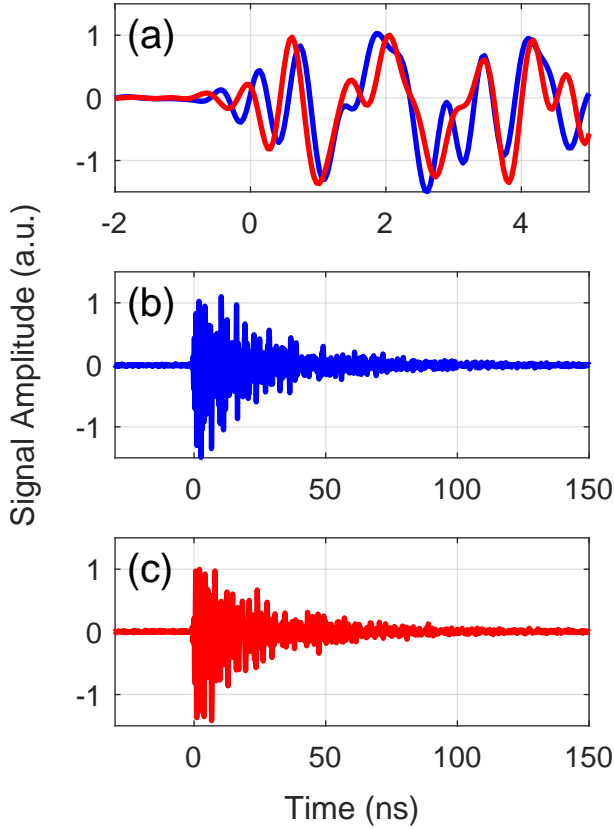
FIG. 2. Remote RF breakdown detection. Overlapped signals from two D-Dot detectors are seen in (a). Geometric considerations related to the detection axis of the D-Dots, and their placement relative to the trap, as well as signal reflections from the vacuum chamber and environment, prevent the traces from being identical. However, they are similar in structure for the first several nanoseconds, and their temporal coincidence shows that the detectors are nearly equidistant from the discharge source. In (b) and (c) the same two signals are shown at a longer scale so that the entire ≈ 100 ns pulse generated by RF breakdown is visible. The signal before and after the pulse is unstructured noise.

we were able to detect electric field pulses generated by RF breakdown emanating from our ion trap devices (Figure 2). The signals shown in Figure 2 were taken with D-Dots each set approximately one meter from the ion trap. The near coincidence of the signal on different D-Dots, as well as their similar shapes, made the source clearly distinguishable from other discharges that occurred regularly in the lab. This measurement is similar to work done at Sandia for lightning detection imaging, except we did not need to implement sophisticated cross-correlation (as done in Ref 27) since the breakdown signals were so distinct. More details about the D-Dot measurement setup and execution can be found in the Supplementary Material.

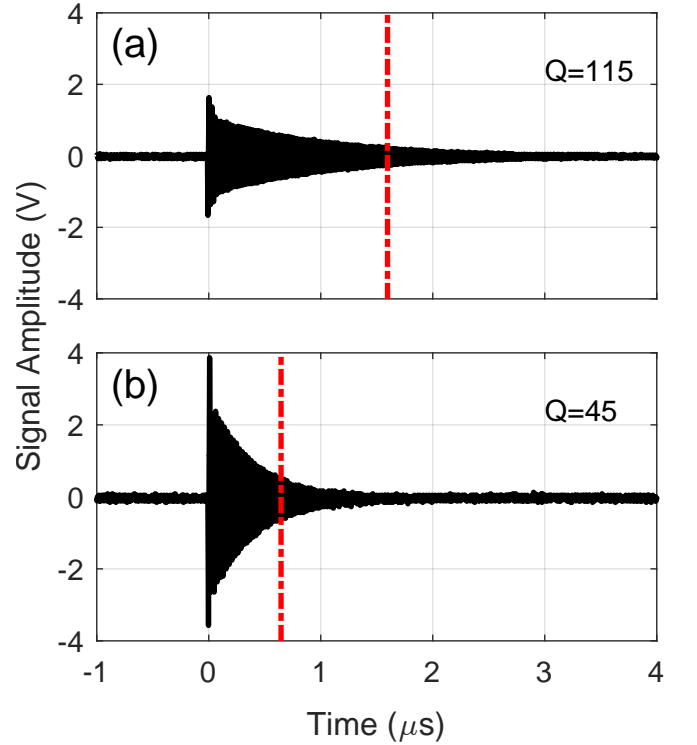
FIG. 3. Self-triggered signals of the RF back-reflection during two separate RF breakdown events. Each event was on a different device where (a) had a Q of 115 ± 3.4 and (b) had a Q of 45 ± 1.3 . The black traces are the 35 MHz back-reflection spiking and then decaying. The spike is coincident with a D-Dot detection like the ones plotted in Figure 2. The back-reflection takes a longer time to decay to its initial state after a breakdown than the RF signals picked up by the D-Dots. The time it takes each signal to decay to $1/e^2$ its maximum (t_{decay}) is plotted in (dashed) red. We find that t_{decay} is proportional to Q , with a proportionality $c_0 = 0.0140(3) \mu s$.

Once establishing the success of this technique for in situ detection of even a very small breakdown event, we used the oscilloscope that was being triggered by the D-Dots to trigger a second scope. The second scope measured an RF signal reflected back from the resonator and through a directional coupler (see Figure S2 in the Supplementary Material). We aimed to find a reliable signal that would be identifiable on other experiments without needing the addition of D-Dot sensors. We discovered that breakdown events had a large and measurable effect on the back-reflected RF, making them easy to detect with a simple oscilloscope. Figure 3 shows the RF back-reflection during a breakdown event on two different devices. The signals shown were observed simultaneously with D-Dot detection. Although the breakdown event (Figure 2) and the interruption to the forward power on

the device is short, the effect on the back-reflection takes a relatively long time to decay. The signal is easily measurable on any oscilloscope with larger bandwidth than the RF signal being applied, and could be used as its own trigger source. The inductance of the resonator circuit prevents a quick return to equilibrium after breakdown occurs. On average, the time the signal took to decay to $1/e^2$ of its maximum (t_{decay}) was:

breakdown can possibly remove problematic regions of the trap where breakdown is more likely to occur. In addition, the back-reflection should be monitored for breakdown. Signals like the one in Figure 3 should be straightforward to measure in other ion trapping experiments. If multiple events are observed at or near the same voltage, the RF power should be immediately reduced to avoid the development of permanent shorts.

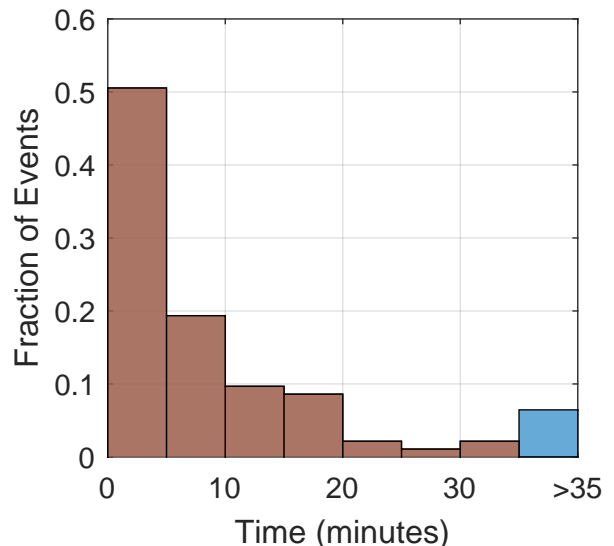
FIG. 4. Distribution of minutes before breakdown across multiple tested devices. This histogram shows the results of 93 distinct breakdown events. We recorded the time at which a breakdown event occurred after a voltage change, or the delay between separate events at the same voltage. Roughly half of the breakdown events happened within five minutes, and the majority happened within 20 minutes. Four events occurred at an interval of more than 35 minutes, with the longest being almost 200 minutes. Not every voltage was held for that long, but all measurements were held for at least 40 minutes at each voltage. The temperature and the pressure in the trap should be stable well within that time.

Another approach which has been used for measuring breakdown, introduced in Ref. 22, is to monitor the surface of the device using a camera. In this case, the voltage is continuously increased until an arc occurs and is observable. This approach requires breakdown that is large and optically bright enough to be visible on the device surface. Continuously increasing the voltage for such a measurement makes sense under the assumption that a device either can or cannot sustain a particular voltage and that past some threshold breakdown is inevitable and sudden. Other RF breakdown measurements and theories seem to use similar assumptions^{23,24,28}. In our measurement, however, we observed that a trap could be kept at a specific voltage for a long time before a breakdown event would occur. We saw events occur as quickly as a few seconds and up to several hours after we changed to a new voltage, as seen in the histogram in Figure 4.

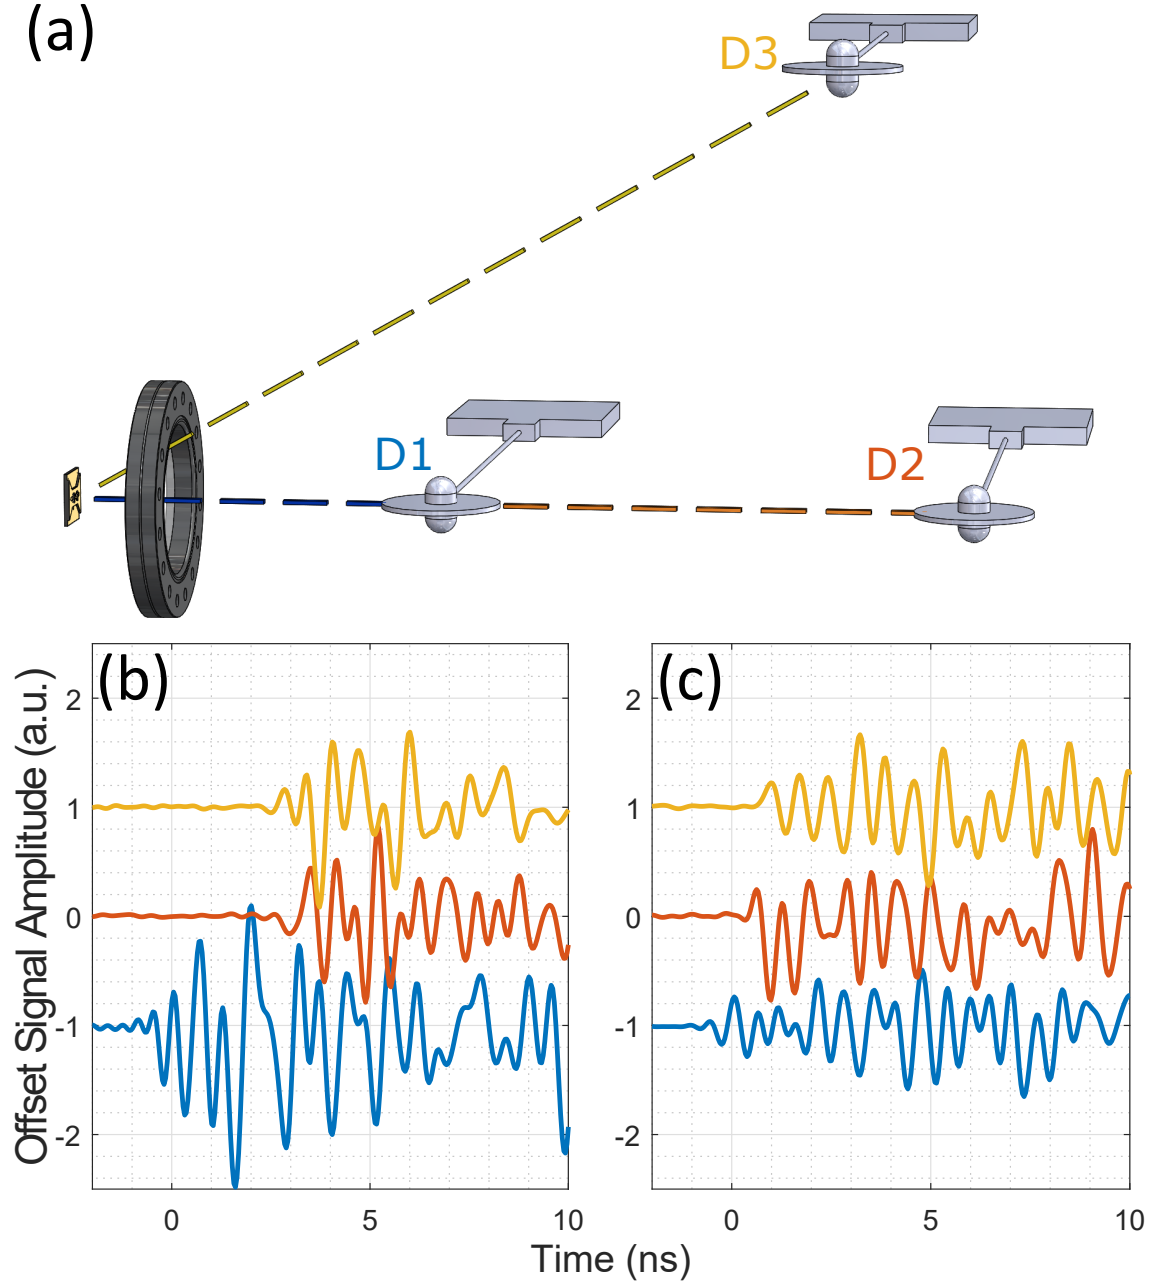
FIG. S1. Details of the D-Dot measurement. The sketch in (a) shows the RF driven trapping device (yellow bow-tie shape) inside the vacuum chamber (only window is shown). A breakdown event emits an RF pulse that is detected by detectors D1, D2 and D3. The disk shape on the front of each detector is the D-Dot, and the slim box shape on the rear is the balun. In the setup as displayed D2 and D3 are equidistant from the trapping device, so the yellow dashed line is the same length as the blue and orange lines combined. The D-Dot measured breakdown signal in (b) arrived at D1 about 3 ns before it arrived at D2 and D3. This time delay corresponds with speed of light transit across the physical separation of the detectors. D2 and D3 were one meter farther from the source than D1. In (c) there is no such delay, although the detector setup was the same. Thus it was clearly generated by some other lab discharge. In (b) and (c) the signals are offset vertically for clarity. In reality they all were centered around zero. Also, only the first 10 ns of a signal that lasted much longer is shown (see Figure 2).

The D-Dots and corresponding equipment were set-up external to the vacuum chamber, allowing for the assembly to occur around a live experiment. The D-Dots themselves were Prodyn AD-70s¹ (sketched as a grey disk in Figure S1) which operate from DC to 3.5 GHz. Each D-Dot is connected to a Prodyn BIB-100G balun² which operates from 250 kHz to 10 GHz. The balun (sketched as a slim grey box in Figure S1) takes a differential measurement from each side of the D-Dot and outputs a single value. We then amplified the signal (Pasternack PE15A3311: 0.1 MHz to 10 GHz, 32.5 dB gain) and measured it with a fast (>2 GHz) oscilloscope. To avoid noise and loss we used Pasternack PE-P142LL cables (low-loss triple shielded coax) for sending the signal to the scope.

All of our measurements were conducted with 3 D-Dots. We arranged the D-Dots in two main configurations during the measurement process. Our initial measurements and calibration were done with an arrangement like the one sketched in Figure S1(a). D1 was placed about 30 cm from the trapping device. D2 and D3 were about a meter farther from the device, but at different heights relative to each other. D1 and D2 were at the same relative height as the trapping device. The measured breakdown signals shown in Figure S1(b) came from an event at the device and the signal in S1(c) did not. This is clear because in S1(b) the signal from D1 proceeds the signals on D2 and D3 by about 3 ns. It takes 3 ns for light to travel the extra meter past D1 to the other detectors.

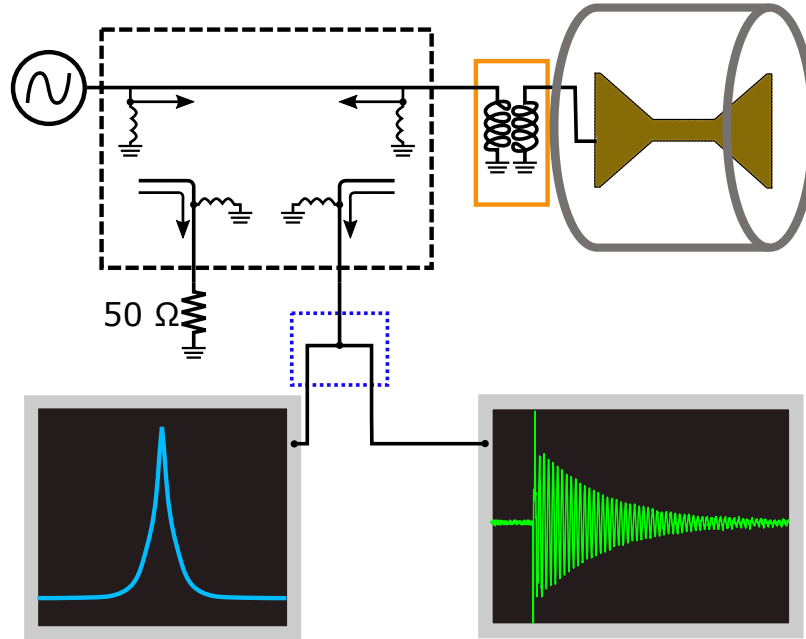
FIG. S2. Sketch of setup for measuring the breakdown signal in the back-reflected RF. The RF signal is sent through a bi-directional coupler (black dashed box), a helical-resonator (orange solid box), and through a vacuum feed-through into the vacuum chamber (grey cylinder). In the vacuum chamber, the RF signal is connected to the ion trapping device (brown bow-tie). The back-reflected signal is monitored and minimized (blue power spectrum). $50\ \Omega$ termination is essential on the unused coupler port. When monitoring for breakdown, a power splitter (blue dotted box) sends half the the signal to an oscilloscope which uses the back-reflection as a trigger source. Breakdown events in our setup generated signals like the green waveform (see also Figure 3).

Most of the ion-trapping experiments at Sandia National Labs have RF power delivered to the trapping device in accordance with the sketch in Figure S2. A low noise, pre-amplified RF signal goes through a bi-directional coupler (Mini-Circuits ZFBDC20-61HP-S+, 1-60MHz), a helical resonator, and a vacuum feed-through to get to the trapping device. The back-reflected signal coming from the coupler is minimized to ensure optimal power delivery to the trapping device. When optimizing, we typically measure a peak back-reflected signal amplitude of around 10 dBm, which is minimized to between -30 and -60 dBm.

The only difference to the setup when monitoring for breakdown is adding a power splitter (Mini-Circuits ZFSC-2-5-S+, 10-1500 MHz) on the back-reflected path. One half of the split signal is used for normal power coupling optimization. The other half is sent to an oscilloscope in normal trigger mode using the input signal as a trigger source. As is visible in the green signal in Figure S2 (as well as in Figure 3) the breakdown signals that we observed were much bigger than the 35 MHz background amplitude. Setting the trigger at two to three times the background level was enough to avoid (most) spurious triggers and to capture a breakdown event when it happened. The time scale that we observed was Q times about 0.014 microseconds. We don't know if this time scale will be consistent across different experiments.
