# Developing a Free and Open-source Automated Building Exterior Crack Inspection Software for Construction and Facility Managers

This study presents the development of an easy-to-use, free and open-source Automated Building Exterior Crack Inspection Software (ABECIS) for construction and facility managers, using state-of-the-art segmentation algorithms to identify concrete cracks and generate a quantitative and qualitative report. ABECIS was tested using images collected from a UAV and smartphone cameras in real-world conditions and a controlled laboratory environment. From the raw output of the algorithm, the median Intersection over Unions for the test experiments is (1) 0.686 for indoor crack detection experiment in a controlled lab environment using a commercial drone, (2) 0.186 for indoor crack detection at a construction site using a smartphone and (3) 0.958 for outdoor crack detection on university campus using a commercial drone. These IoU results can be improved significantly to over 0.8 when a human operator selectively removes the false positives. In general, ABECIS performs best for outdoor drone images, and combining the algorithm predictions with human verification/i

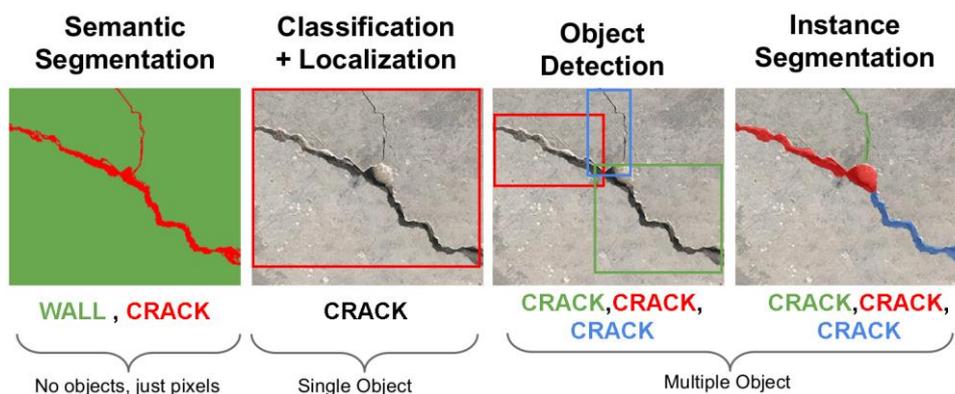
Figure 1: General Types of Object Detection Algorithms available at present

Many algorithms currently exist for the detection of objects. However, almost all the algorithms can be generally classified into 4 broad categories. These algorithms can be classified into (a) Semantic Segmentation, (b) Classification and Localization, (c) Object Detection and (d) Instance Segmentation algorithms (Figure 1). Semantic Segmentation classifies every pixel in the image into classes (e.g., wall and crack). Classification and Localization algorithms only show the location of a single object. Object Detection algorithms are superior to the former two since they detect each object (e.g., in Figure 1) and its location, but not shape and size. Instance Segmentation is the most powerful technique among the four because it provides information about each object's location, shape and size. Therefore, for this study, instance segmentation was used as the main detection algorithm.

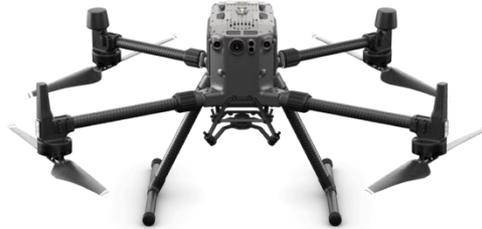
Figure 2: DJI Matrice 300 RTK [51]

The ABECIS system is designed in a very flexible way such that it can accept a variety of inputs produced by different methods of data collection – from very accessible, simplistic methods such as photos taken using smartphones to complex, professional methods such as photos taken using industrial drones such as the DJI Matrice 300 RTK (Figure 2), or autonomous robotic platforms as suggested by [50]. The only requirement is that the input must be an RGB image. For this study, two methods for image collection, namely cameras on (1) an industrial drone and (2) smartphones, were used.

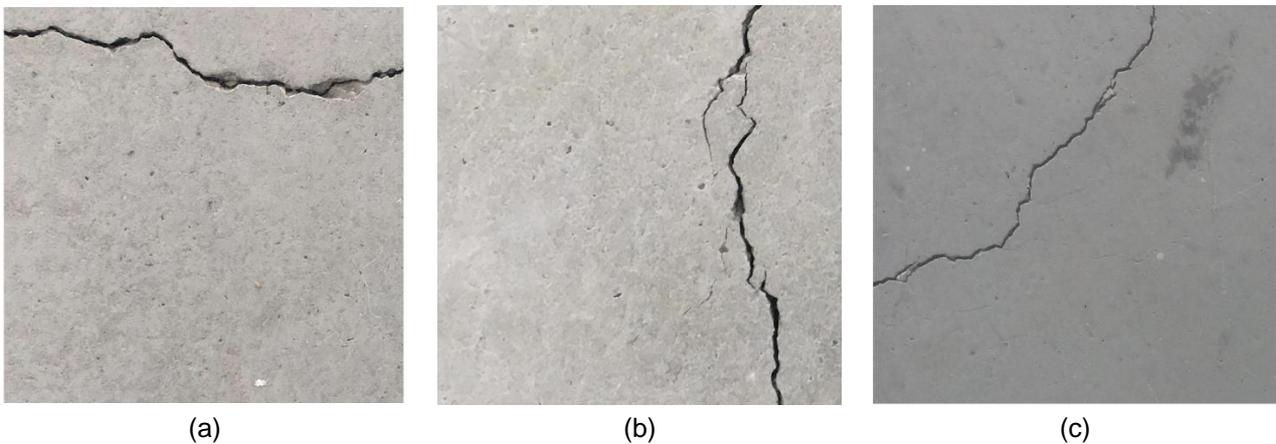
Figure 3: Different types of cracks classified in ABECIS: (a) horizontal, (b) vertical, and (c) diagonal from a horizontal perspective (source [53])

The classification of the concrete cracks for this study has been done in accordance with the ACI Concrete Terminology report by American Concrete Institute [52]. In particular, concrete cracks have been classified into 3 categories based on their orientation (Horizontal Crack, Vertical Crack and Diagonal Crack). Cracks that are either 180° or 90° to the horizontal are classified as horizontal and vertical cracks, respectively. Other cracks are classified as diagonal cracks (Figure 3). It is assumed that the images of the cracks are upright and not rotated, taken from a horizontal position, and with a camera orientation perpendicular to the plane being inspected.

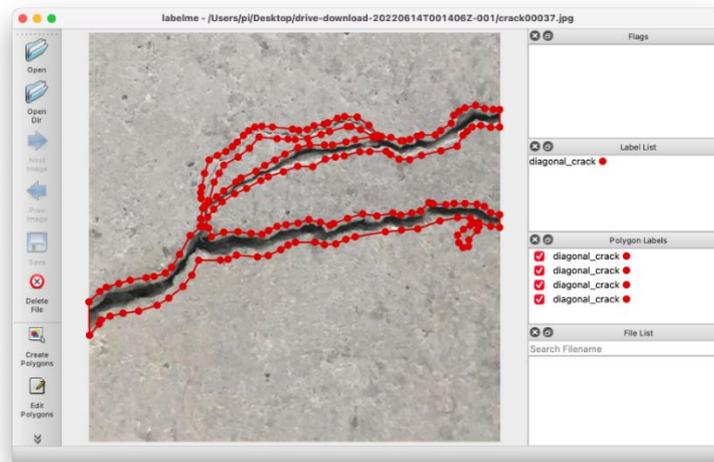
Figure 4: Polygonal annotation of images by the authors using LabelMe [57]. Labeled images used for model training.

The algorithm must first be trained to detect cracks using instance segmentation. The training requires many pre-labeled images. This dataset can be obtained by oneself or using publicly available datasets. Özgenel et al. [53] have publicly shared their dataset of concrete crack image data, which has been used in this research to train the model for concrete wall crack detection. For this study, the authors did a manual polygonal annotation of 800 images from [53] using LabelMe software [57] [58] (e.g., Figure 4) so that those images could be used for instance segmentation training for model development. A sample of the labeled images developed for this study is publicly shared and available at [59].

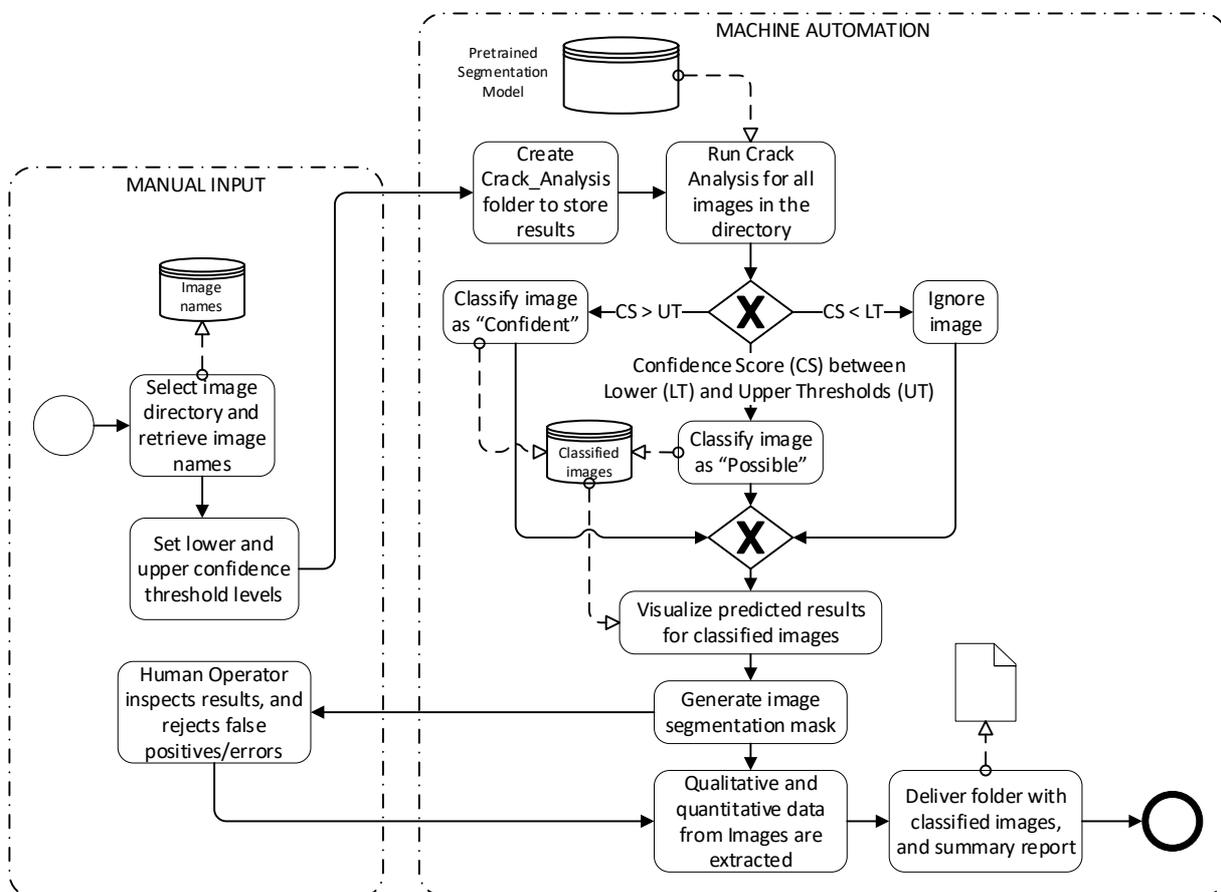
Figure 5: System architecture of the Automated Building Exterior Crack Inspection System (ABECIS) (expanded from [60])

The overall system architecture for ABECIS is an expansion of the authors' work presented in [60]. It includes the human input and machine automation parts (Figure 5). Initially, the system will prompt the user to select a directory on their computer containing all the images to be analyzed for cracks. Afterward, the user will need to adjust the lower and upper confidence score threshold. Confidence scores are numbers between 0 and 100 used to describe how well the algorithm thinks it has detected a crack (100 being a perfect detection). The threshold values set a cutoff point such that identified cracks with a confidence score below the threshold value will be rejected. However, there may be some images of non-cracks for which the software is highly confident that they are cracks, resulting in false positives. In some scenarios, there might be objects which resemble cracks (e.g., dents or scratches on the walls, intentional man-made crack-like grooves, such as small gaps between two walls). For such cases, the algorithm might not be certain of the cracks identified and might require the assistance of a human operator to make a judgment (i.e., verification/intervention).

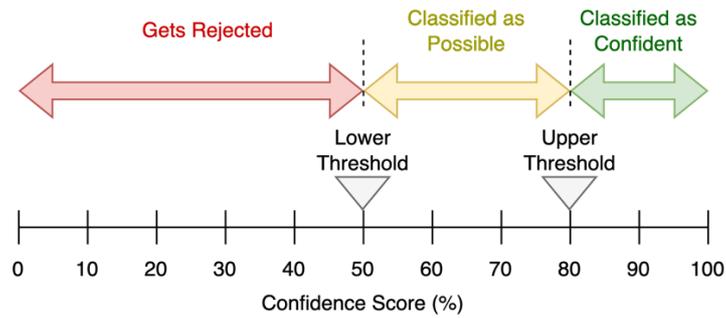
Figure 6: Confidence threshold in ABECIS

Therefore, ABECIS has two threshold values (upper and lower) for the confidence scores, which work as shown in Figure 6. Any images containing crack detection confident scores higher than the upper threshold will be classified into a folder named "Confident," whereas identified cracks that fall within the upper and lower threshold will be classified into a folder named "Possible". Otherwise, the identified cracks are rejected. These two parameters are fully adjustable by the human operator and are to be decided by their judgment based on the environmental situation and difficulty of the crack detection task.

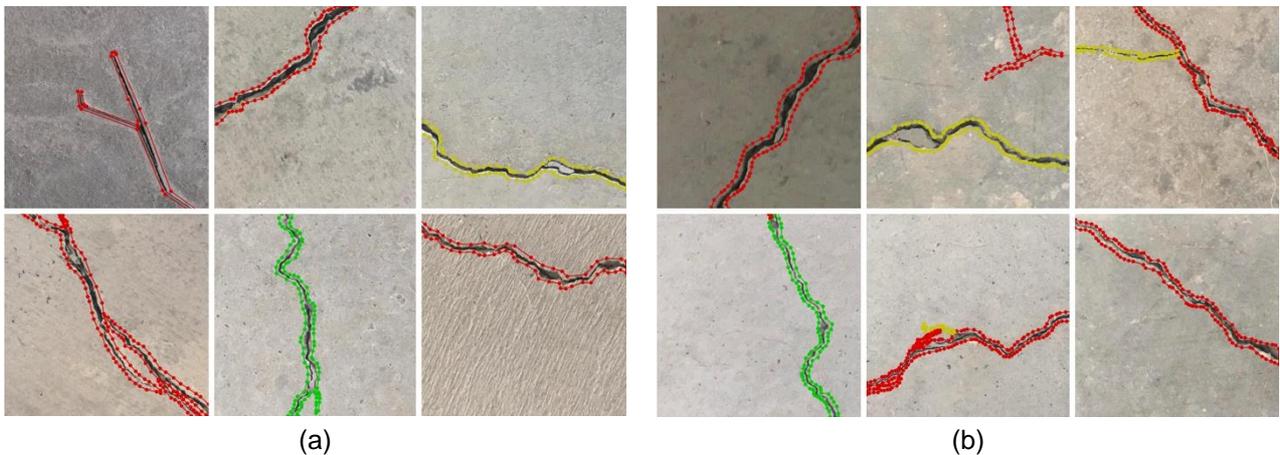
Figure 7: Examples of images used for the (a) training and (b) testing datasets (red = diagonal cracks, green = vertical cracks, yellow = horizontal cracks). The dataset was prepared via polygon labeling by the authors in LabelMe using raw images from [49, p. 2]. A subset of the labeled images developed for this study can be found in [59]

The image segmentation model was developed using 800 images and the Detectron2 library using the Özgenel et al. [53] dataset labeled by the authors. The training dataset consists of 700 images, and the testing dataset consists of 100 images. Example images of the training and testing datasets can be seen in Figure 7. The model was trained using COCO-Instance Segmentation, mask\_rcnn\_R\_50\_FPN\_3x as the pre-trained model. Although Detectron2 contains more pre-trained models, such as C4 and DC5, FPN was chosen because it provides the best speed/accuracy tradeoff, according to Detectron2 documentation [61, p. 2].

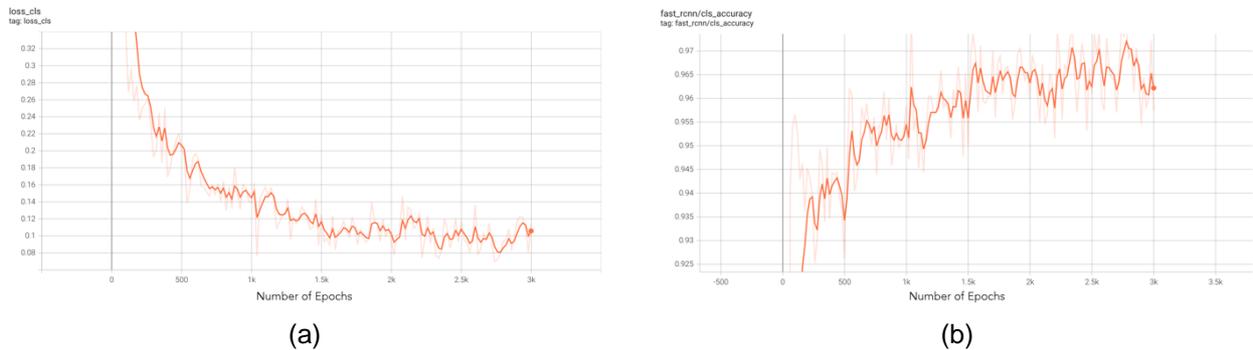
Figure 8: (a) Cross-Entropy Loss and (b) Accuracy during the training of the Neural Network model

Cross-entropy loss [62] and accuracy [63] were calculated to measure how well the model performed. Cross-entropy loss of 0 indicates a perfect model, and an accuracy of 1 indicates a perfect model, too. After training for 3,000 epochs, the cross-entropy loss of the model reached close to 0.1 (Figure 8a), and the accuracy was 0.97 (Figure 8b). This indicates that the trained model is reliable.

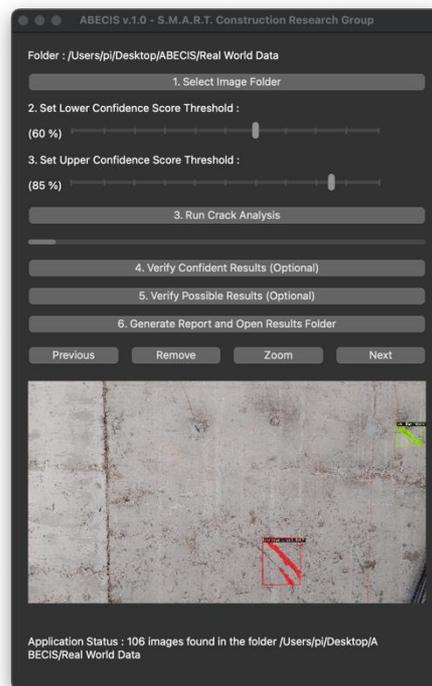
Figure 9: Graphical User Interface (GUI) for the ABECIS Software

Once the image segmentation model was trained, a cross-platform software application was developed using Detectron2 [49] for the deep learning component, PyQt6 [64] for the Graphical User Interface (GUI), and OpenCV for image processing [65]. The application has been tested on Windows and macOS. Although it has not been used in Linux, it should work in Linux, too. Full installation instructions and code is available in the GitHub repository [66]. All the functions described in Figure 5 have been implemented in the ABECIS Graphical User Interface (Figure 9).

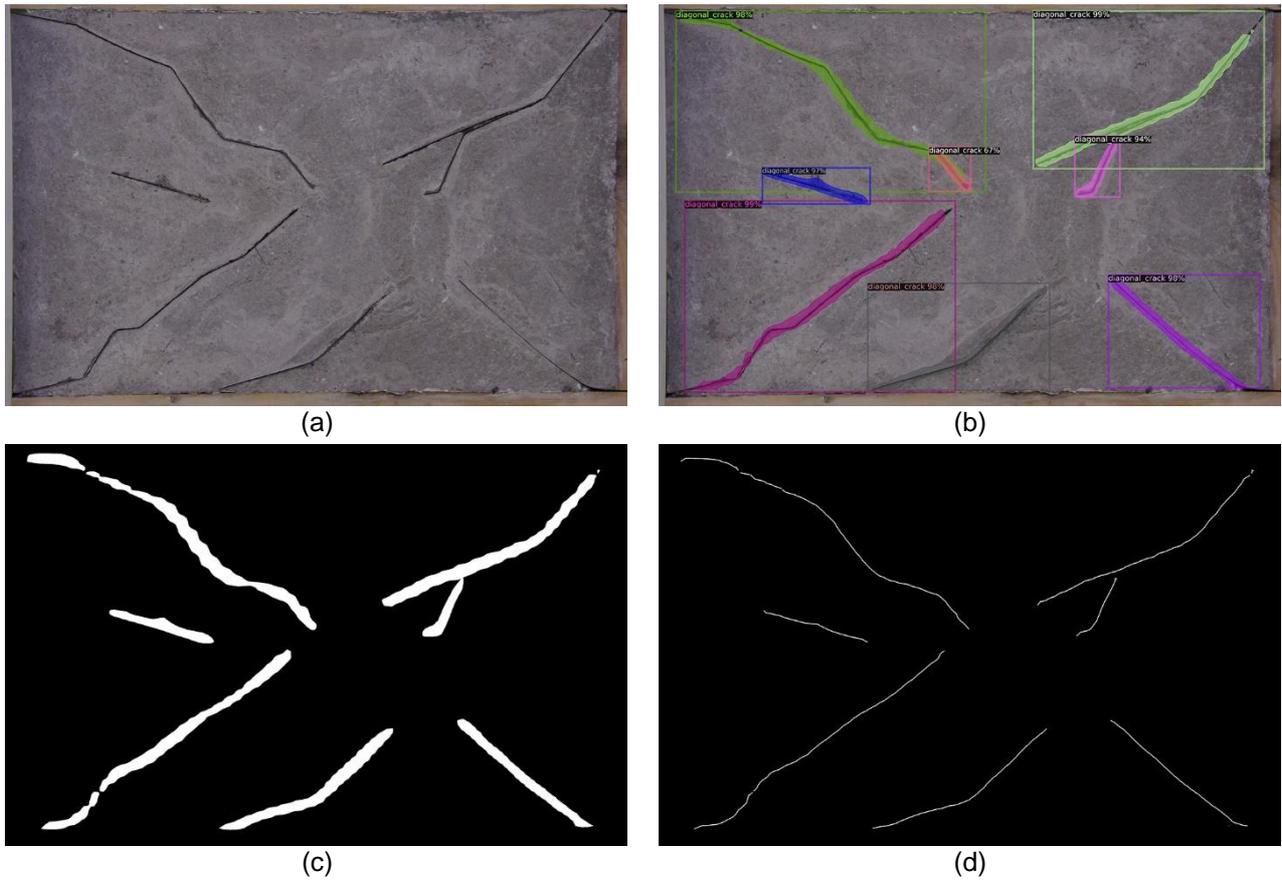
Figure 10: Different components of the crack length estimation process showing (a) original image, (b) instance segmentation of cracks, (c) binary mask resultant from the segmentation process, and (d) morphological thinning operation applied to the binary mask, resulting in lines with a width of 1-pixel.

As shown in Figure 10, the original image is analyzed for cracks, and the cracks are segmented. Then, the segmented cracks are converted to a binary mask, followed by the thinning process of the lines to 1-pixel width. Once the lines have a width of 1 pixel, the total length of the cracks in the image is simply the number of white pixels belonging to each crack. Without a metric reference in the image or information regarding the scale, it is not possible to get a proportional conversion between pixels and real-world measurements.

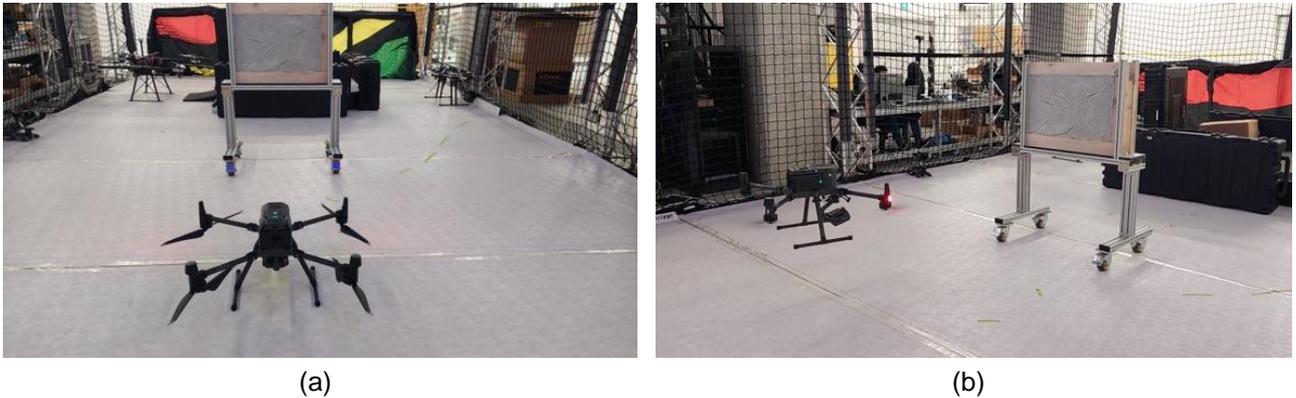
Figure 11: General views of the experimental setup showing the mockup wall with concrete cracks and the drone used in (a) standby mode and (b) in operation (i.e., flying and taking images)

A movable mockup wall and a drone were used for the laboratory test (Figure 11). The mockup wall consisted of a concrete surface (approximate dimensions 63 cm height by 76 cm long) with a wood frame and 7 diagonal cracks. It was mounted on an aluminum frame with wheels for ease of transport. The drone was a DJI Matrice 300 RTK commercial. Altogether, 14 images were taken (the images can be found in [69]) and analyzed using ABECIS. The results (i.e., IoU and length) from these images are in Appendix B (Table 6).

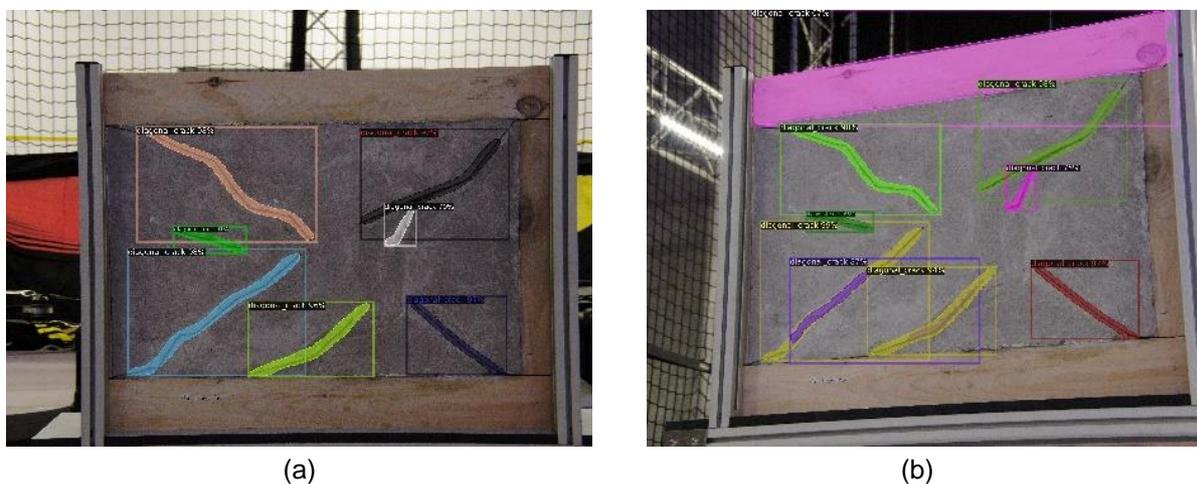
Figure 12: Crack detection results from the experiment in the lab. (a) Annotations (b) False-positive segmentation of a non-crack object (upper member frame surrounding concrete wall).

From the visual inspection of the different images and the result summarized in the report, it was found that the ABECIS system was able to successfully detect all the cracks in the controlled laboratory environment (Figure 12a), with just a small number of false positives. The false positives occurred when the image contained the surrounding objects in addition to the wall. In such cases, surrounding objects (similar to cracks) were classified as cracks (Figure 12b).

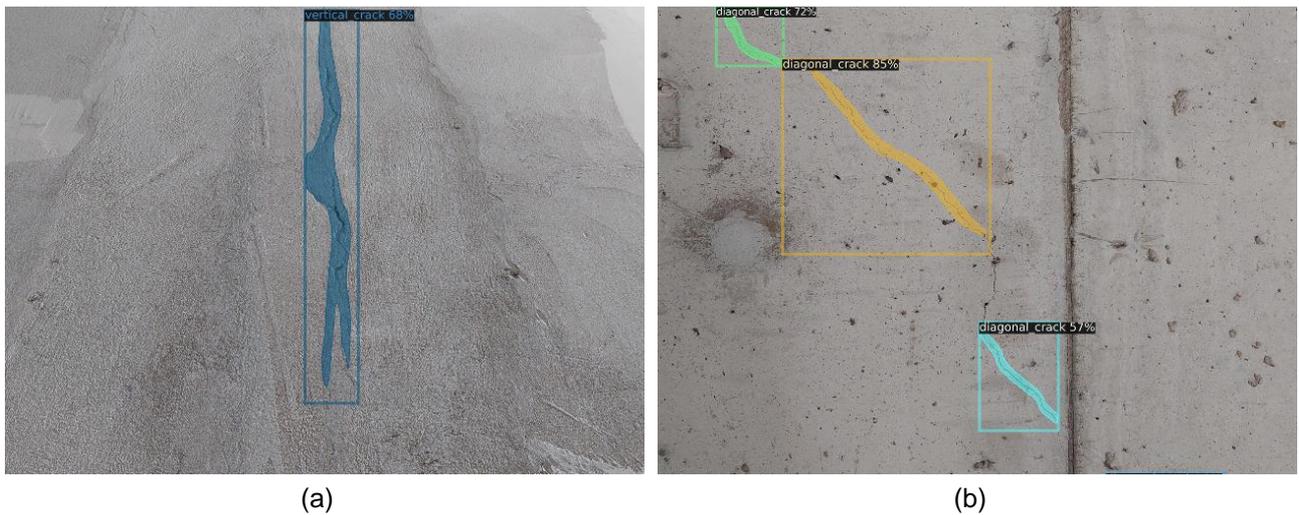
Figure 13: Examples of correctly detected (a) vertical and (b) diagonal cracks from the indoor construction site images taken using a smartphone

For the on-site test, the authors visited an ongoing construction site at the New York University Abu Dhabi campus and took images using an Android smartphone with a 1.9 Megapixel camera. Altogether 14 images were taken (the images can be found in [69]), and the reports were generated using ABECIS software. The results can be found in Appendix B (Table 7). Although there are not many cracks in the construction site, the ones present were correctly detected with varying degrees of accuracy (Figure 13).

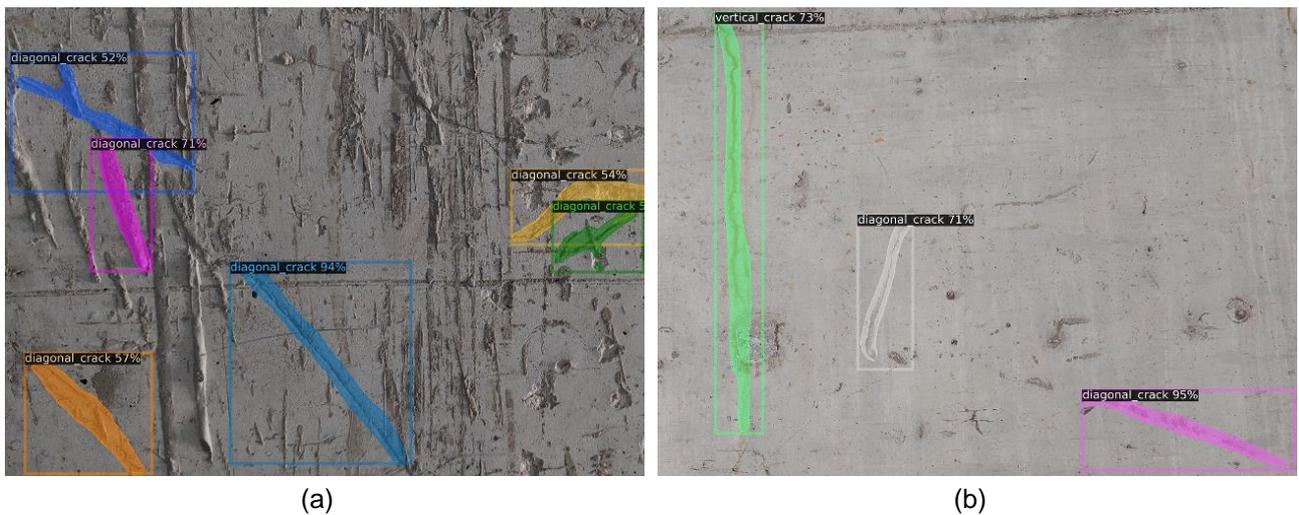
Figure 14: Construction Site false positive examples. (a) Scratches identified as cracks. (b) Liquid stains identified as cracks.

However, there are also several false positives. These are mainly due to objects that are very similar to cracks (e.g., scratches, markings on walls, pipes, wires). Some examples can be seen in Figure 14. It is worth mentioning that a real construction site is an extremely difficult scenario for a segmentation process. Nonetheless, all the true positives were detected, and all the resultant false positives can be manually discarded with an easy manual operation from the ABECIS GUI.

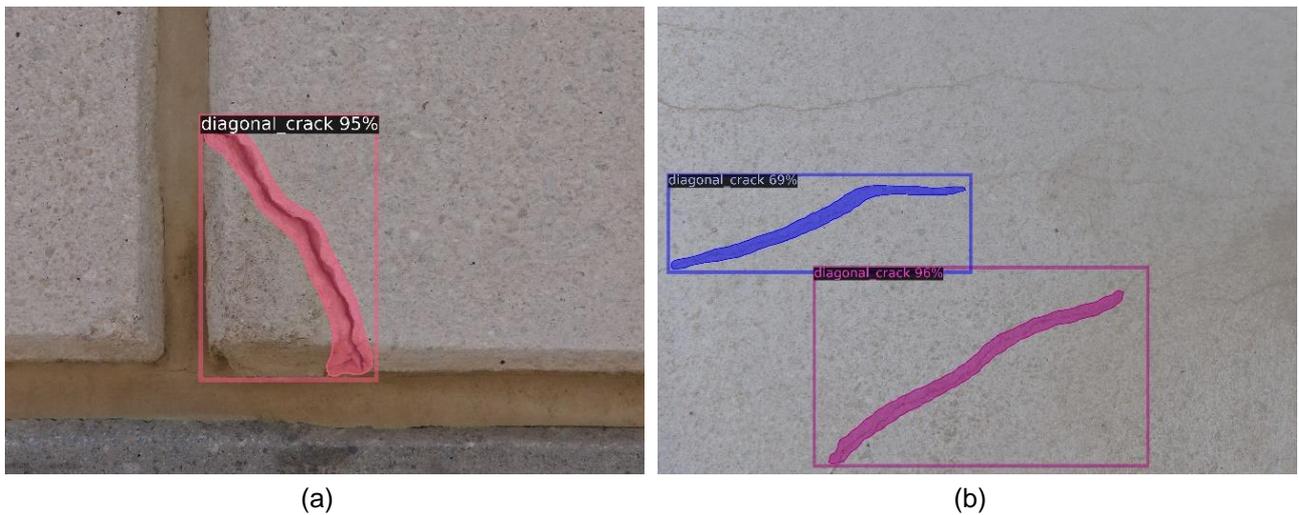
Figure 15: Examples of correctly detected cracks from outdoor images taken with a drone. (a) Single diagonal crack. (b) Multiple hairline cracks.

Moreover, for the outdoor test, the authors also took images of the surrounding areas of the New York University Abu Dhabi campus using a DJI Matrice 300 RTK commercial drone. Altogether, 14 images were taken (the images can be found in [69]), and the results can be seen in Appendix B (Table 8). A few cracks found were detected (e.g., Figure 15). However, the algorithm occasionally missed very thin hairline-type cracks (Figure 15b).

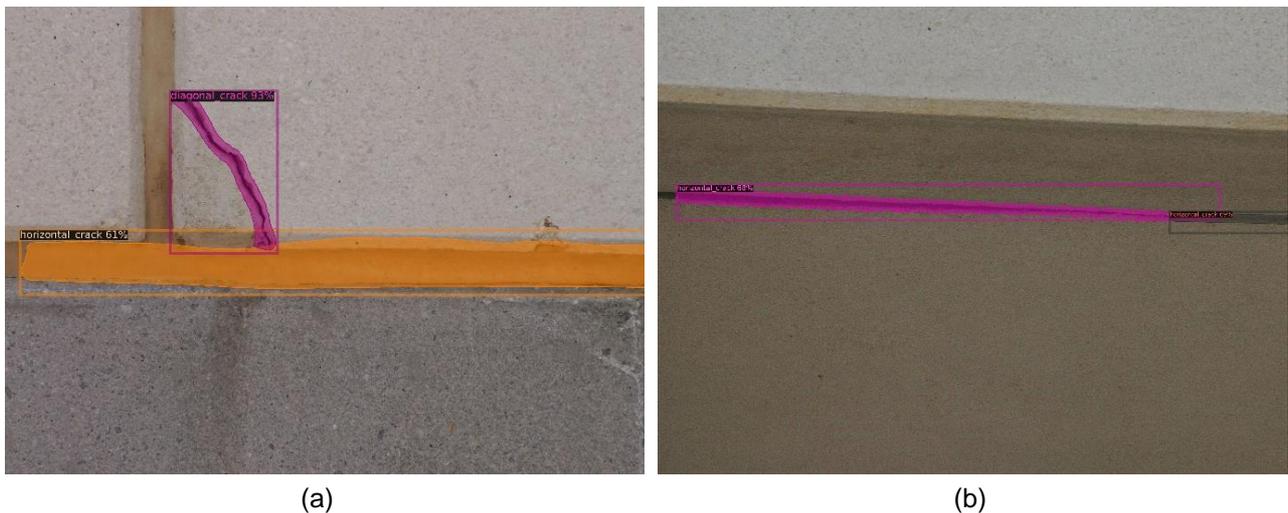
Figure 16: False positives examples from the outdoor experiment. (a) Control joint/filler between walls, identified as a horizontal crack. (b) Area between parapet wall (vertical element) and ceiling panel (horizontal element) detected as crack.

There were a few false positives in the outdoor drone experiment. Many were related to objects resembling cracks, such as the control joints with fillers or areas between the walls or concrete slabs, as in Figure 16a or the gap between two concrete slabs, as in Figure 16b.

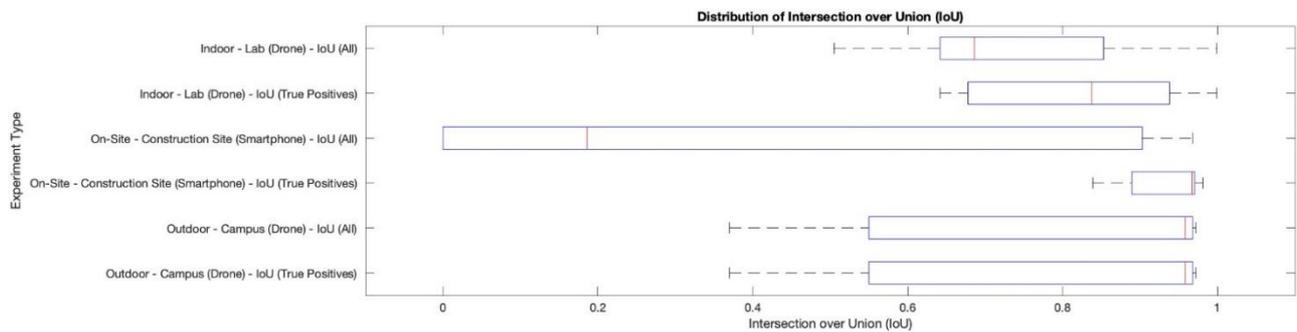
Figure 17: Distribution of IoU for different experiment types. IoU (All) refers to the distribution of IoU from the raw predictions from the algorithm. IoU (True Positives) refers to the distribution of IoU after the human operator has removed all false positives from the results.

For the IoU for all images, the median of IoU is (1) 0.686 for the indoor crack detection experiment in a controlled lab environment using a commercial drone, (2) 0.186 for the on-site crack detection at a construction site using a smartphone and (3) 0.968 for the outdoor crack detection at the NYUAD campus using a commercial drone. The interquartile range is the smallest for the Indoor Lab experiment, followed by the Outdoor Campus Experiment and the On-Site Construction Site Experiment.

However, only considering the true positives after human verification, the median of IoU is (1) 0.838 for the indoor crack detection experiment in a controlled lab environment using a commercial drone, (2) 0.967 for the on-site crack detection at a construction site using a smartphone and (3) 0.968 for the outdoor crack detection at the NYUAD campus using a commercial drone. The interquartile range is the smallest for the On-Site Construction Site Experiment, followed by the Indoor Lab experiment and the Outdoor Campus Experiment.

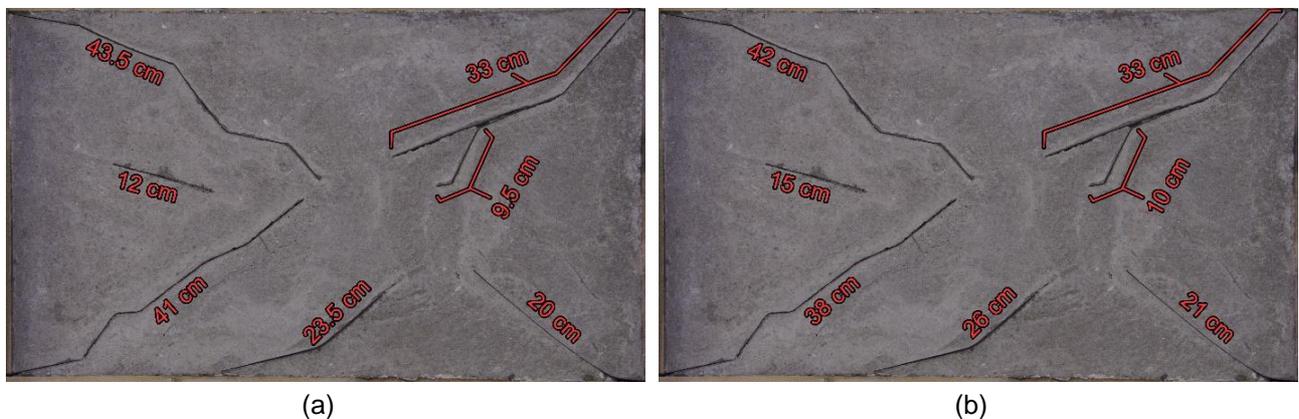
Figure 18: (a) Original dimensions of cracks on the mockup wall, and (b) corresponding predictions

Another of the features provided by ABECIS is the crack length estimation. It is worth mentioning that the length measurement given in metric units is only possible if the image has a scale reference to obtain a proportional relationship between the pixel and real-world dimensions or if the image was taken with a device able to measure the distance to the wall (such as the DJI Matrice 300 RTK used in this experiment). The crack length is a useful metric that can assist inspectors in getting a better assessment of the state of the building and if the crack needs urgent repairing or not (also, it would be useful information to generate preliminary repair scopes and cost estimates); therefore, it is a valuable asset to be included in the final report generated by ABECIS. In order to test the effectiveness and robustness of the estimations calculated by ABECIS, the controlled lab environment with the mockup wall was used. The ground-truth measurements and the predicted lengths of the cracks present in the mockup wall can be seen in Figure 18.

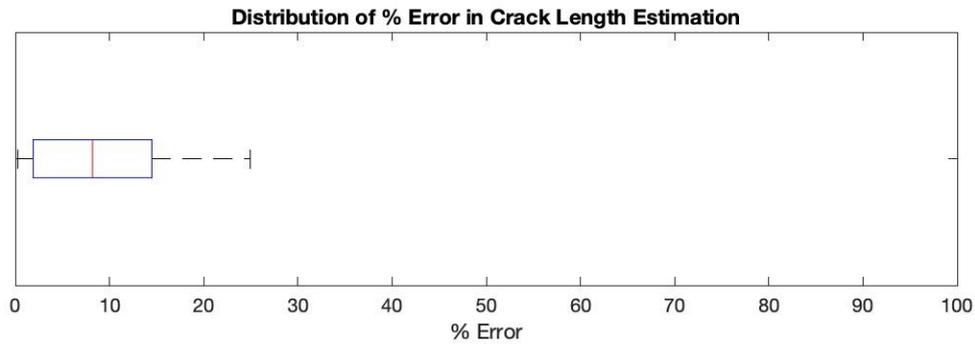
Figure 19: Distribution of % Error in Crack Length Estimation

The length estimations computed for each of the 14 images can be seen in Appendix C (Table 9). The results in the Appendix correspond to the sum of the estimated lengths for all the successfully detected cracks on each image. The computed error is the difference between this value and the sum of all the ground-truth distances. Table 3 and Figure 19 summarize the measurements from the 14 images. The error median is 8.2%, which is an acceptable margin to provide qualitative assessments of the crack lengths.

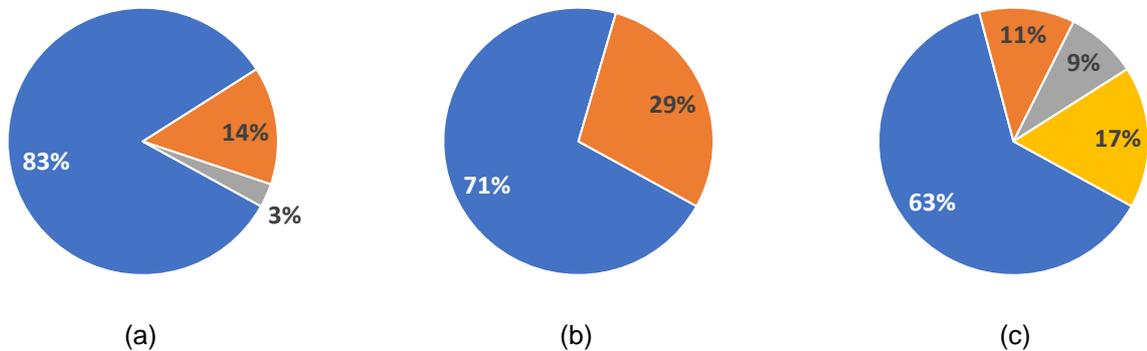
Figure 20. Graphical representation of the most representative columns from Table 5. (a) Level of automation – blue, orange, and grey for SA-semi-autonomous, FA-fully autonomous and M-manual, respectively. (b) Percentage of papers that provide a quantitative evaluation – blue yes, orange no. (c) Classification according to the type of structure – blue, orange, grey and yellow for concrete, asphalt, metal, and other, respectively.

Main elements from Table 5 are broken down in Figure 20.
